# Salt Marsh Adaptation Strategies in Light of Sea Level Rise

**Wenley Ferguson**  
**Land and Water Summit 2015**

**SAVE THE BAY®**

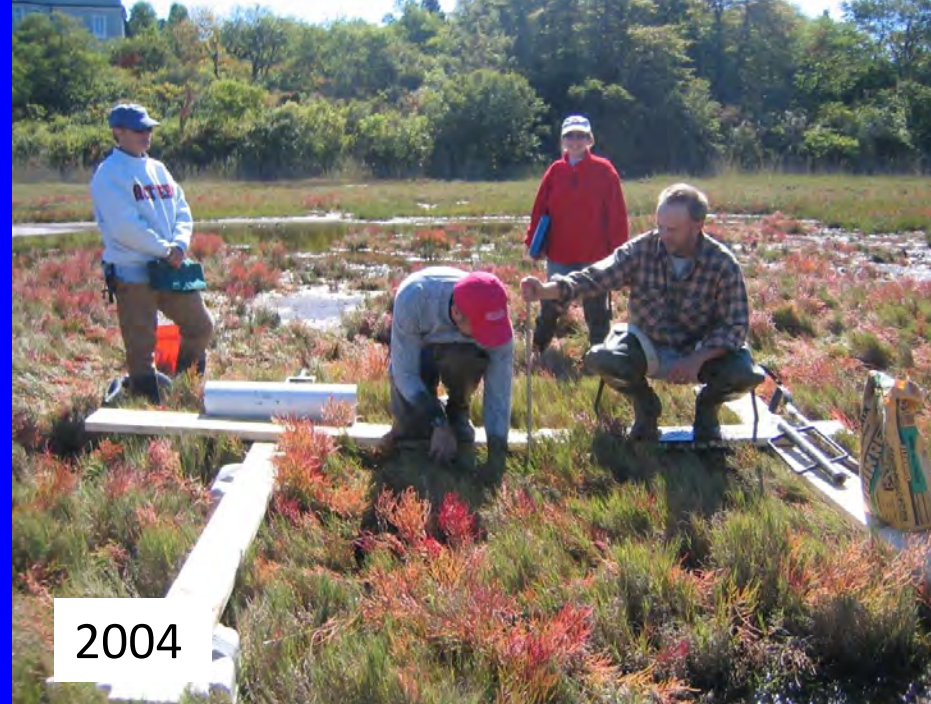
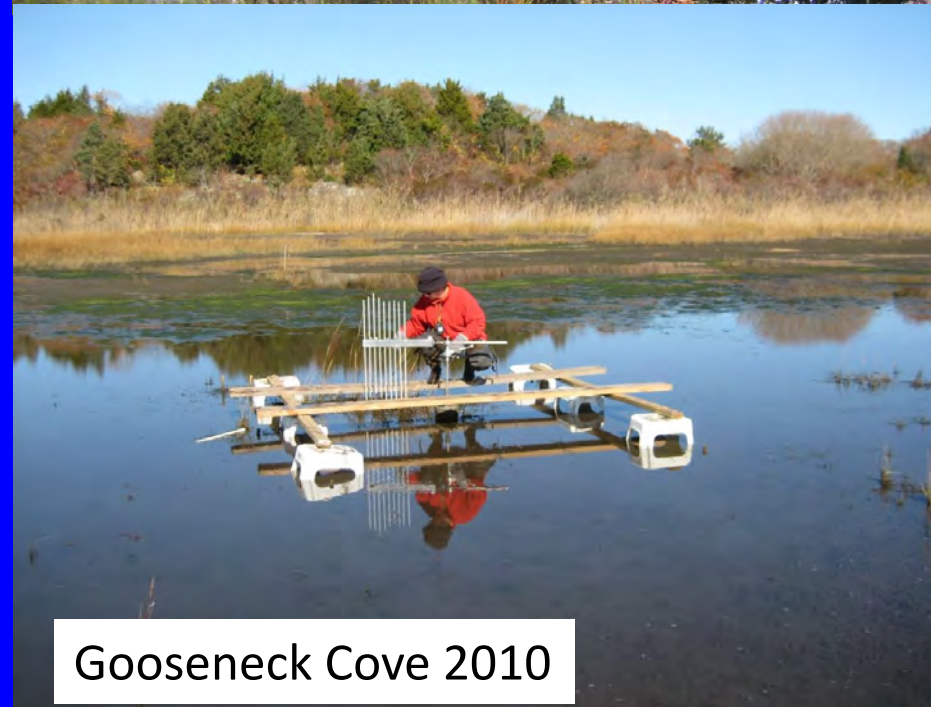
Gooseneck Cove 2010

- Monitoring tidally restricted marshes has shown that conditions can change rapidly
- Similar degraded conditions have been found in marshes with no tidal restrictions
- Increased rate of sea level rise could be major driver of change

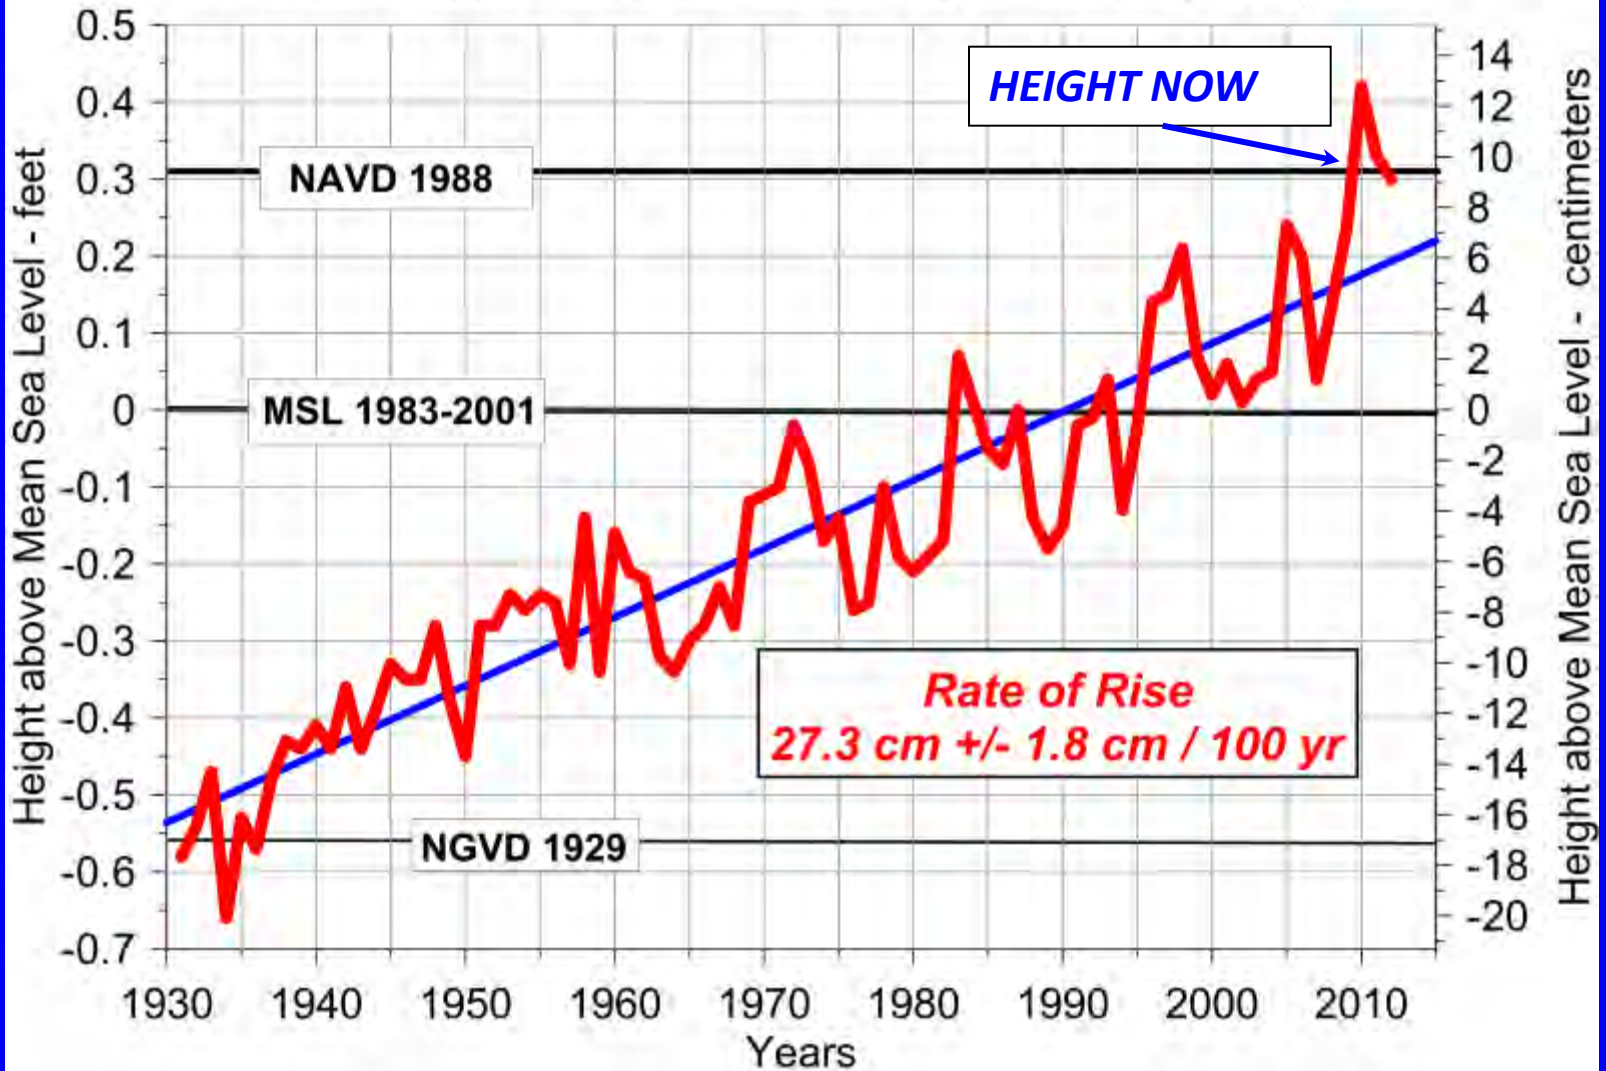
# HISTORIC SEA-LEVEL RISE - Newport, RI

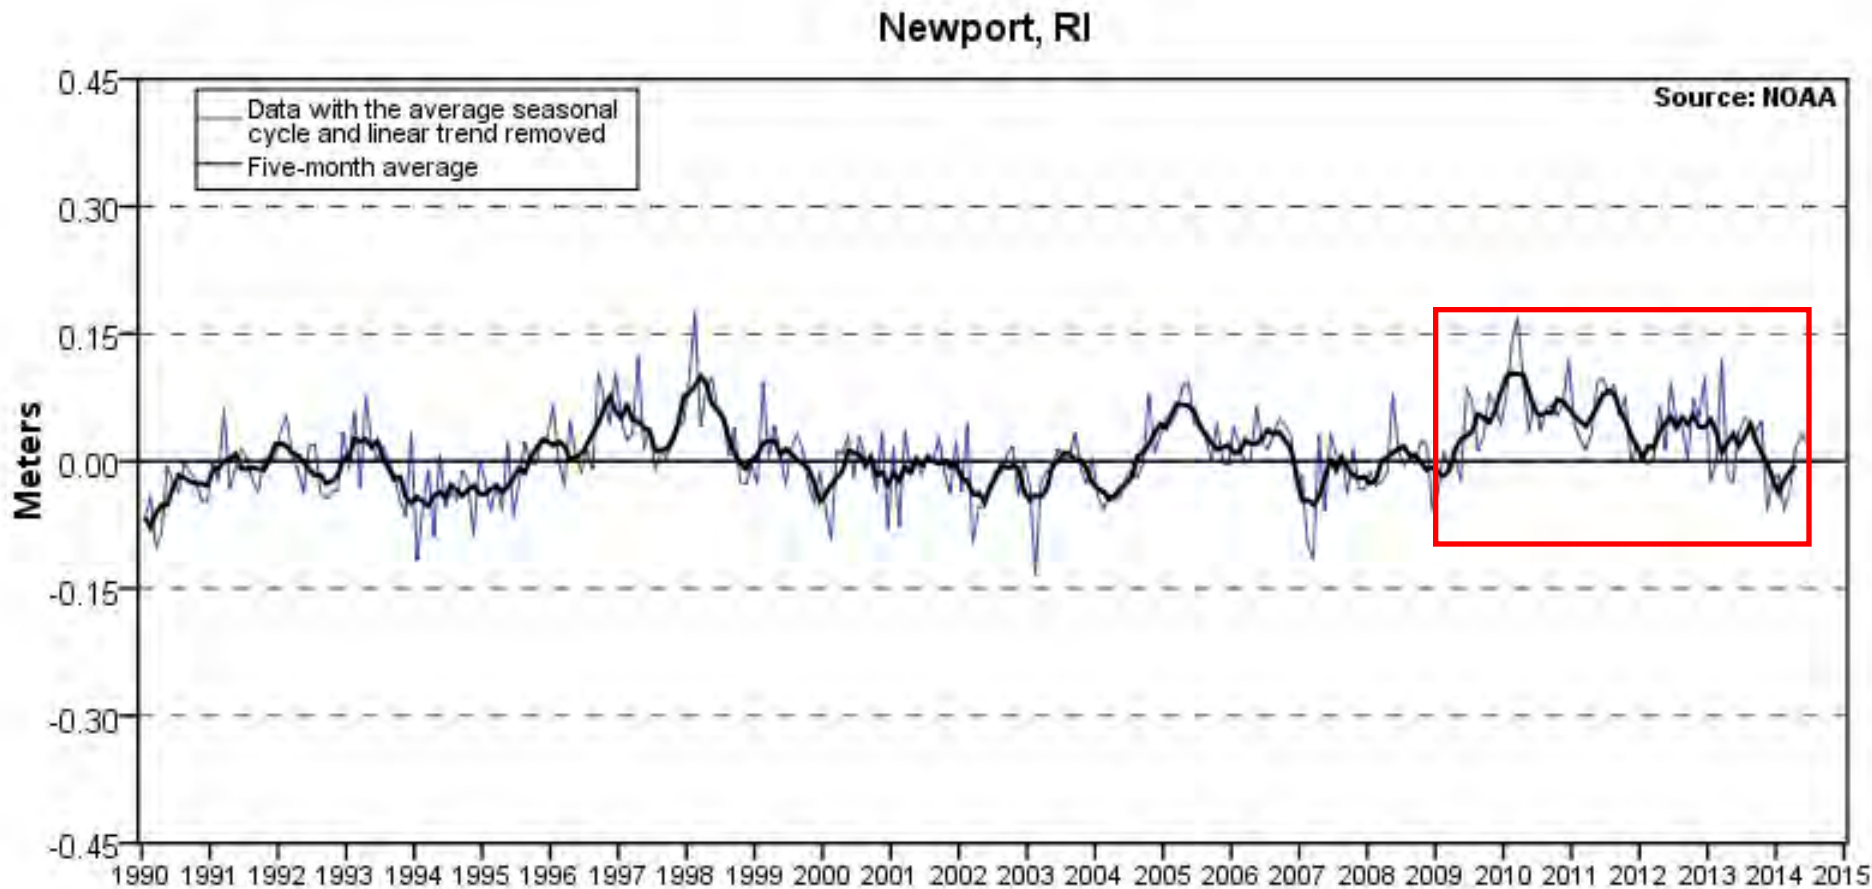
# Interannual variation since 1990 at Newport, RI

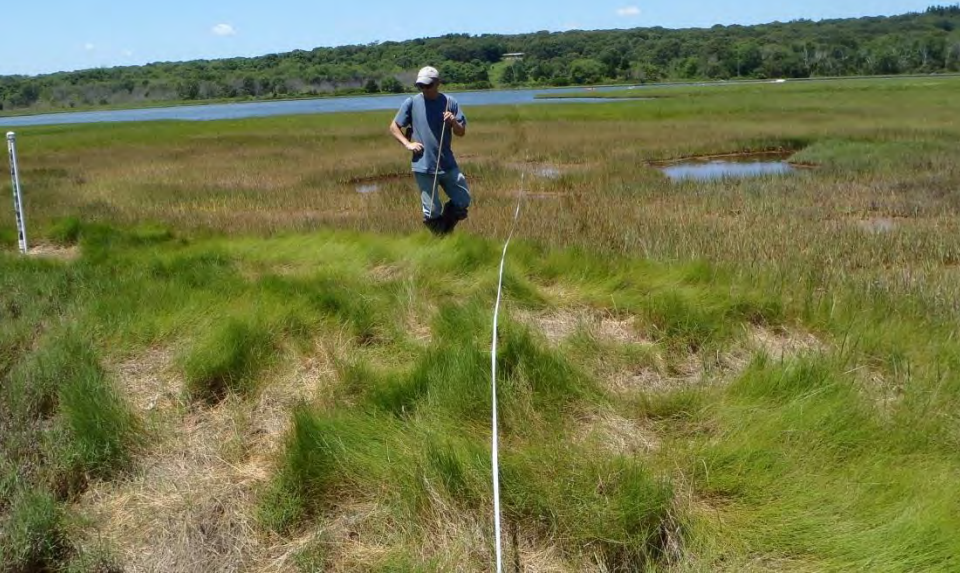
# Belt Transect

- Monitored vegetation every 10 meters and width of plant communities
- Measured bearing capacity
- Additional data: salinity, mosquito density, fish presence

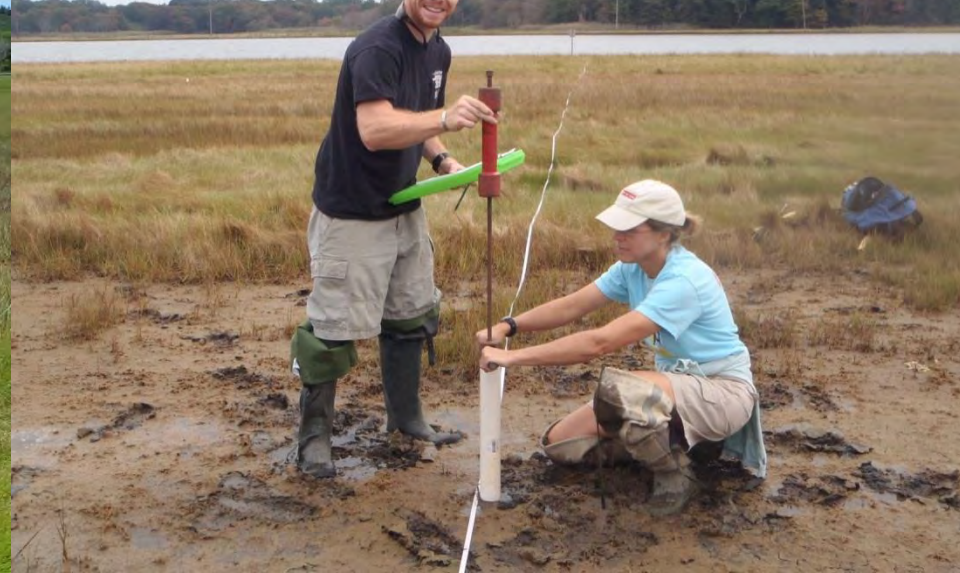
# Bearing Capacity

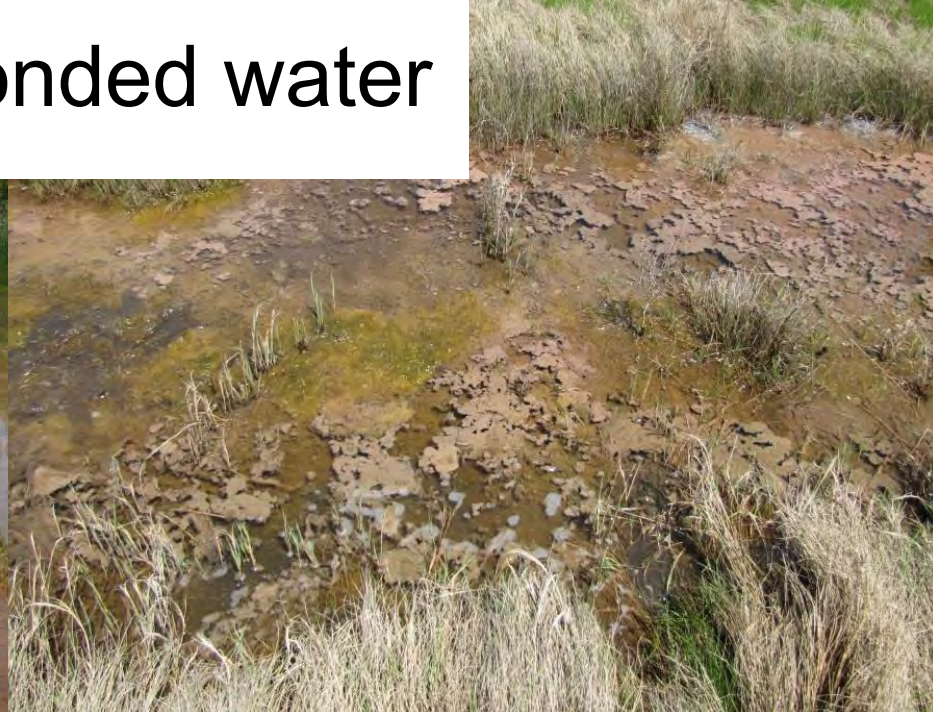
Defined pool in foreground versus shallow standing water

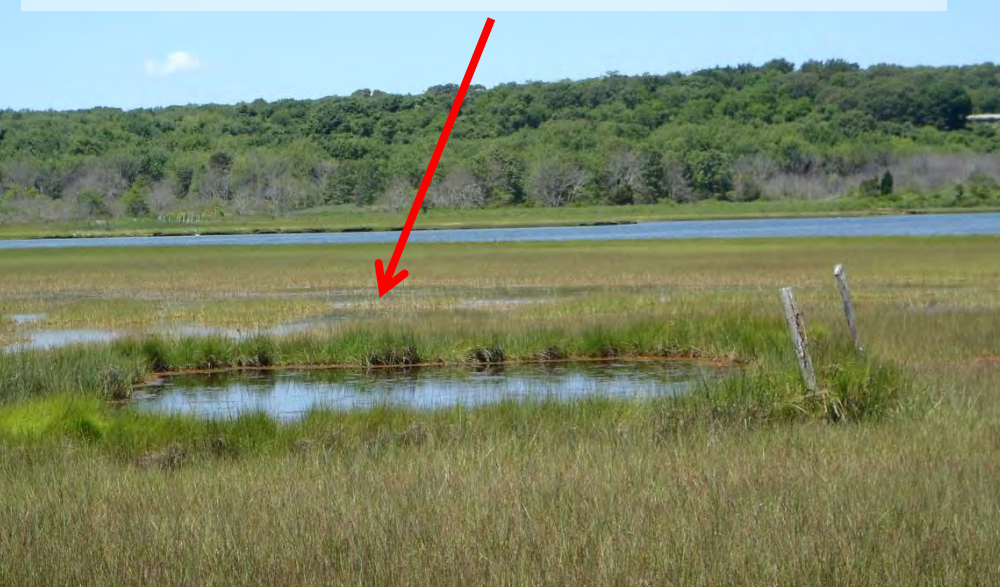
Mosquito breeding habitat

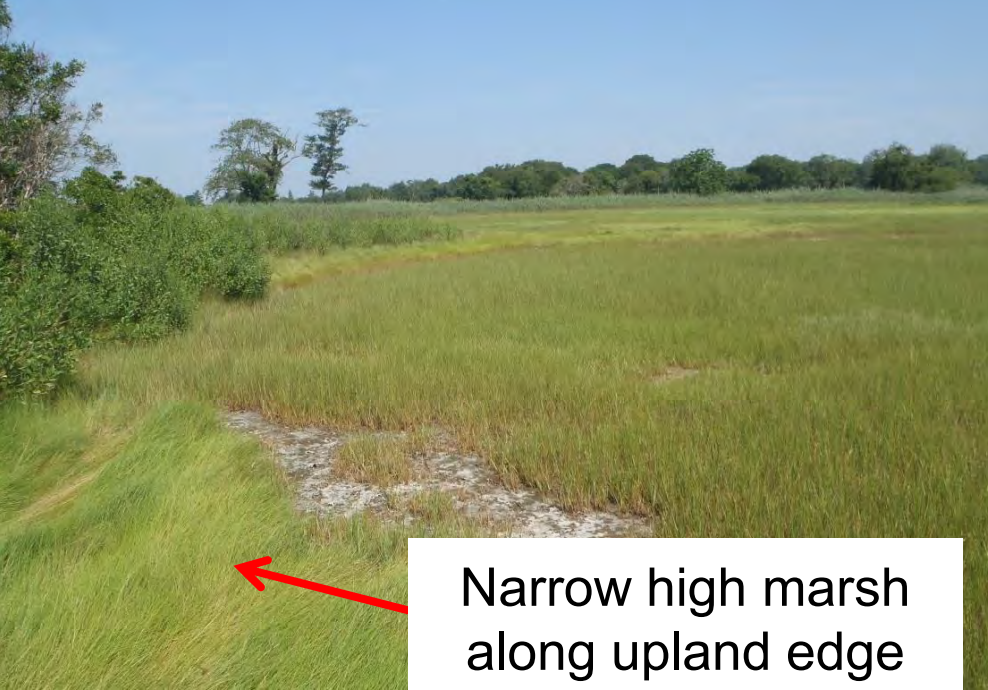
Narrow high marsh  
along upland edge

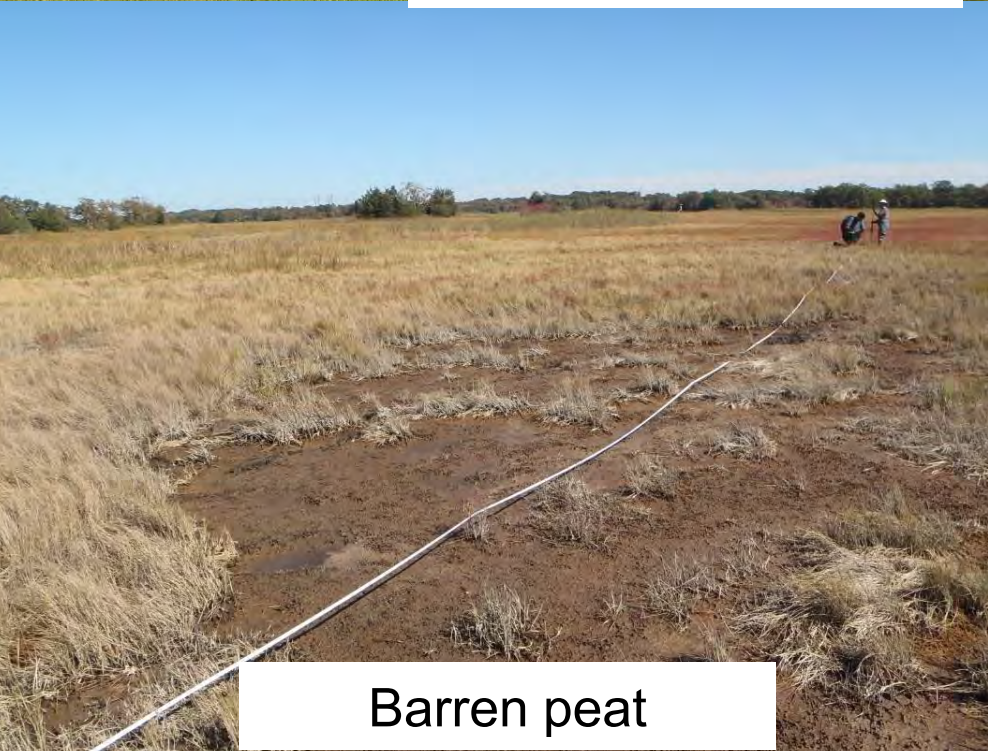
Barren peat

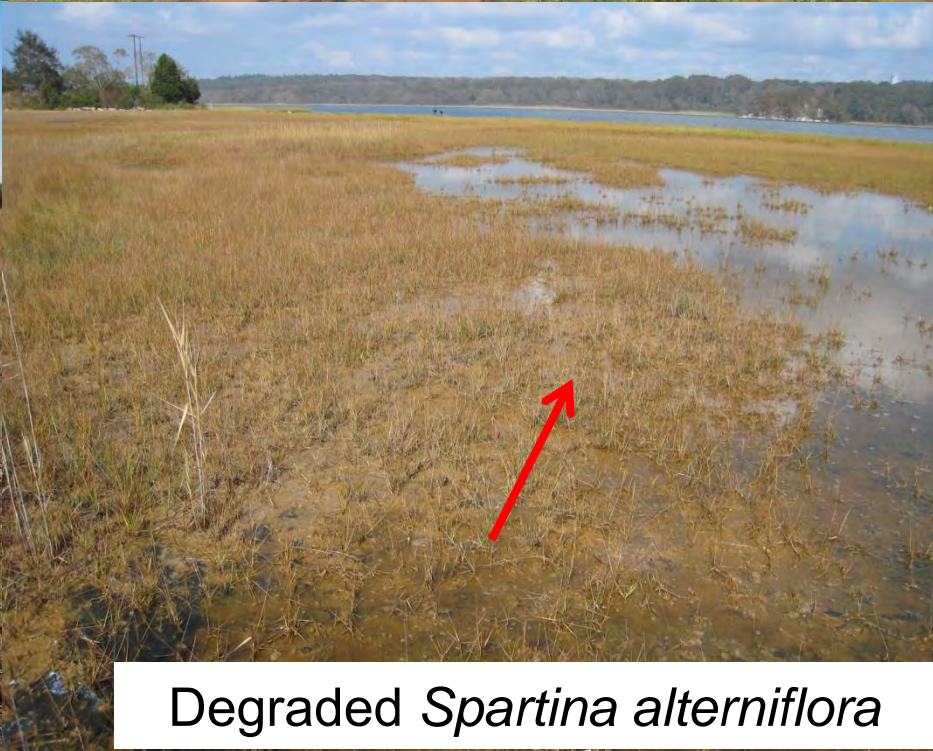
Degraded *Spartina alterniflora*

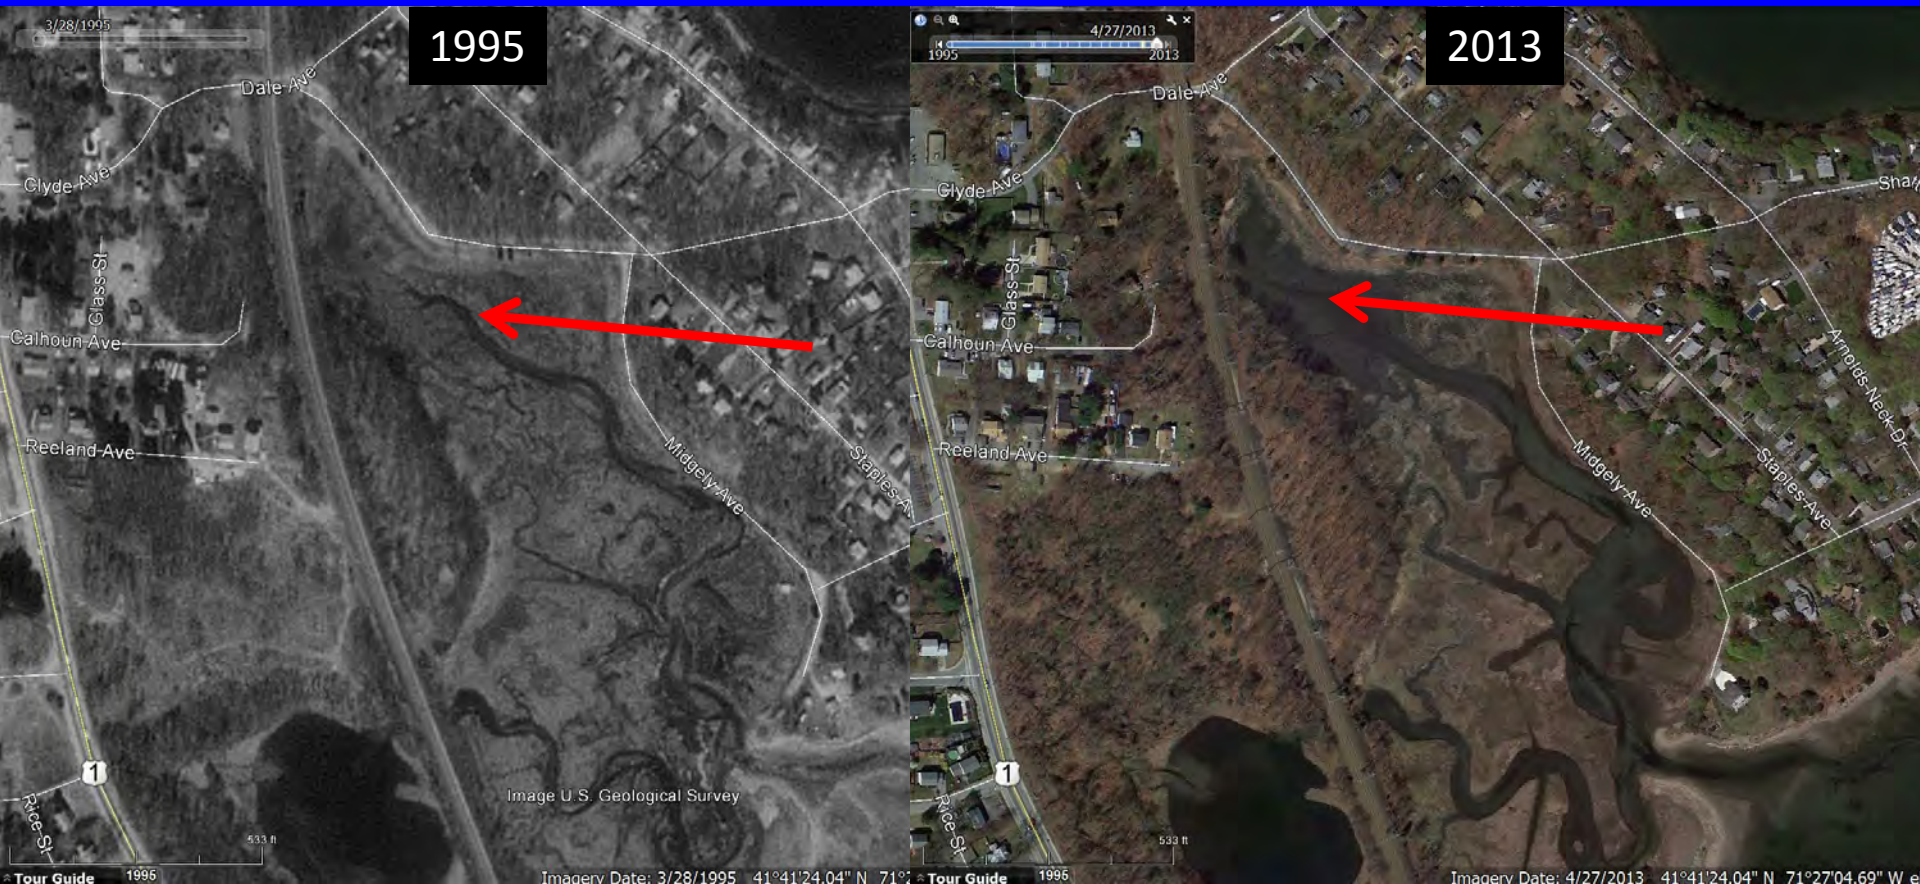
# Marsh Loss: Mary's Creek, Warwick

## 1995-2013

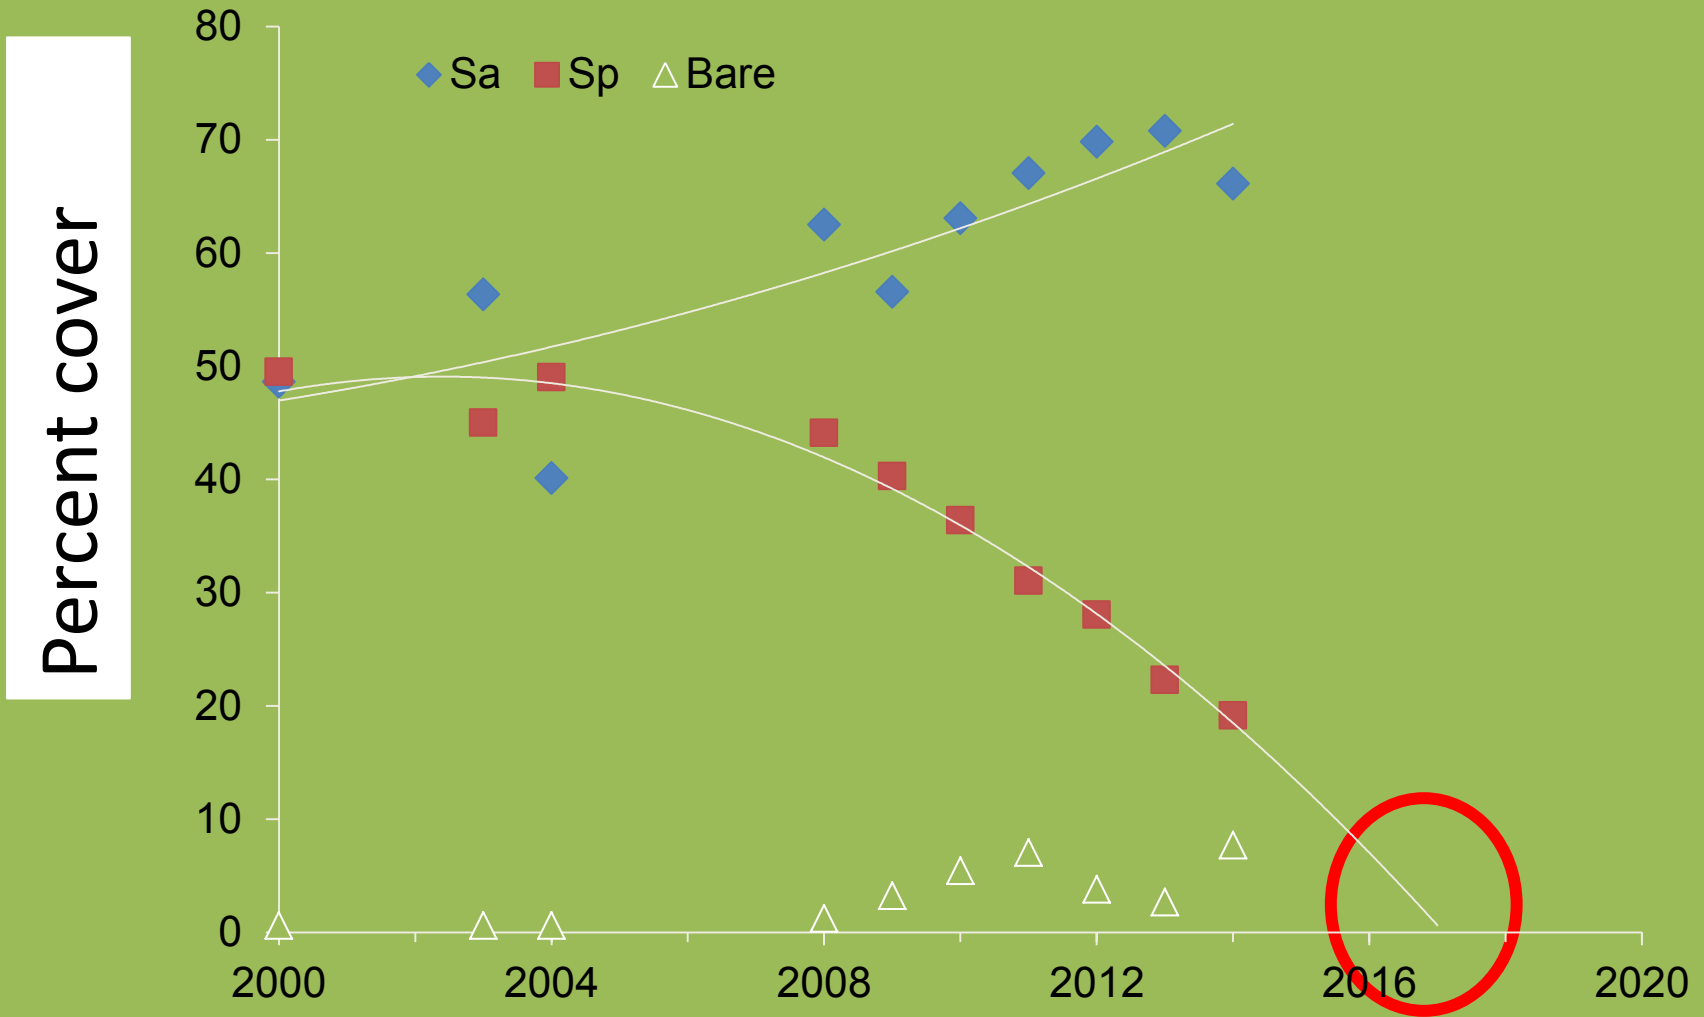
# Coggeshall Marsh: Rapid loss of *Spartina patens*

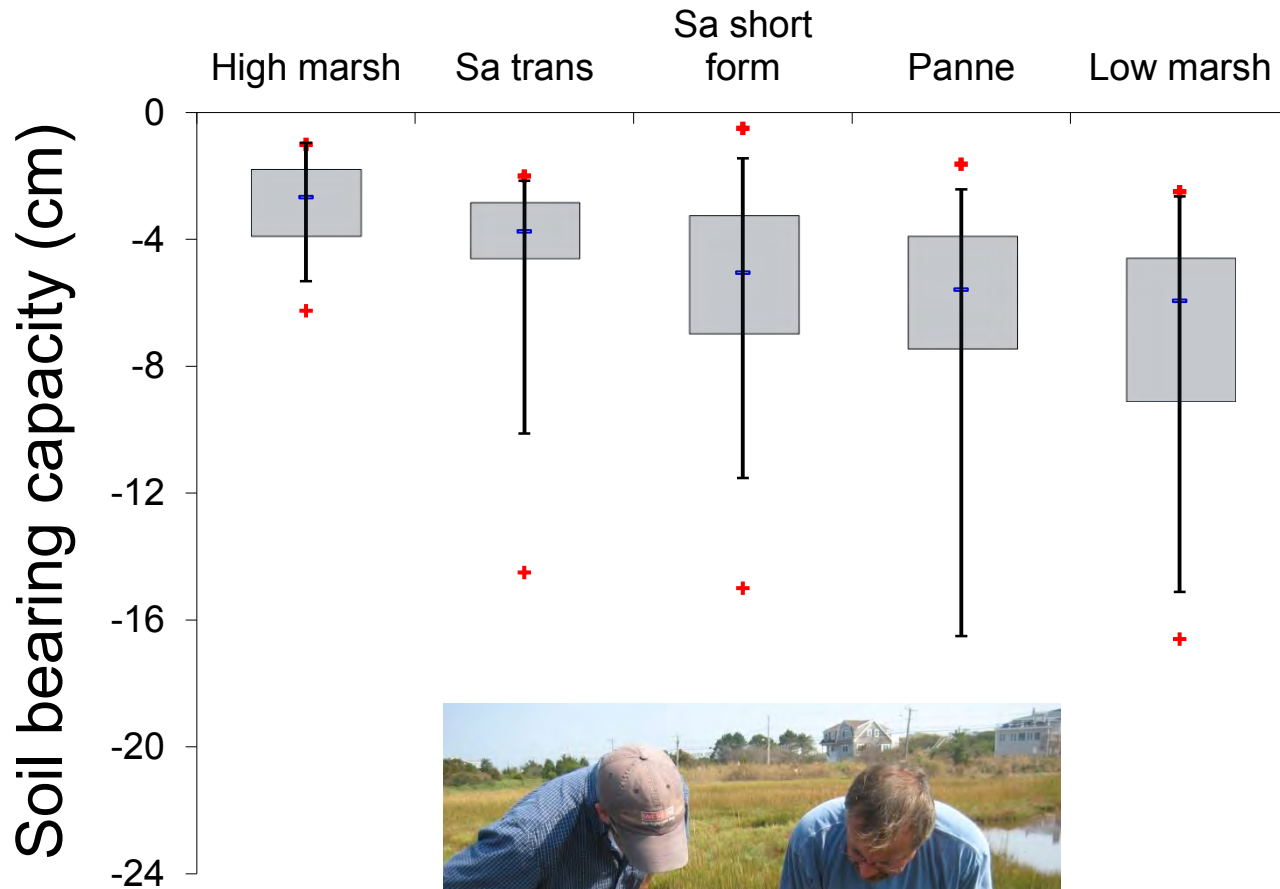
# Bearing Capacity Results

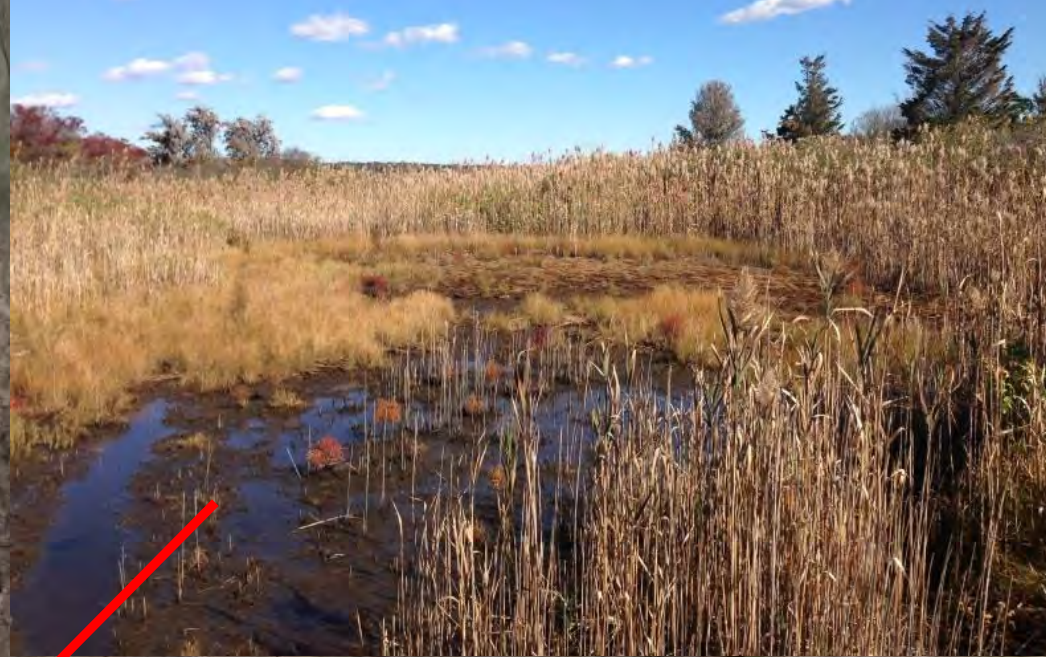
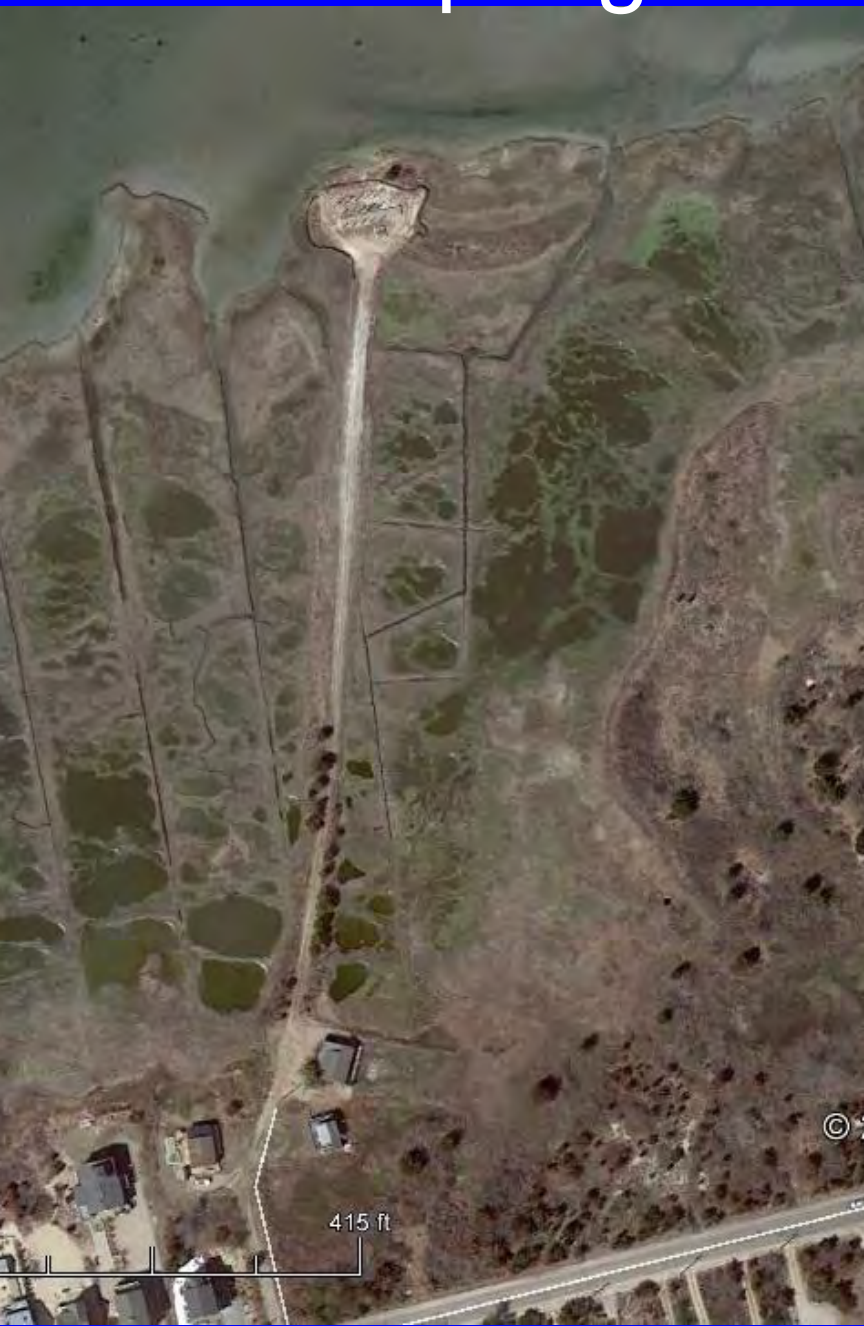
# Winnapaug Pond Marsh

Marsh migration occurring yet impounded water creating mosquito breeding habitat

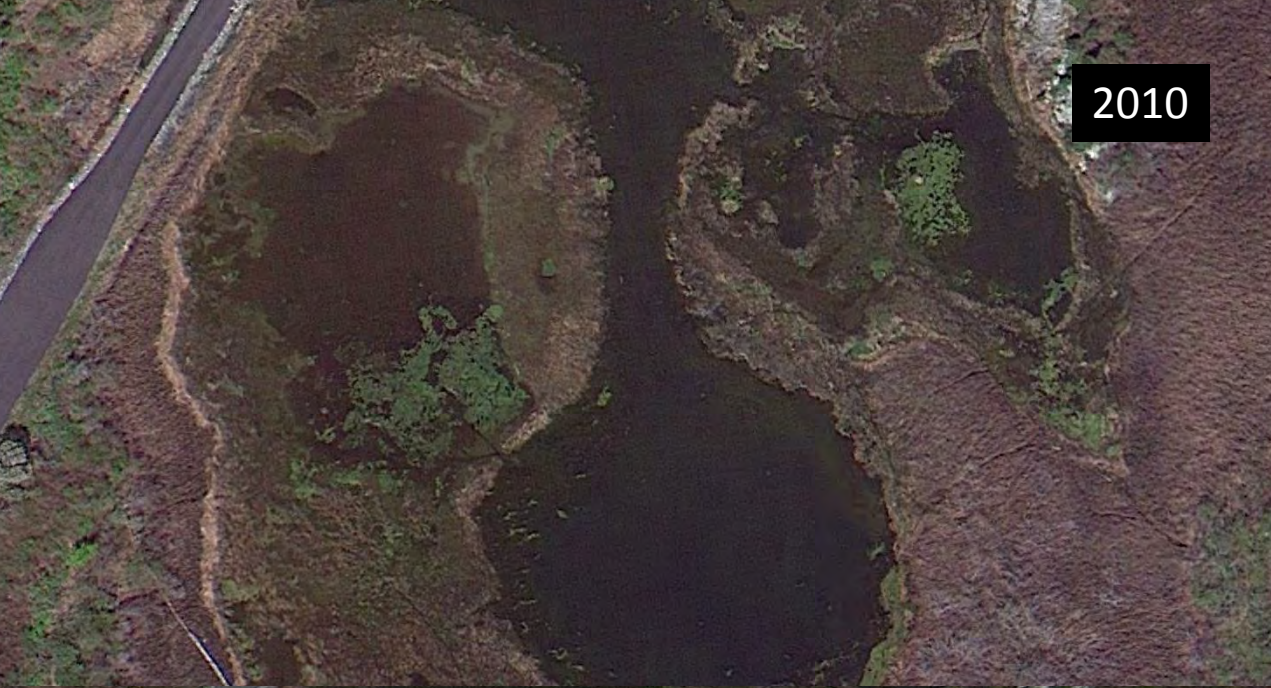
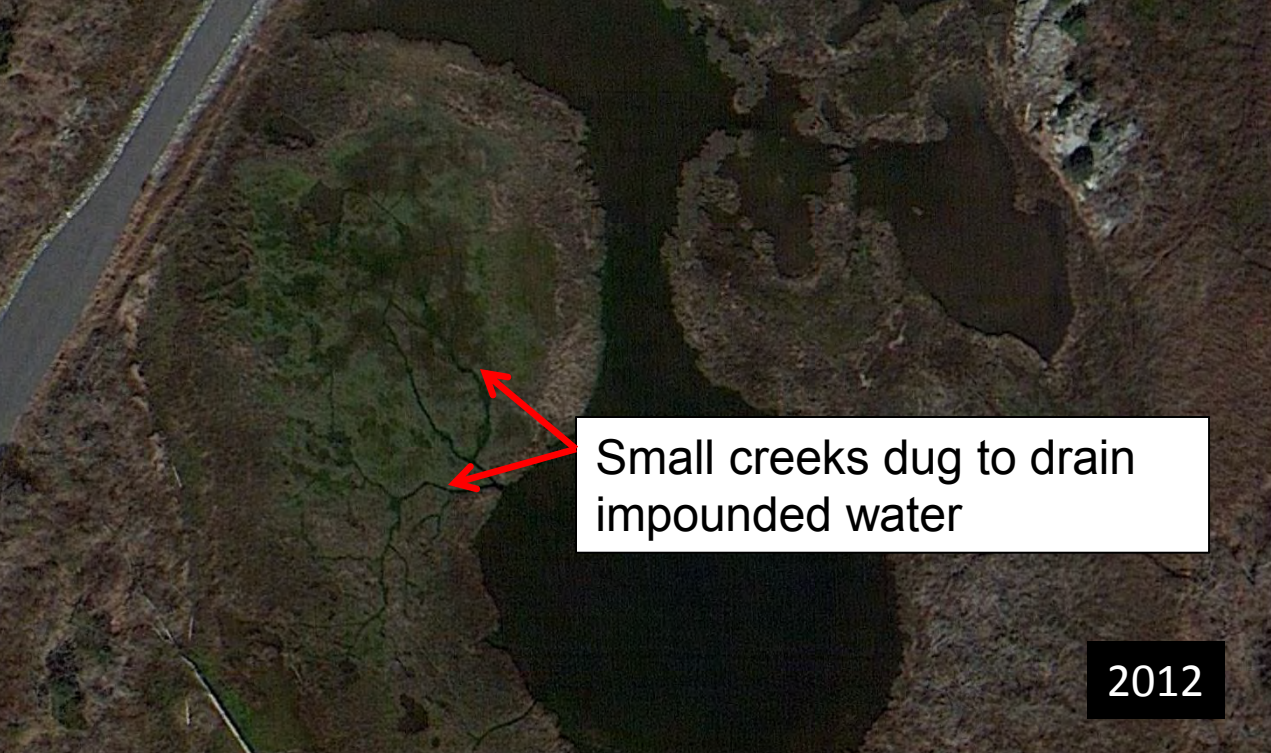
# Gooseneck Cove adaptive management

Small creeks dug to drain  
impounded water

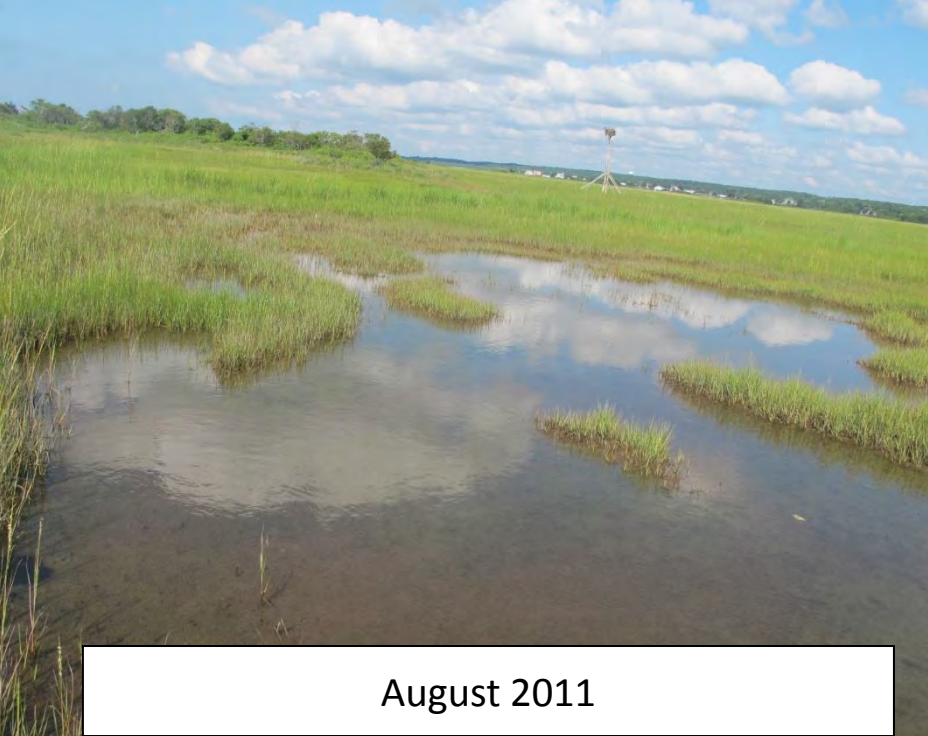
August 2011

# Winnapaug Marsh adaptation project

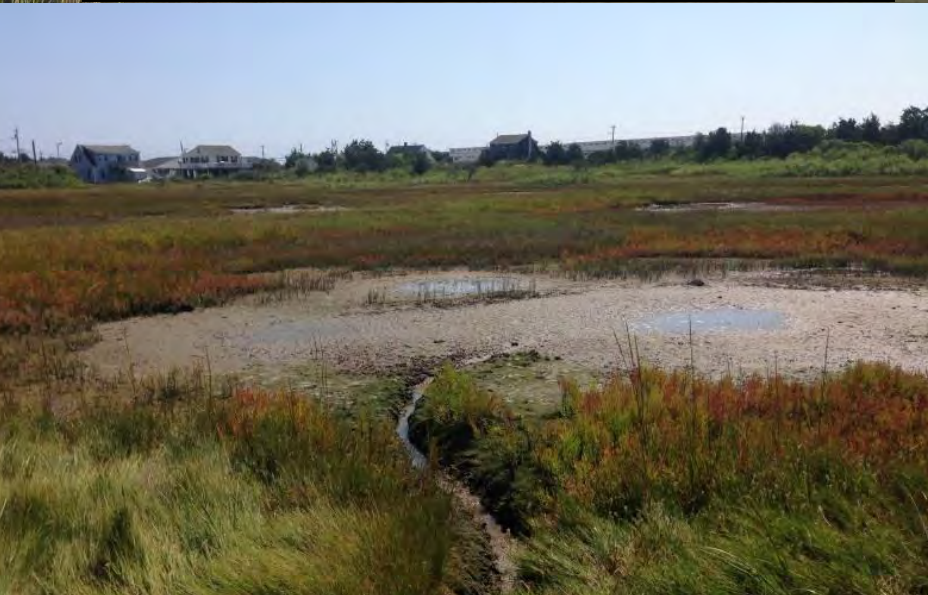
Runnel and revegetation along edge of former ponded area 2014

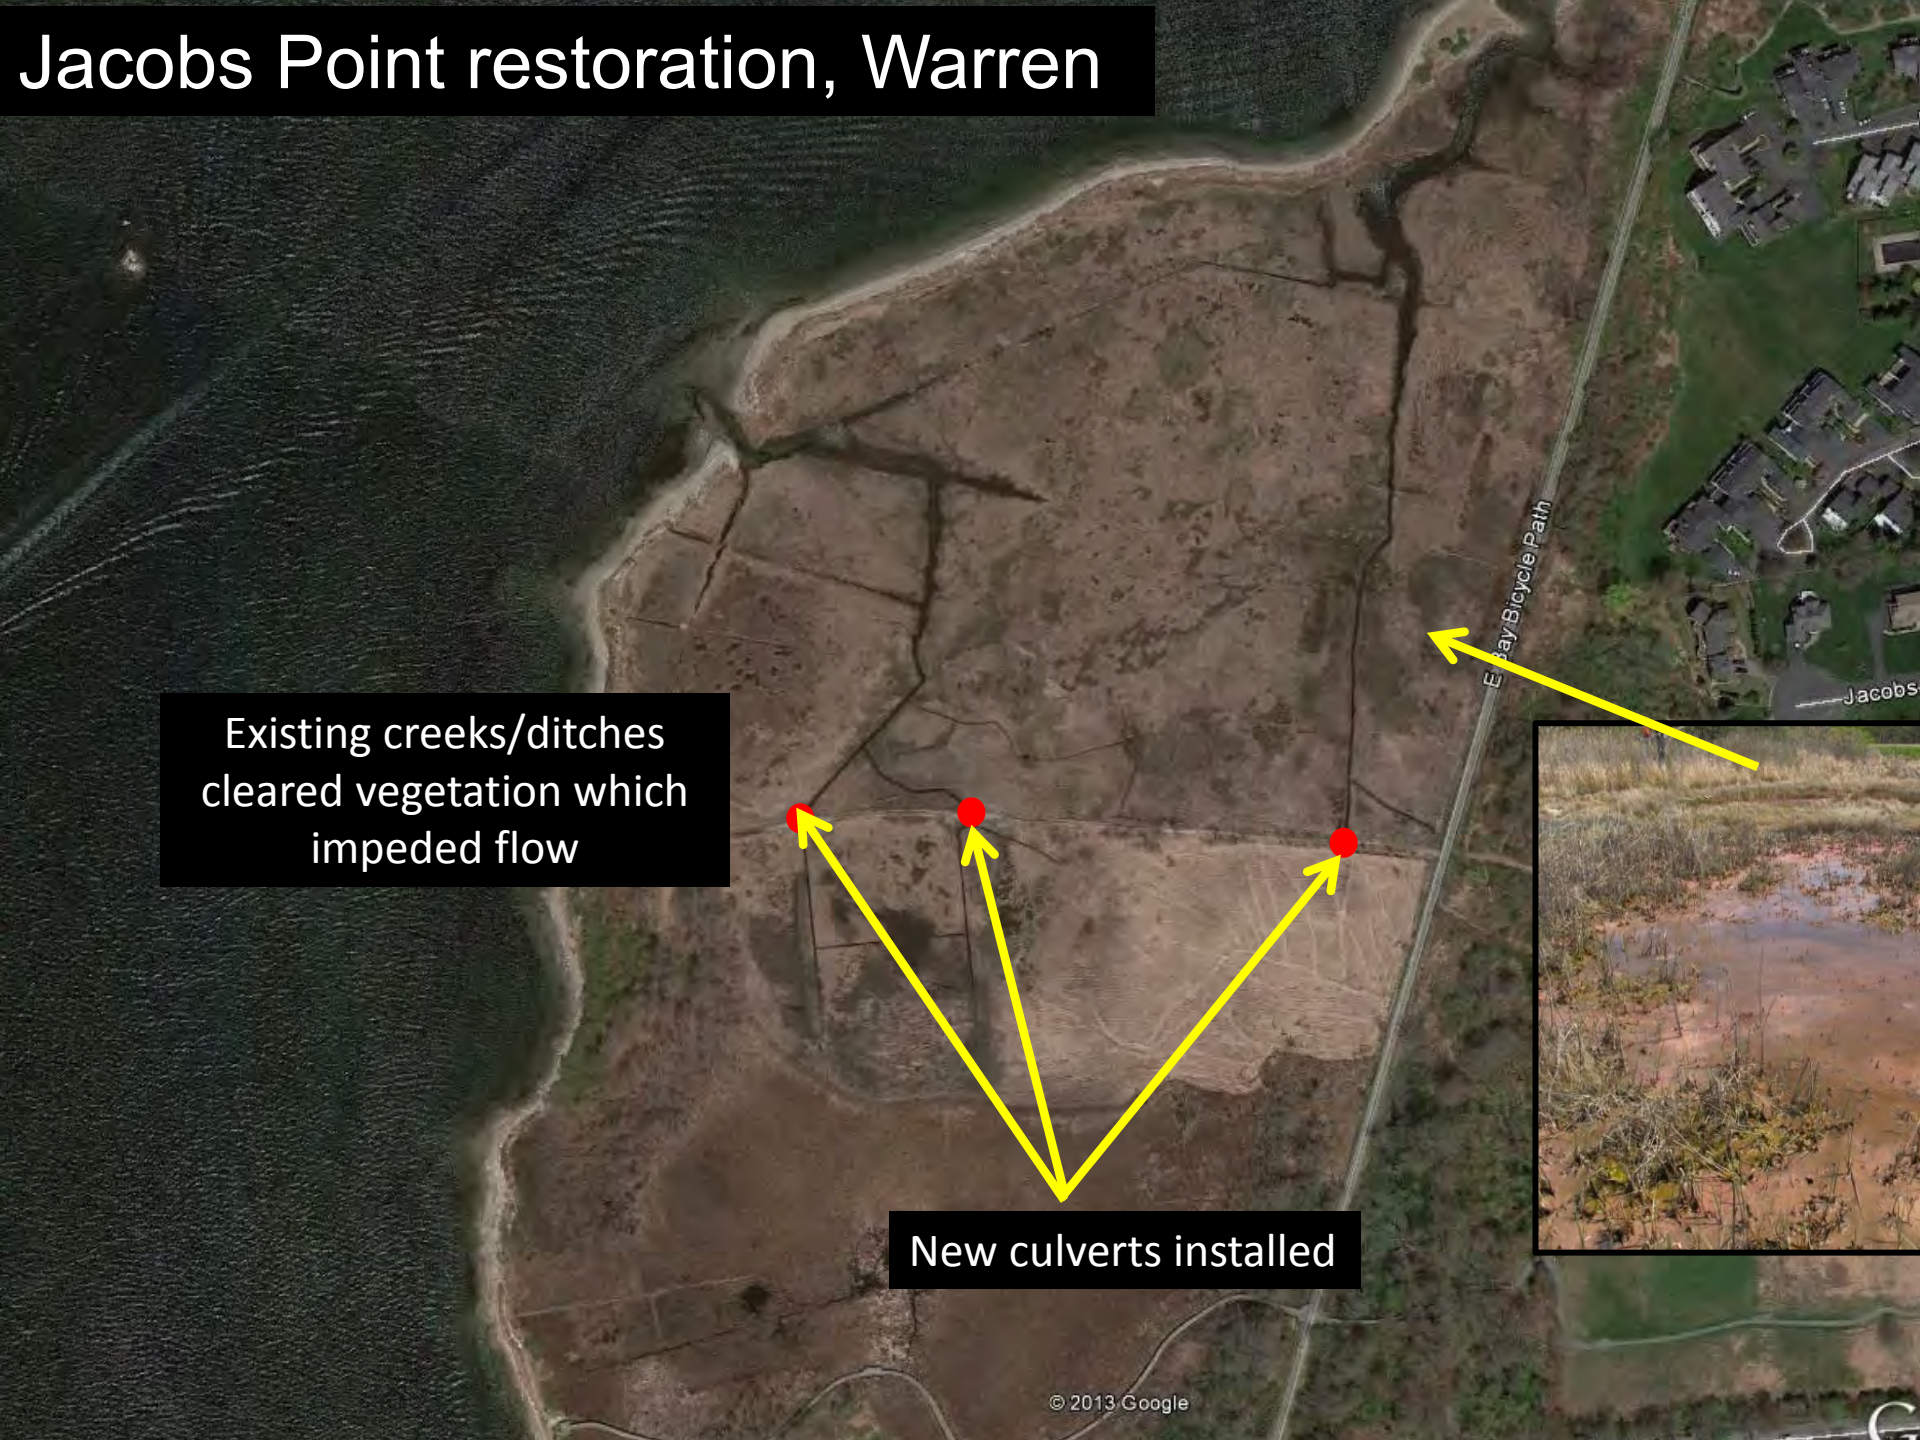
Existing creeks/ditches  
cleared vegetation which  
impeded flow

New culverts installed

Pre restoration: impounded water  
on marsh surface
