# Salt Marsh Adaptation Strategies in Light of Sea Level Rise

**Wenley Ferguson**  
**Land and Water Summit 2015**

**SAVE THE BAY®**

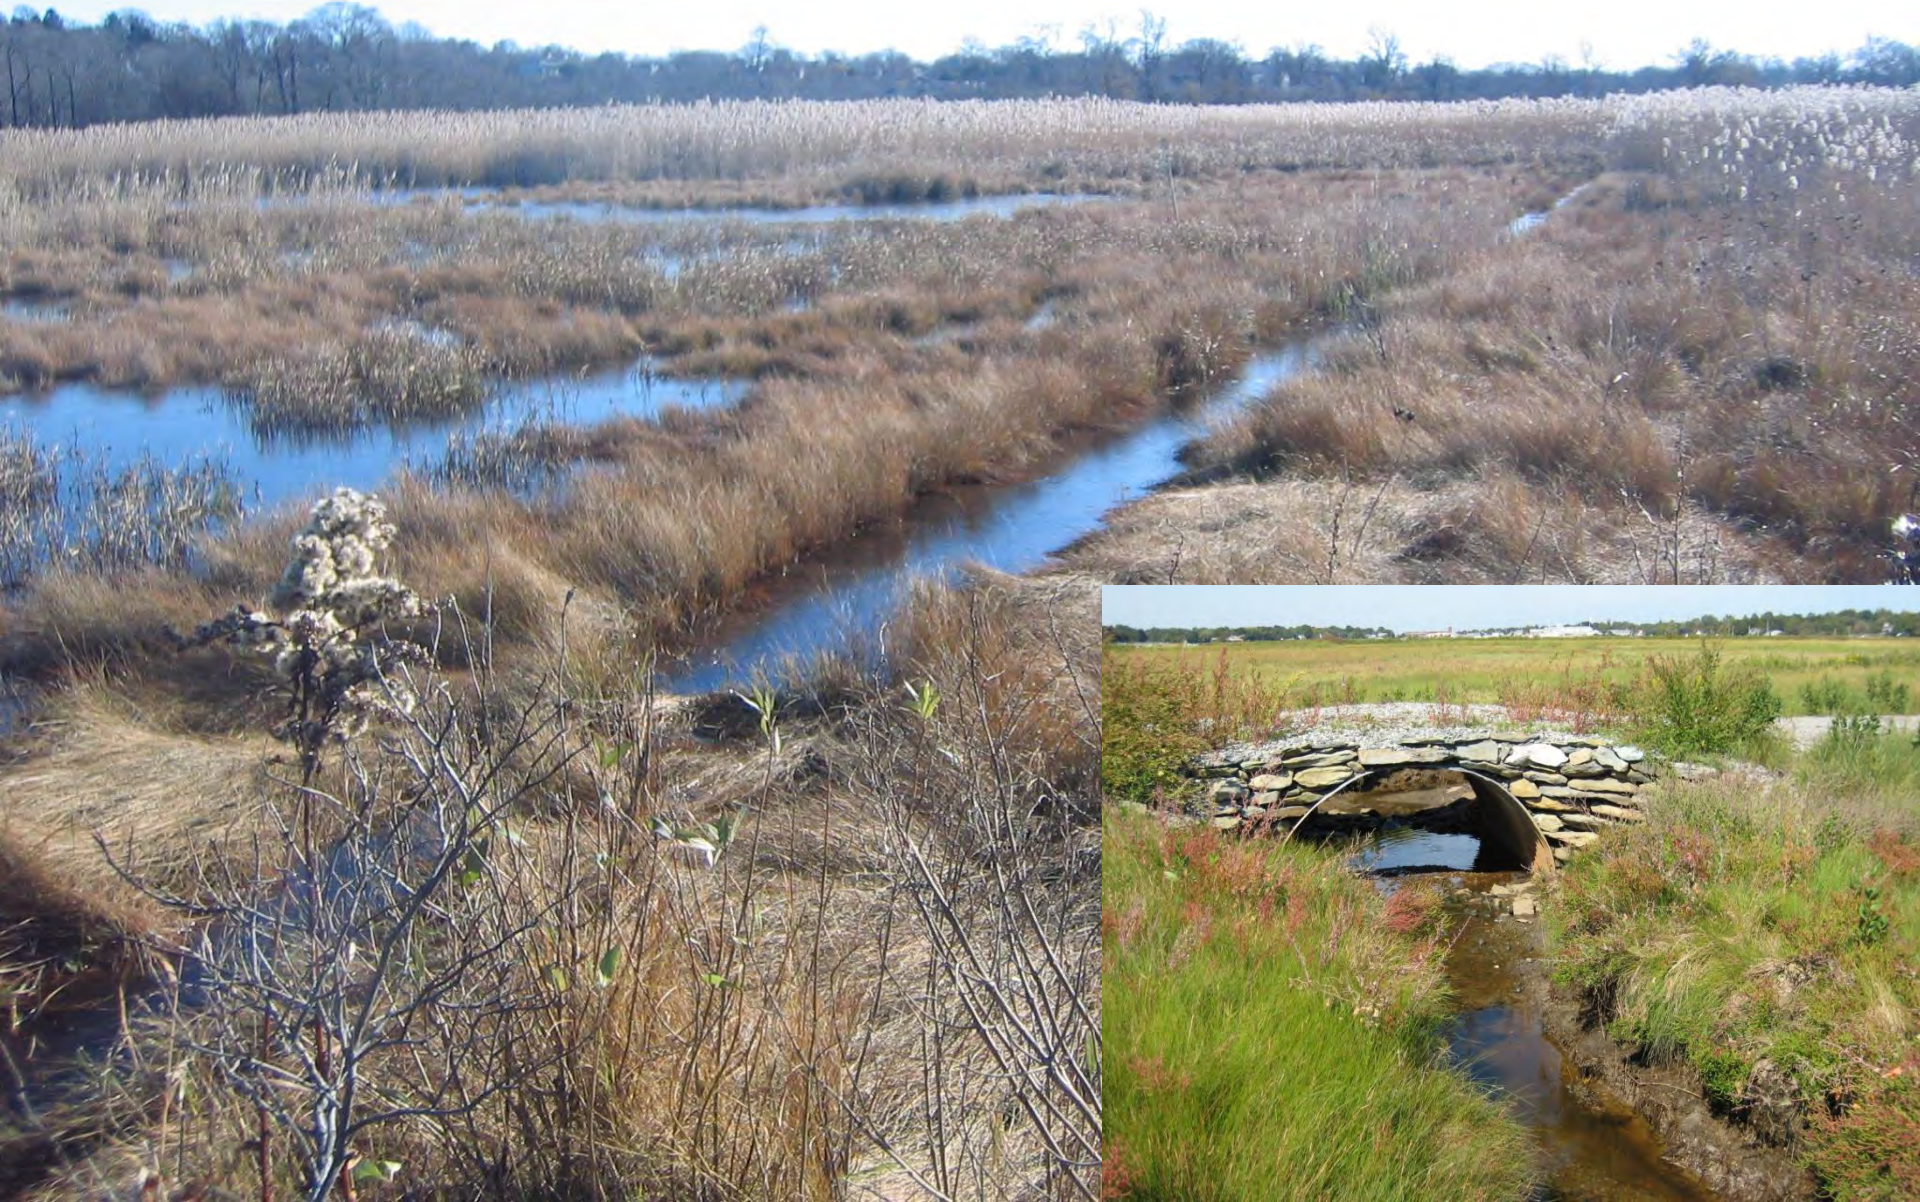
Post restoration: revegetation of formerly flooded areas

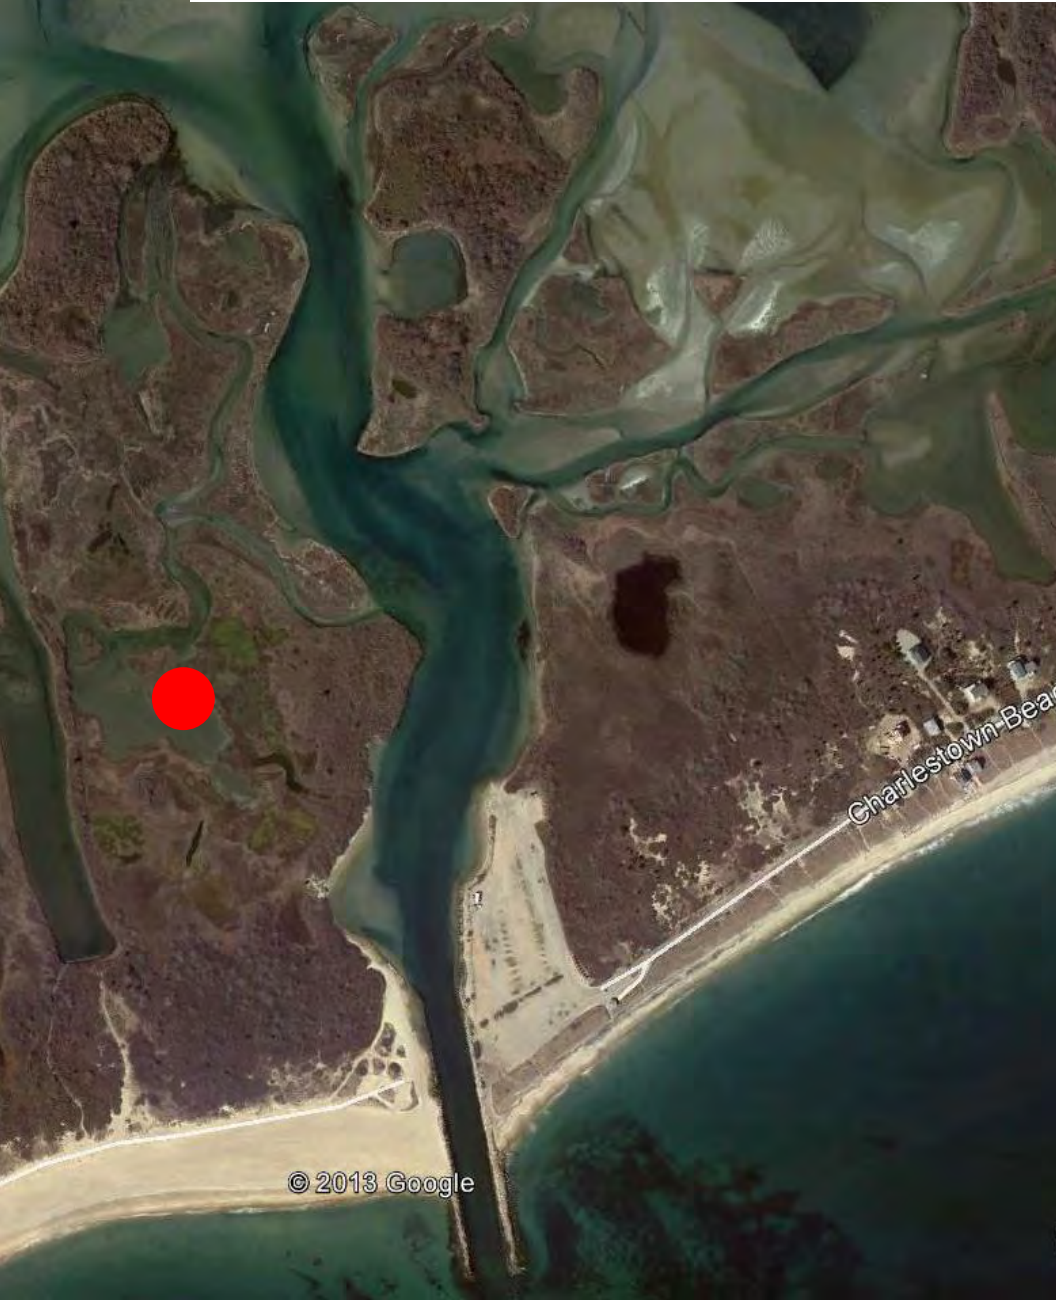
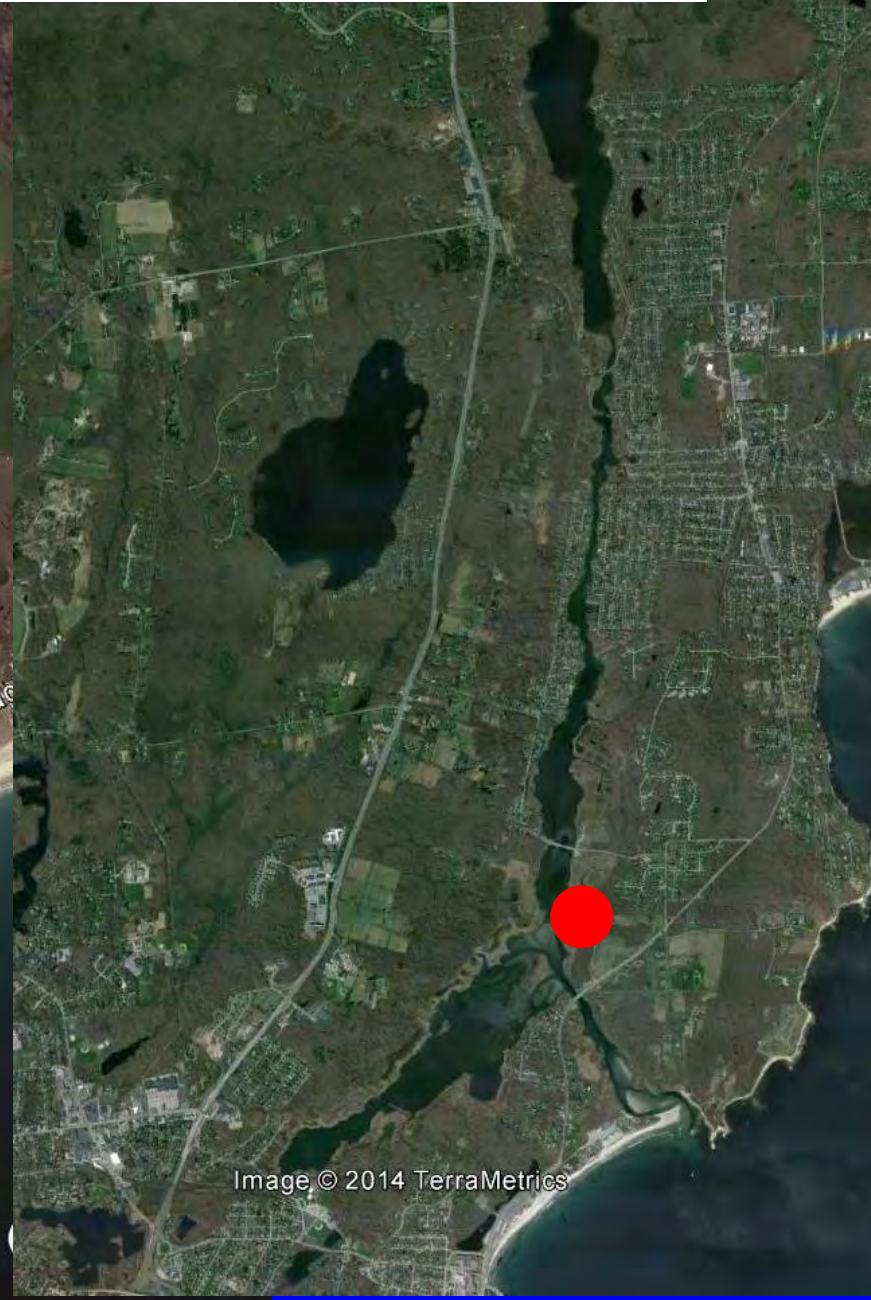
**PROPOSED  
NINIGRET POND  
RESTORATION PROJECT  
2013-2016**

Relief Channel  
estimated 7,000 yd3  
(basin area removed)

Secondary Sedimentation Basin  
estimated 40,000 yd3

Marsh  
Restoration  
Area 2  
~40 Ac

Marsh  
Restoration  
Area 1  
~40 Ac

Primary Sedimentation Basin  
estimated 60,000 yd3

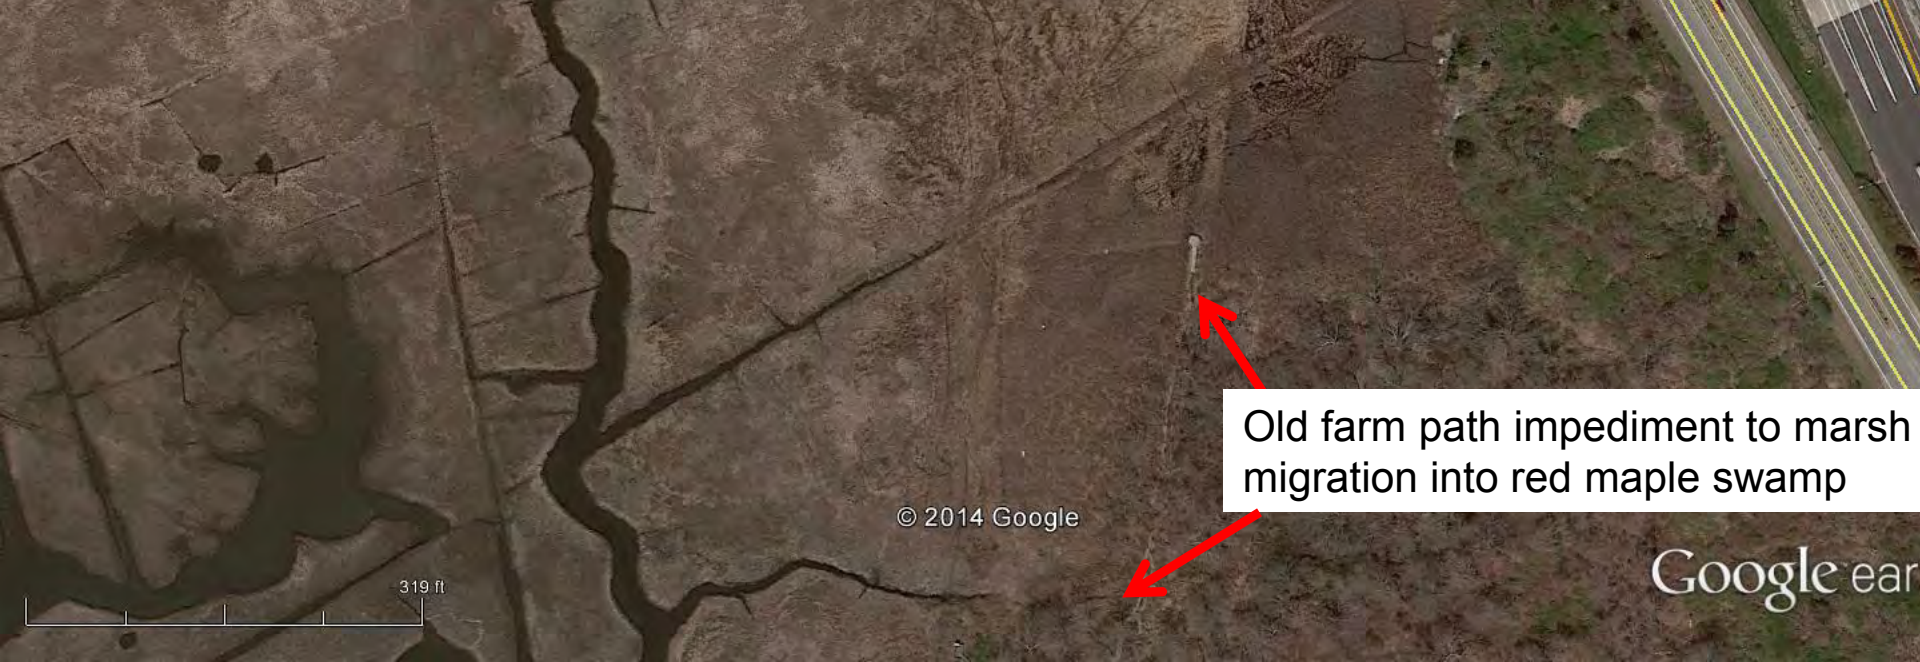
Marsh migrating into field

Old farm path impediment to marsh migration into red maple swamp

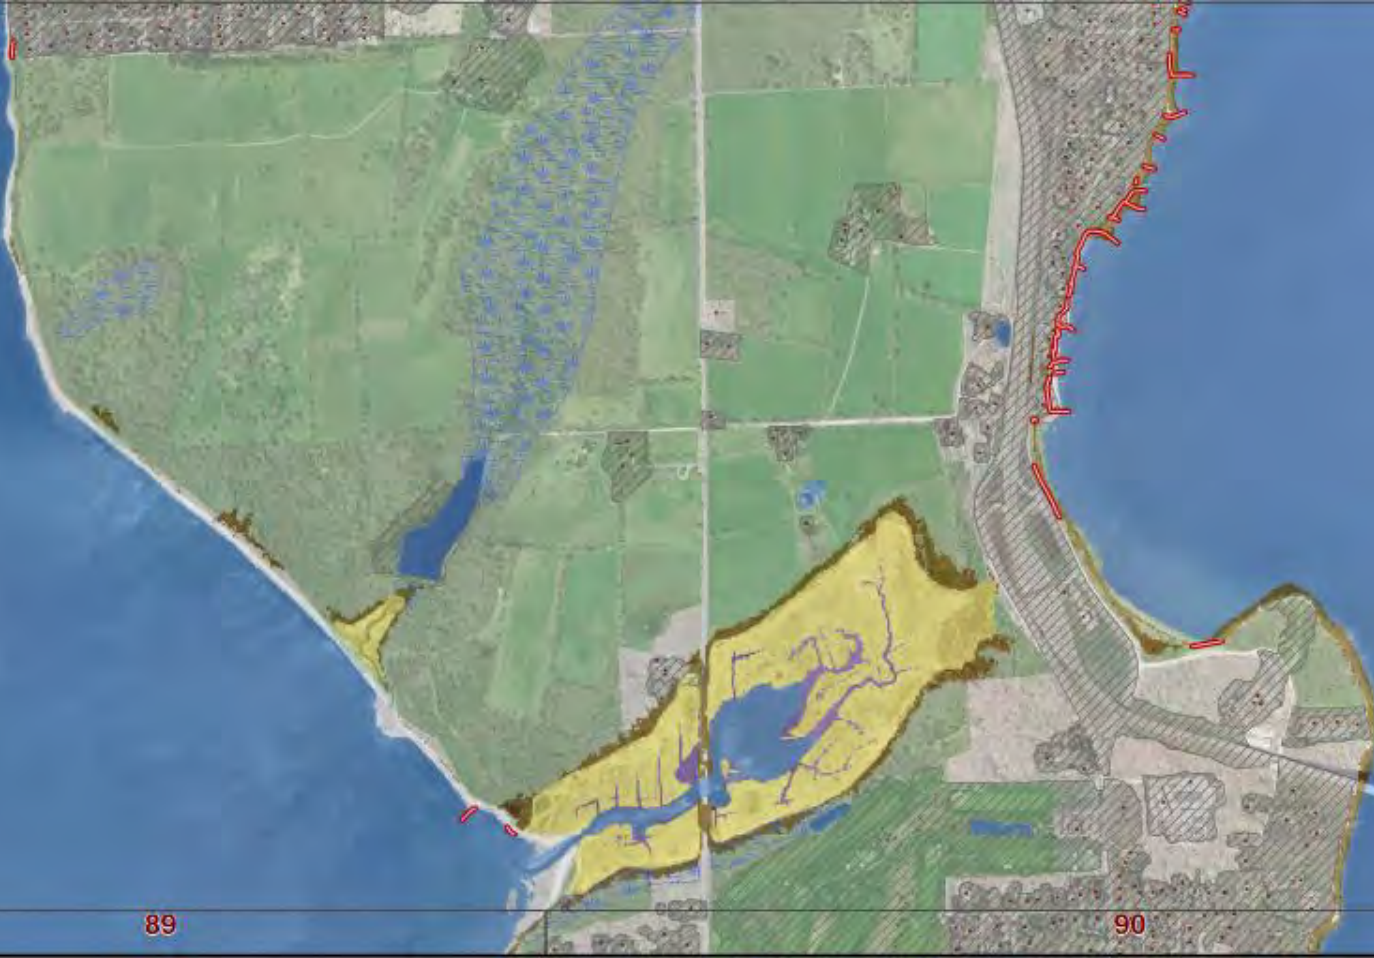
Map 84

## Tidal Marsh Vulnerability Analysis: One Foot Sea Level Rise Model

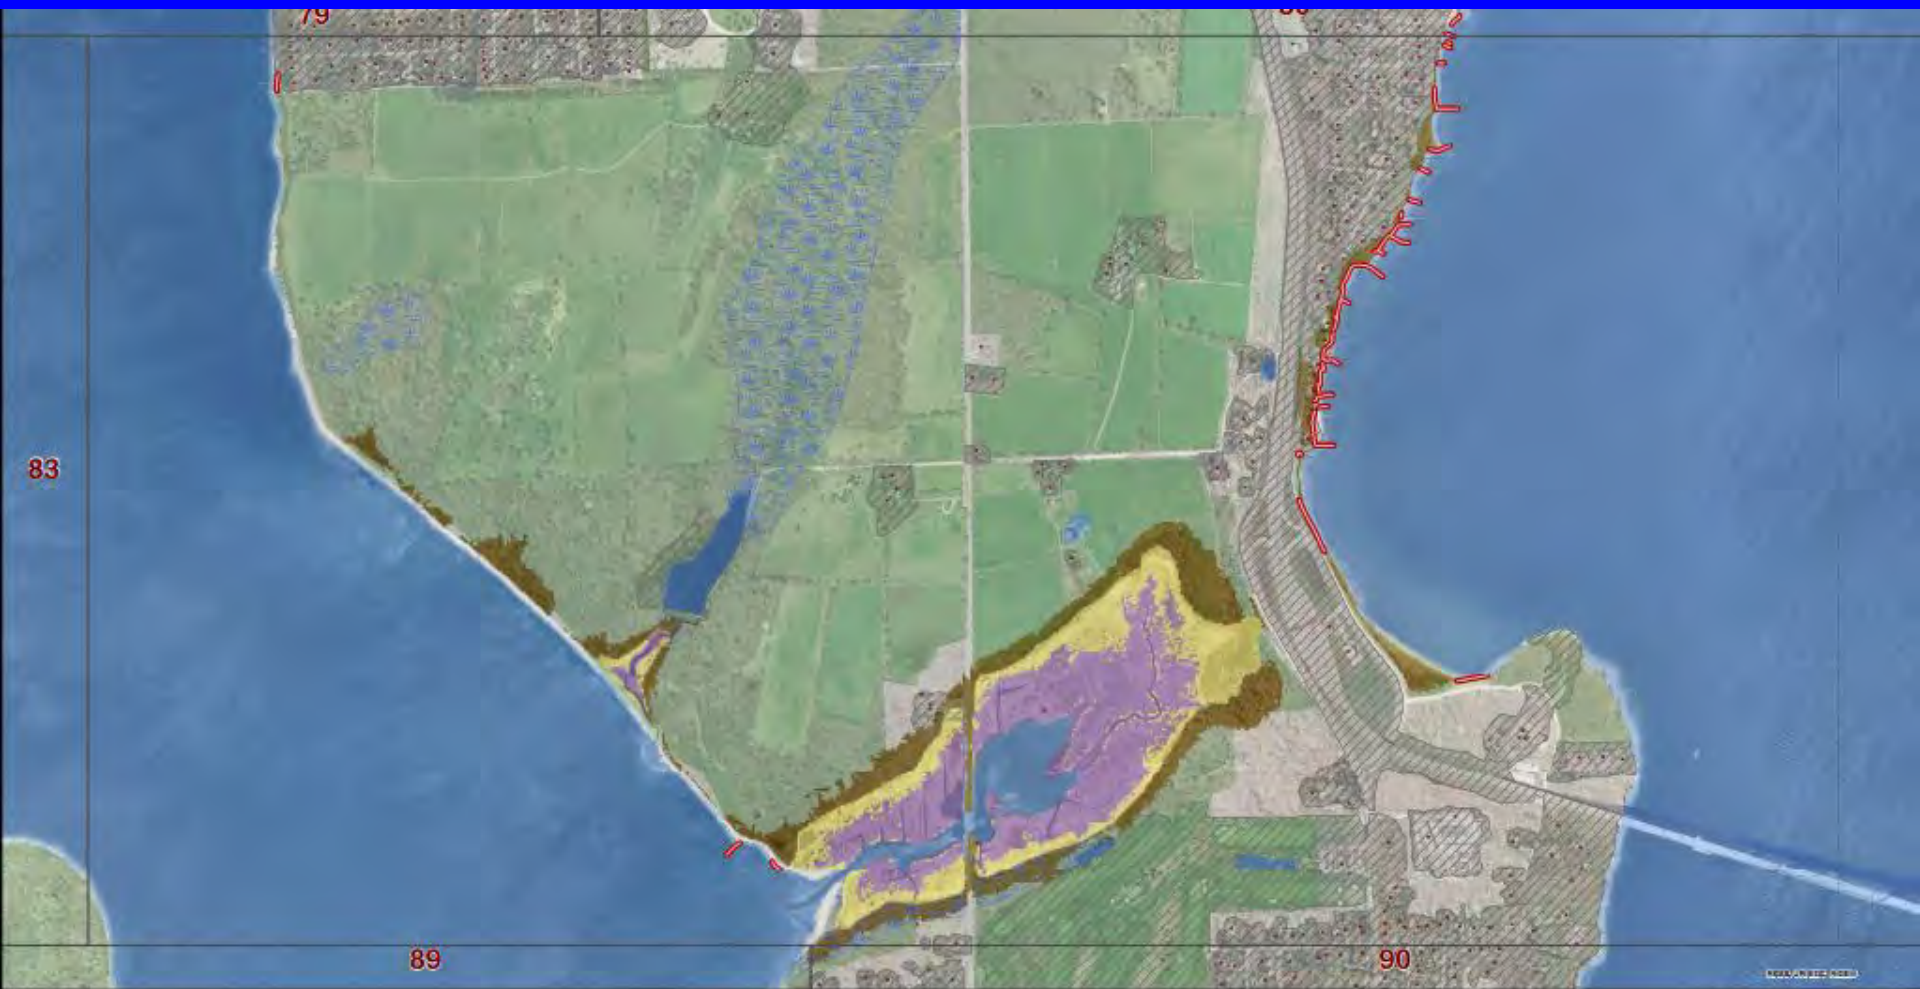
Map 84

## Tidal Marsh Vulnerability Analysis: Three Foot Sea Level Rise Model

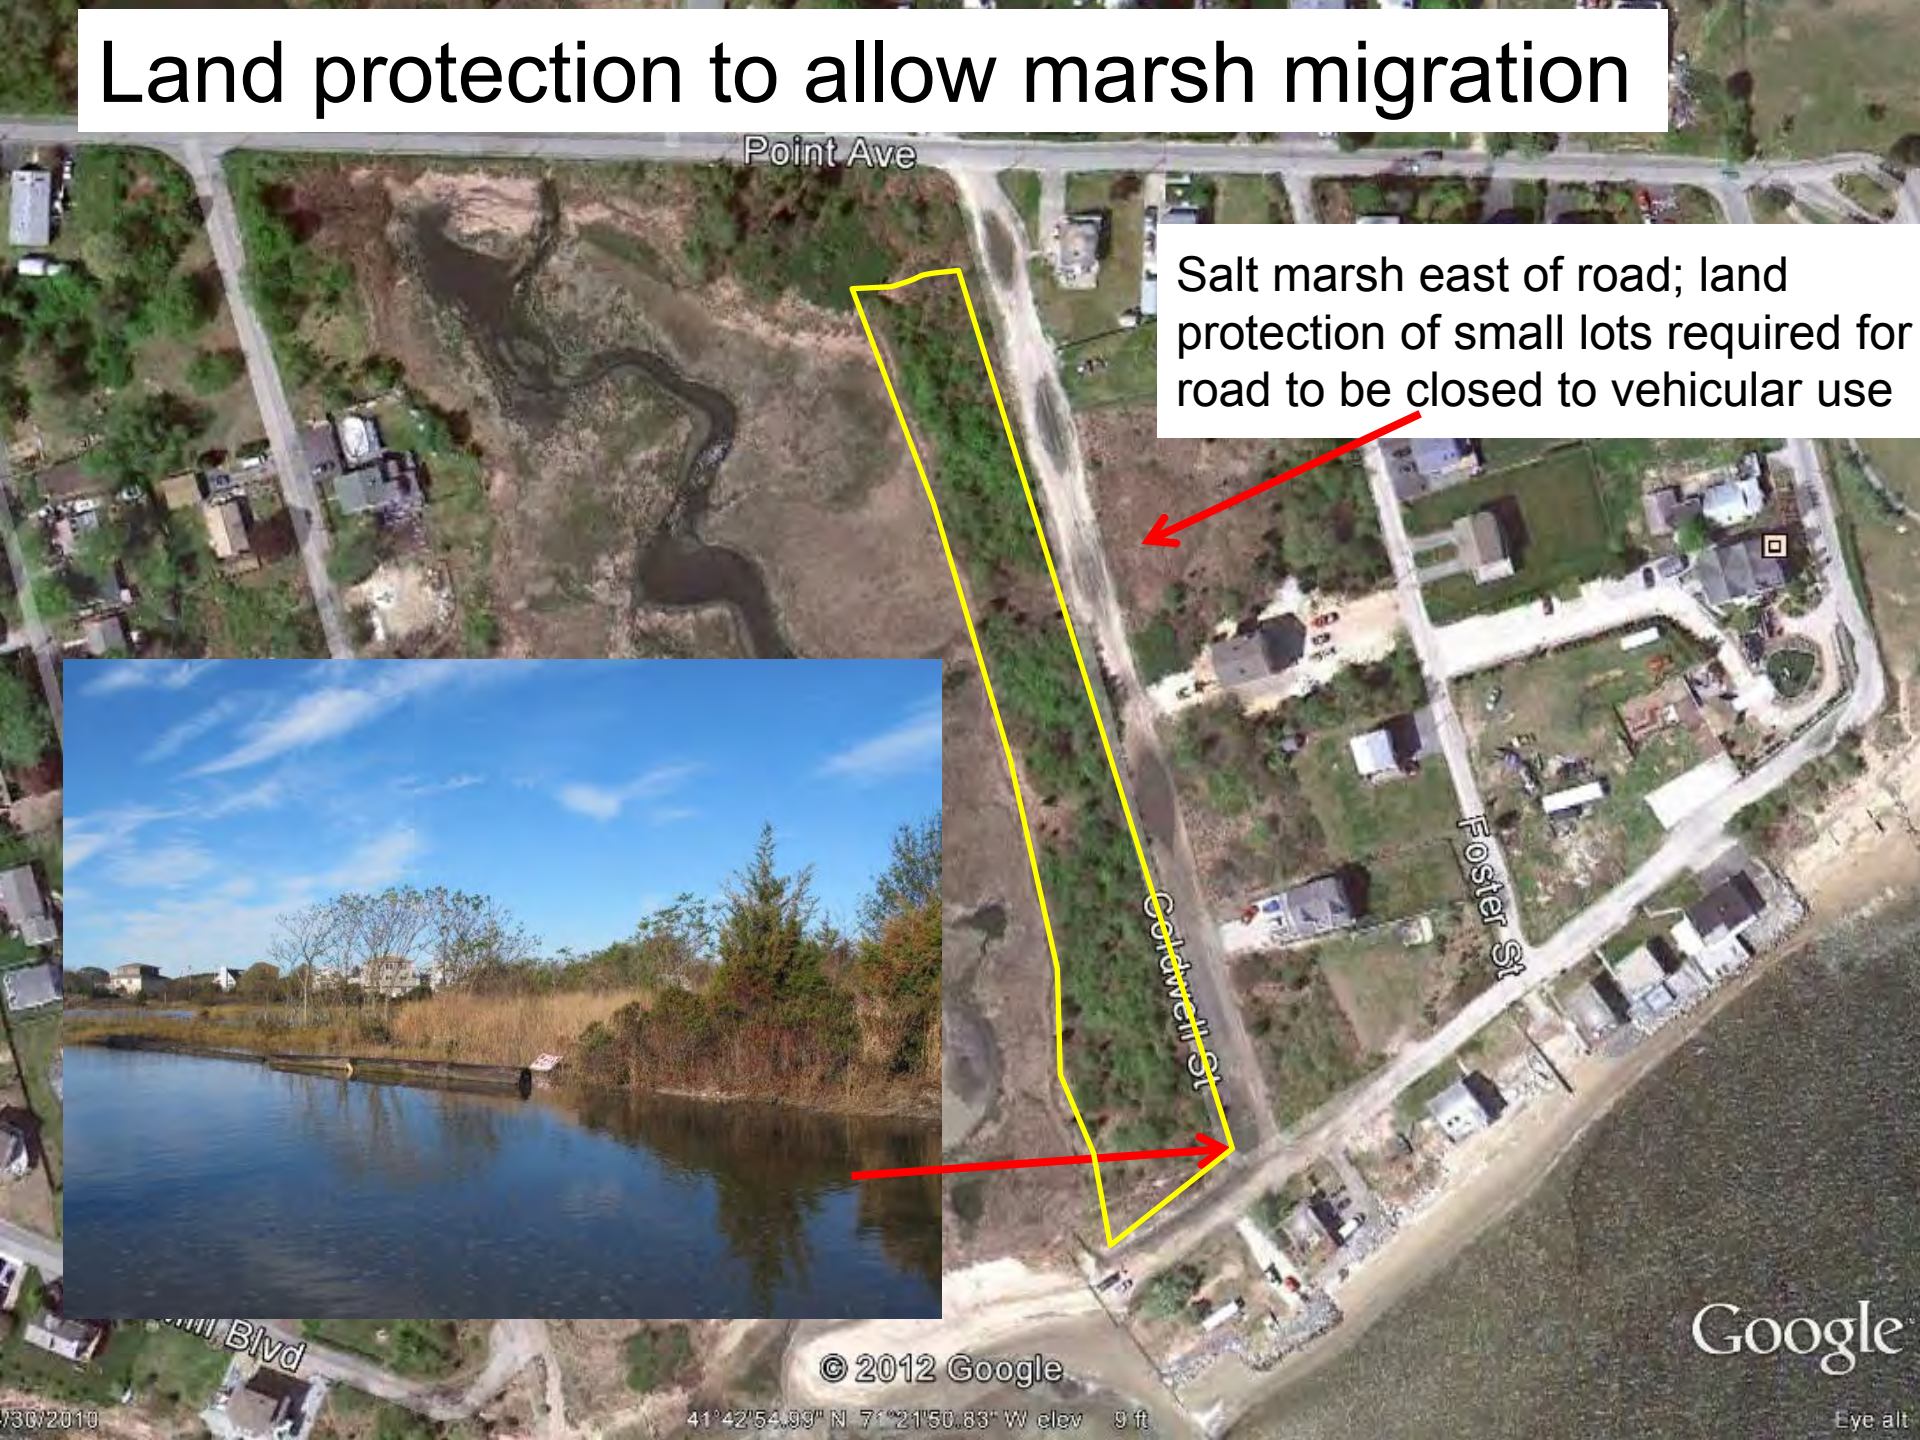
Salt marsh east of road; land protection of small lots required for road to be closed to vehicular use

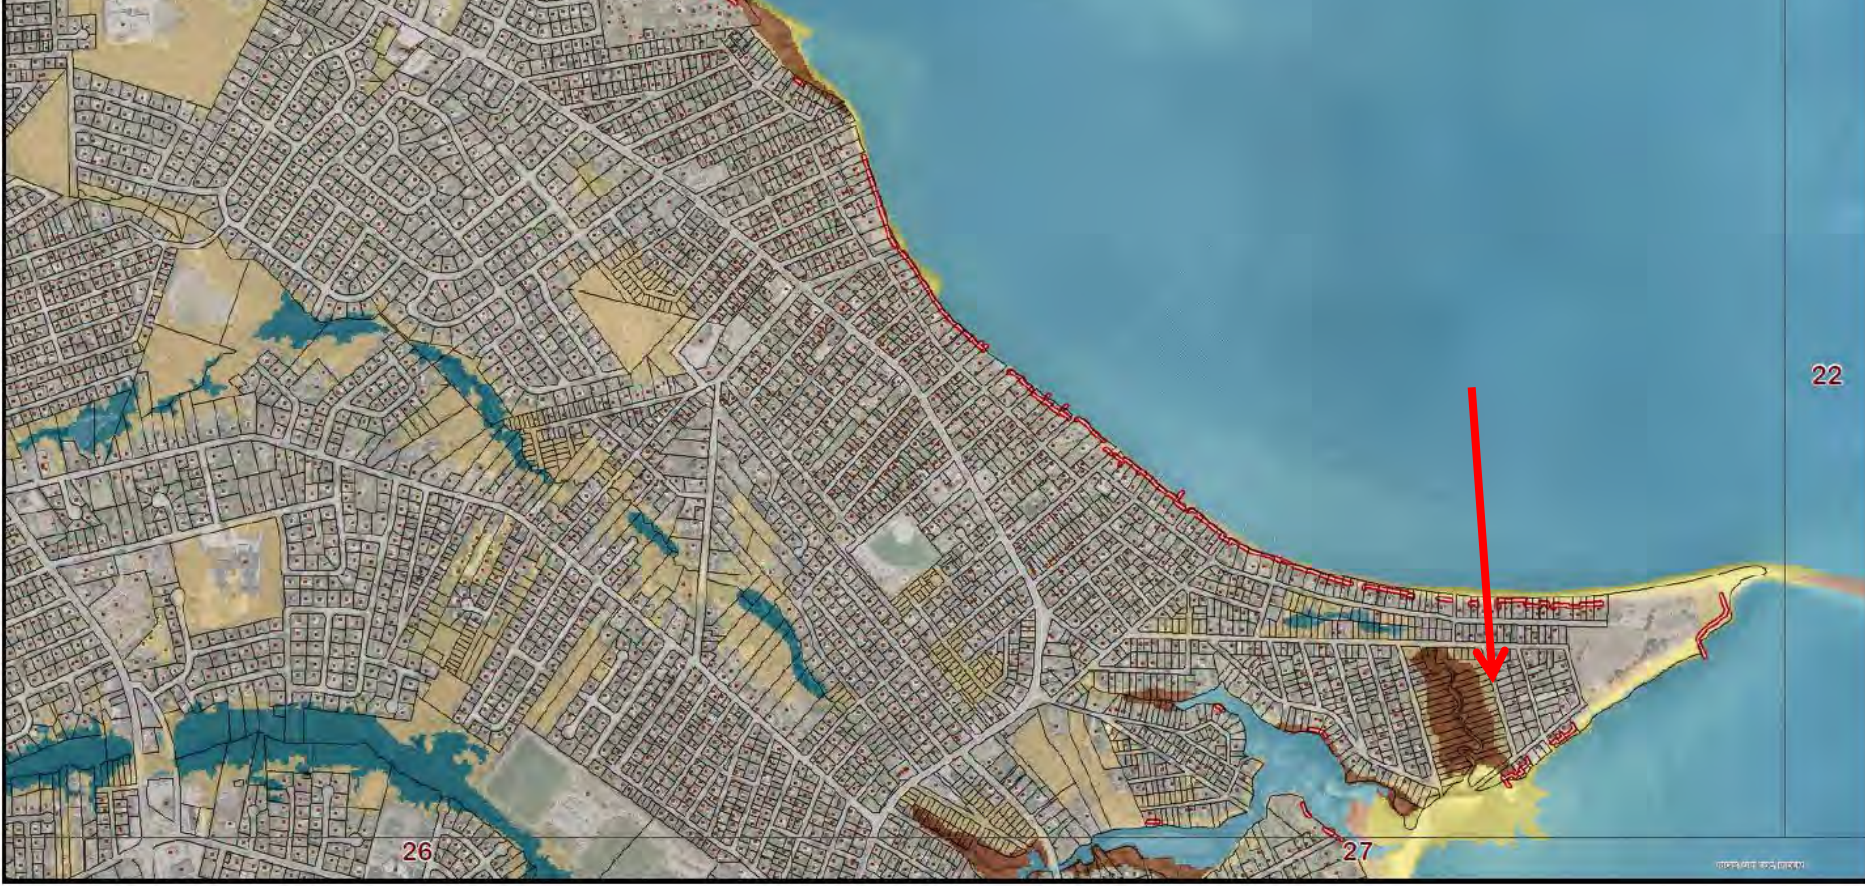
Map 21

## Tidal Marsh Vulnerability Analysis: Current Condition
