Managing Natural Areas for Resilience to Climate Change: Lessons Learned From the Napatree Point Demonstration Project

Resilience in a Coastal Barrier System

Barrier Resilience to Climate Change: Lessons from the Napatree Barrier

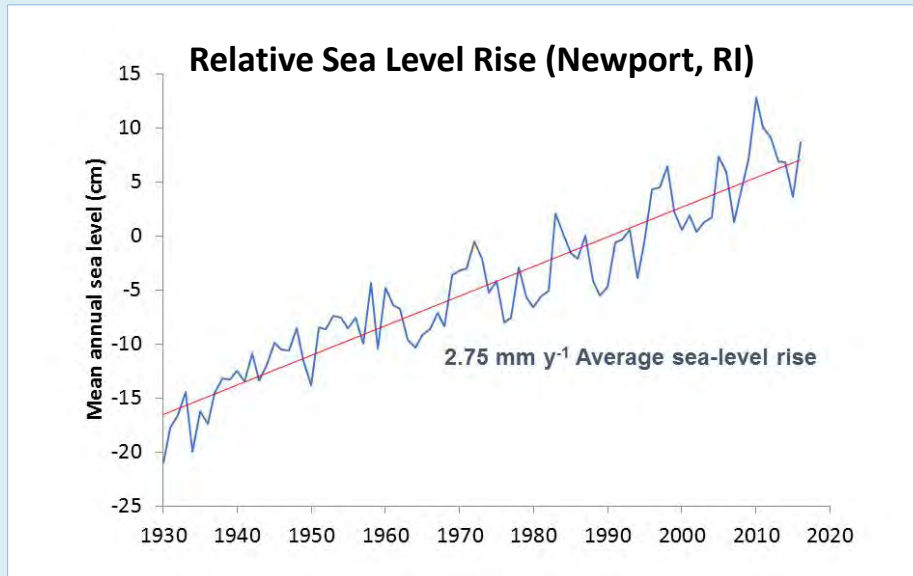
Data Source: <https://tidesandcurrents.noaa.gov/waterlevels.html?id=8452660>

9 inches of rise over past 86 yrs

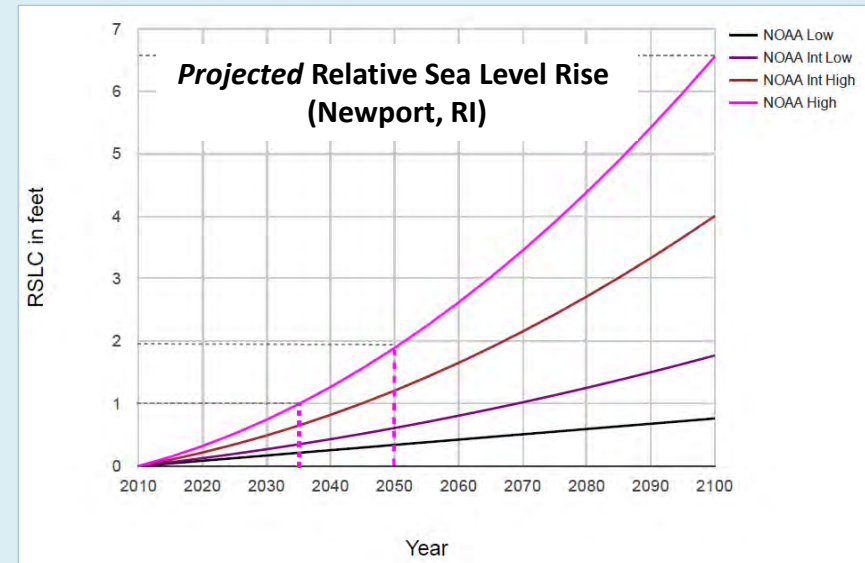
Data Source: <http://www.corpsclimate.us/ccaceslcurves.cfm>

6.5 feet of rise by 2100

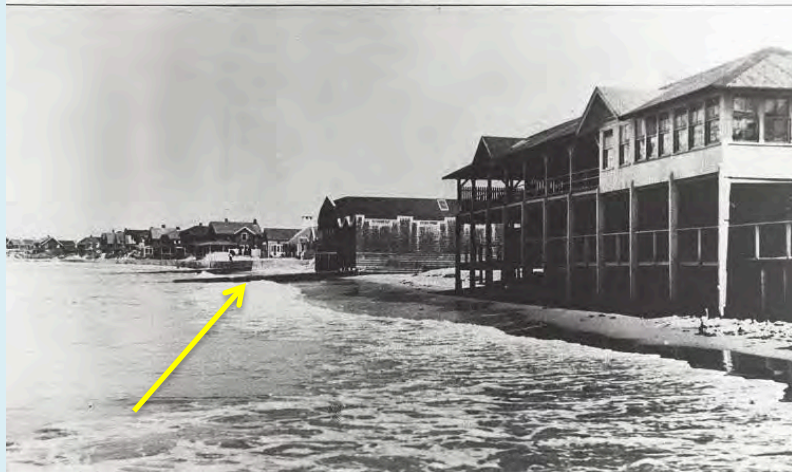
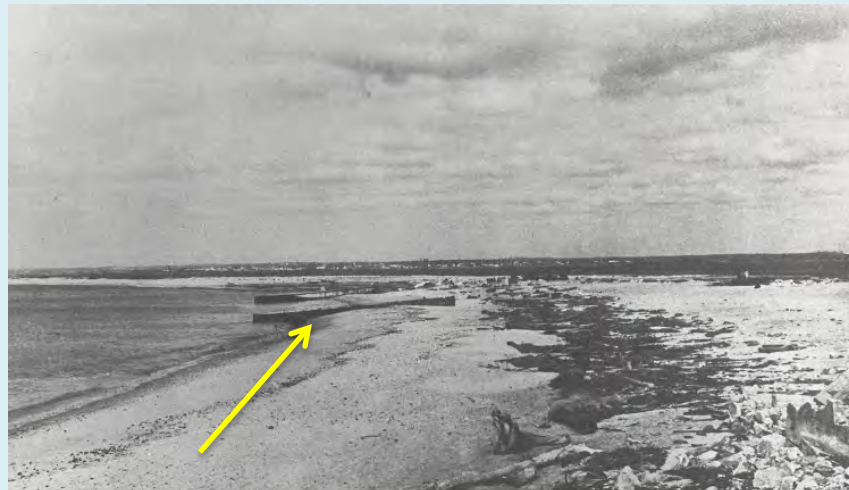
WATCH HILL BEACH FRONT
Before and After

The top view shows the public and private bath houses and the Watch Hill Beach Club along the beach front, and in the background the cottages along Fort Road on Napatree Point. The desolate waste of sand pictured below is all that is left in the wake of the hurricane and high seas. Just back of the two jetties where the Watch Hill Beach Club stood is a breachway. This is the section which bore the brunt of Watch Hill damage.

- All structures swept away
- Napatree wiped clean
- 15 deaths in WH
- 3 breaches (300-900 feet wide)

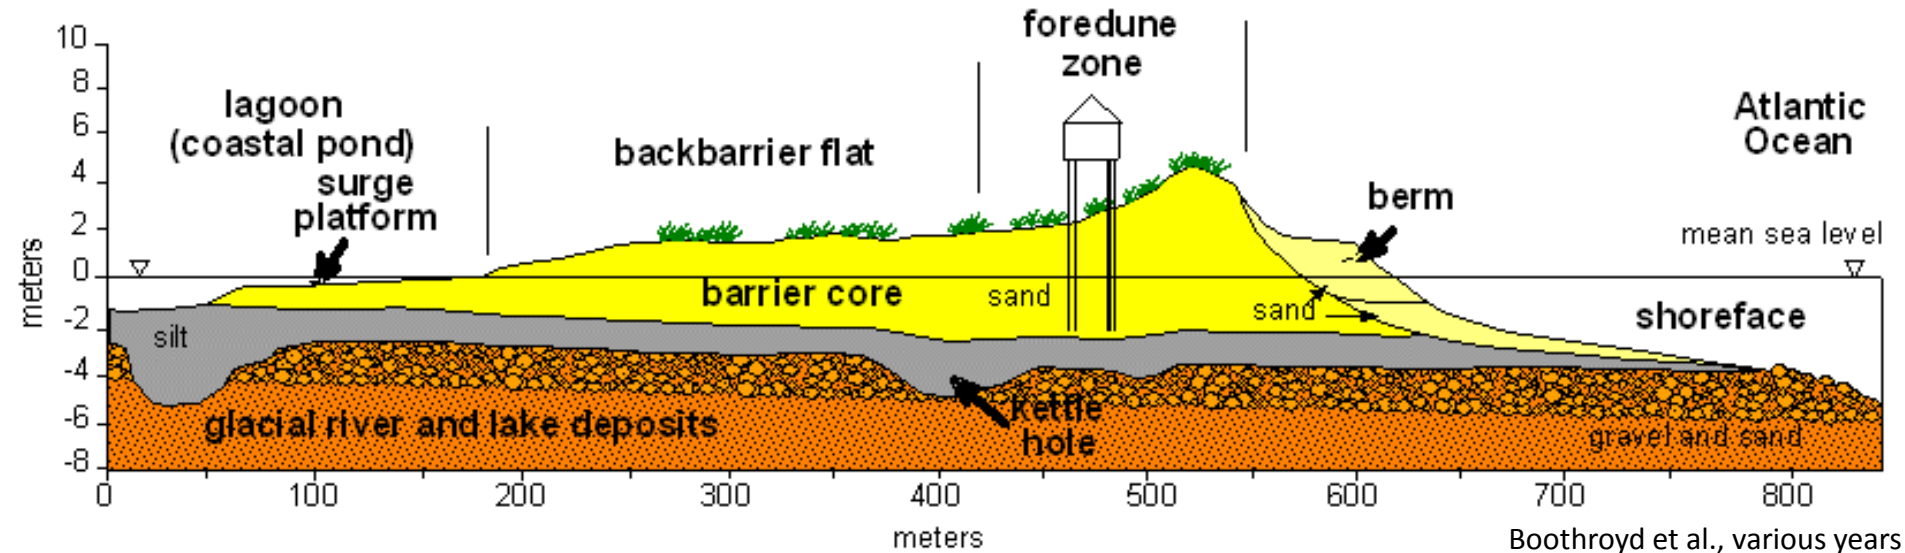
Barrier: Geologic Cross-section

Barrier Geologic Cross-Section

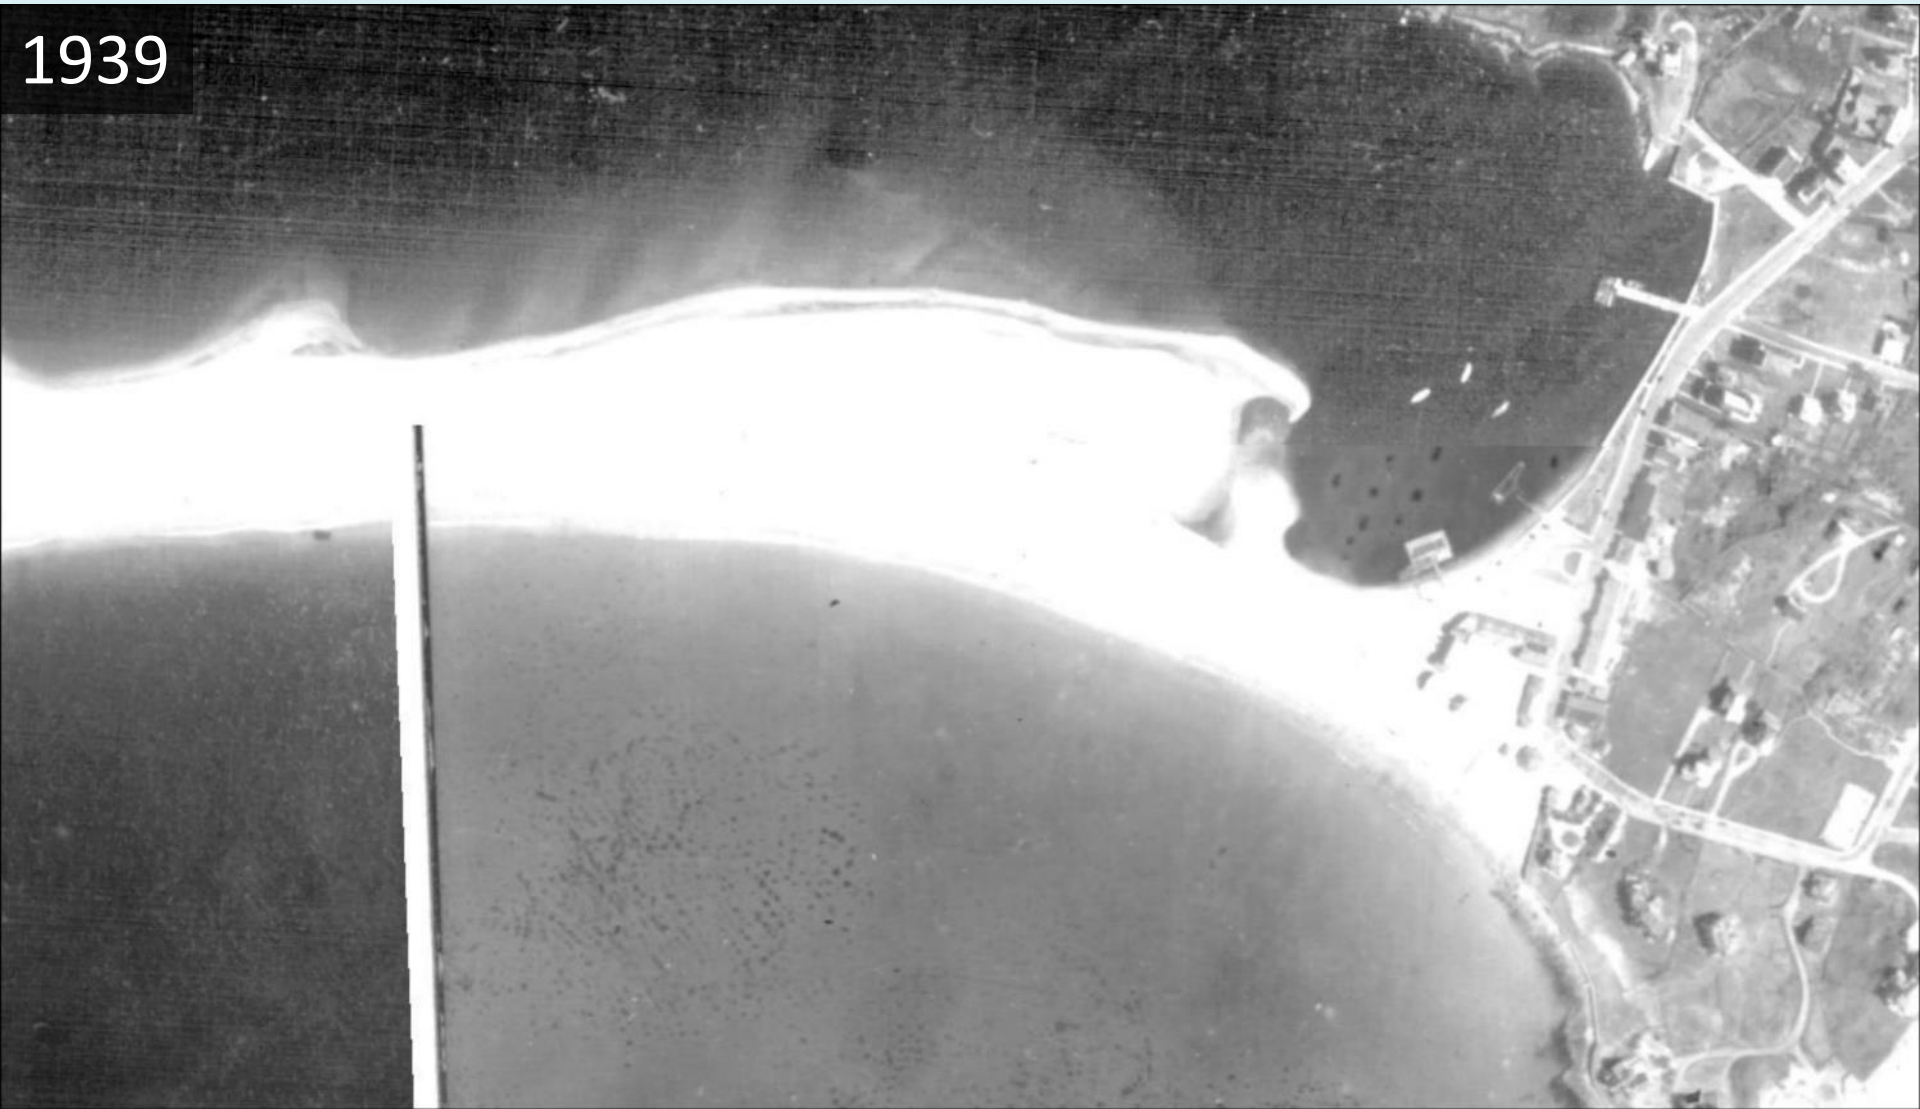
1939

Napatree Point Through Time

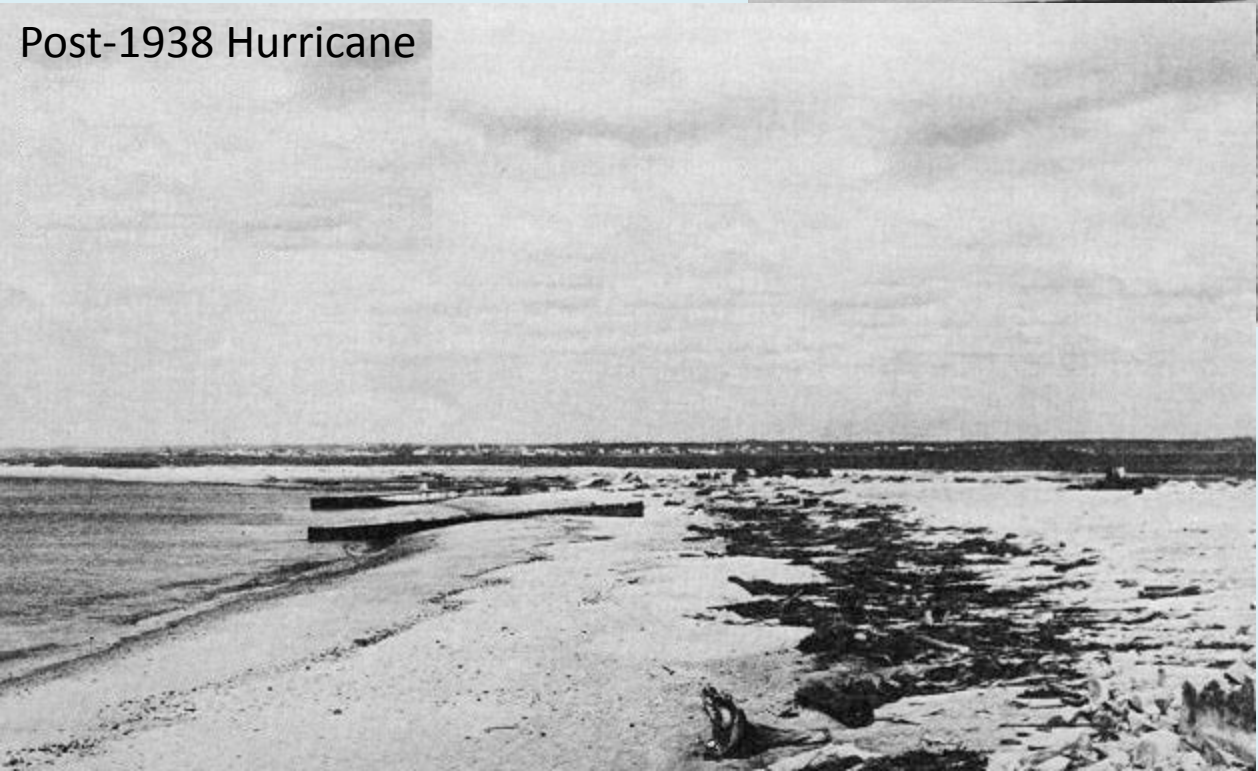
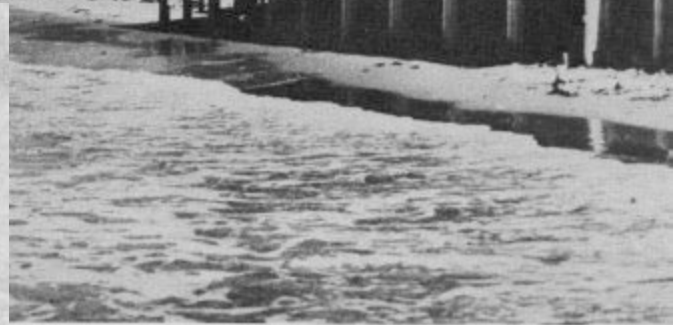
Inlet formation during the 1938 Hurricane

Post-1938 Hurricane

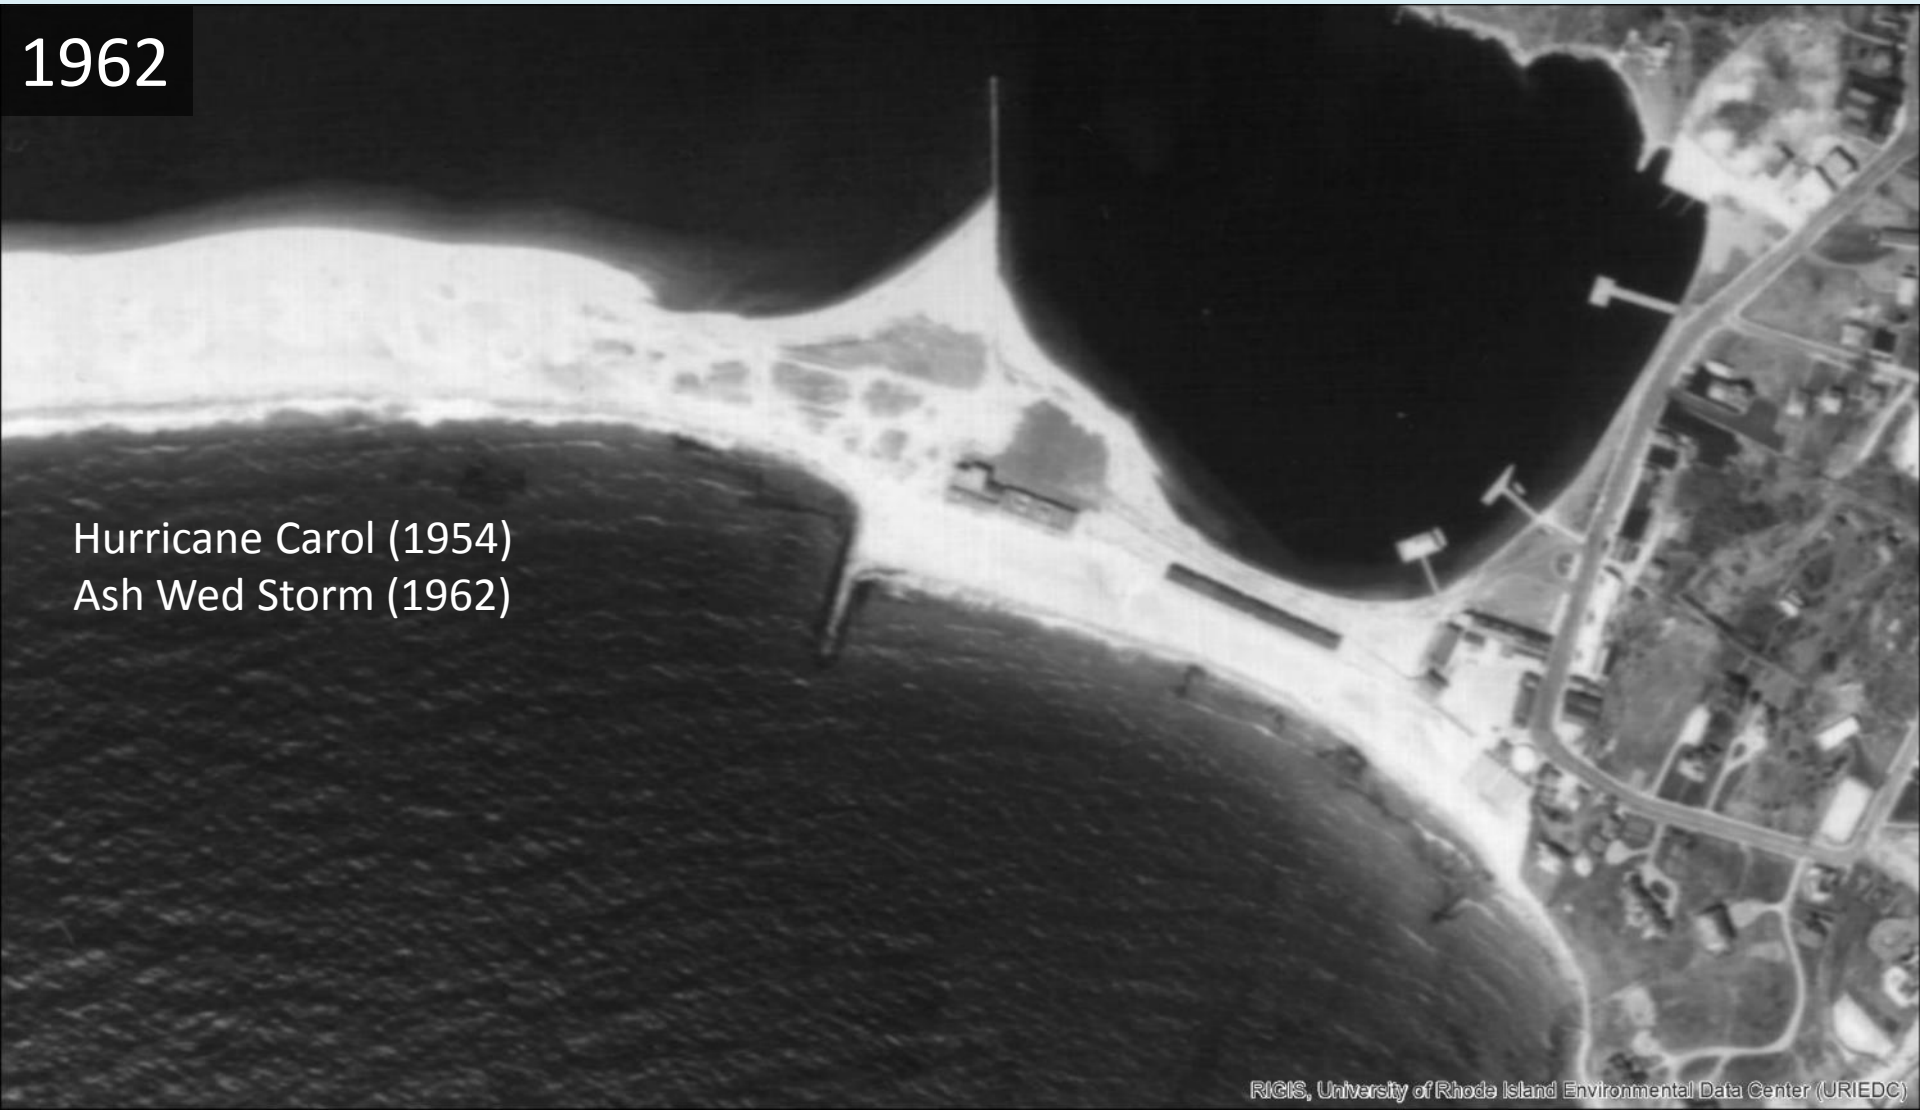
1962

Hurricane Carol (1954)
Ash Wed Storm (1962)

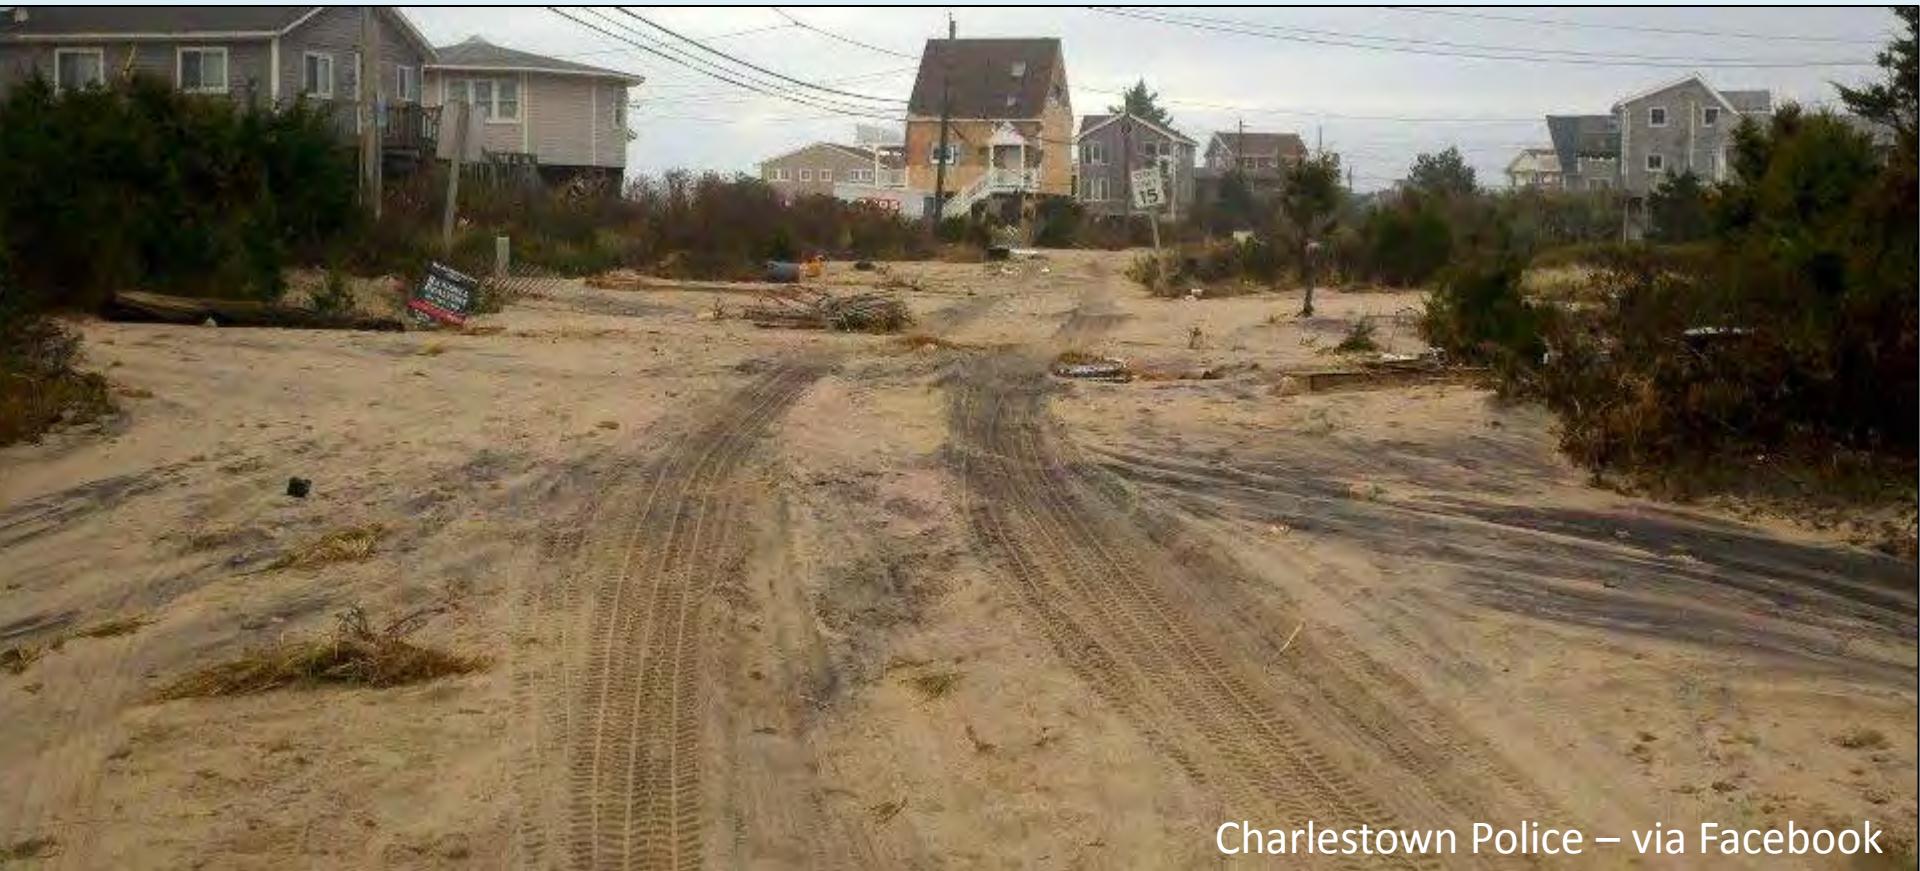
Overwash and washover fan deposition is the natural response of barriers to storms (and sea level rise)

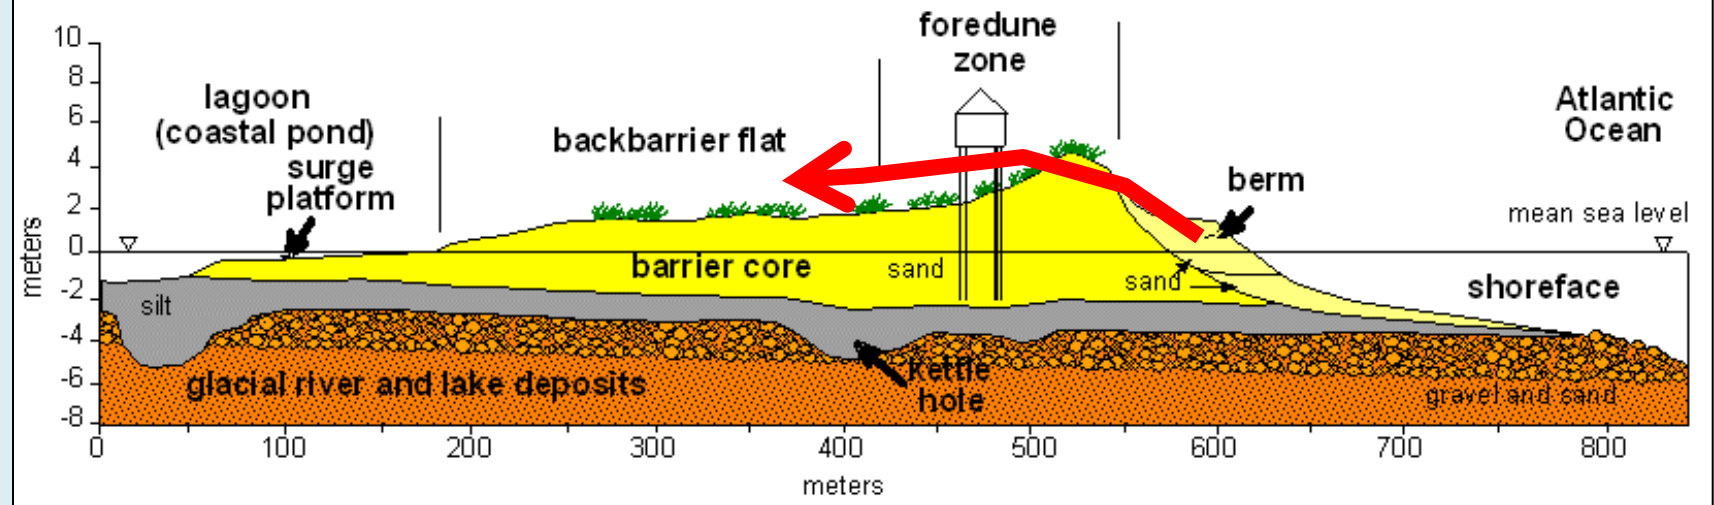
Barriers migrate landward and upward!

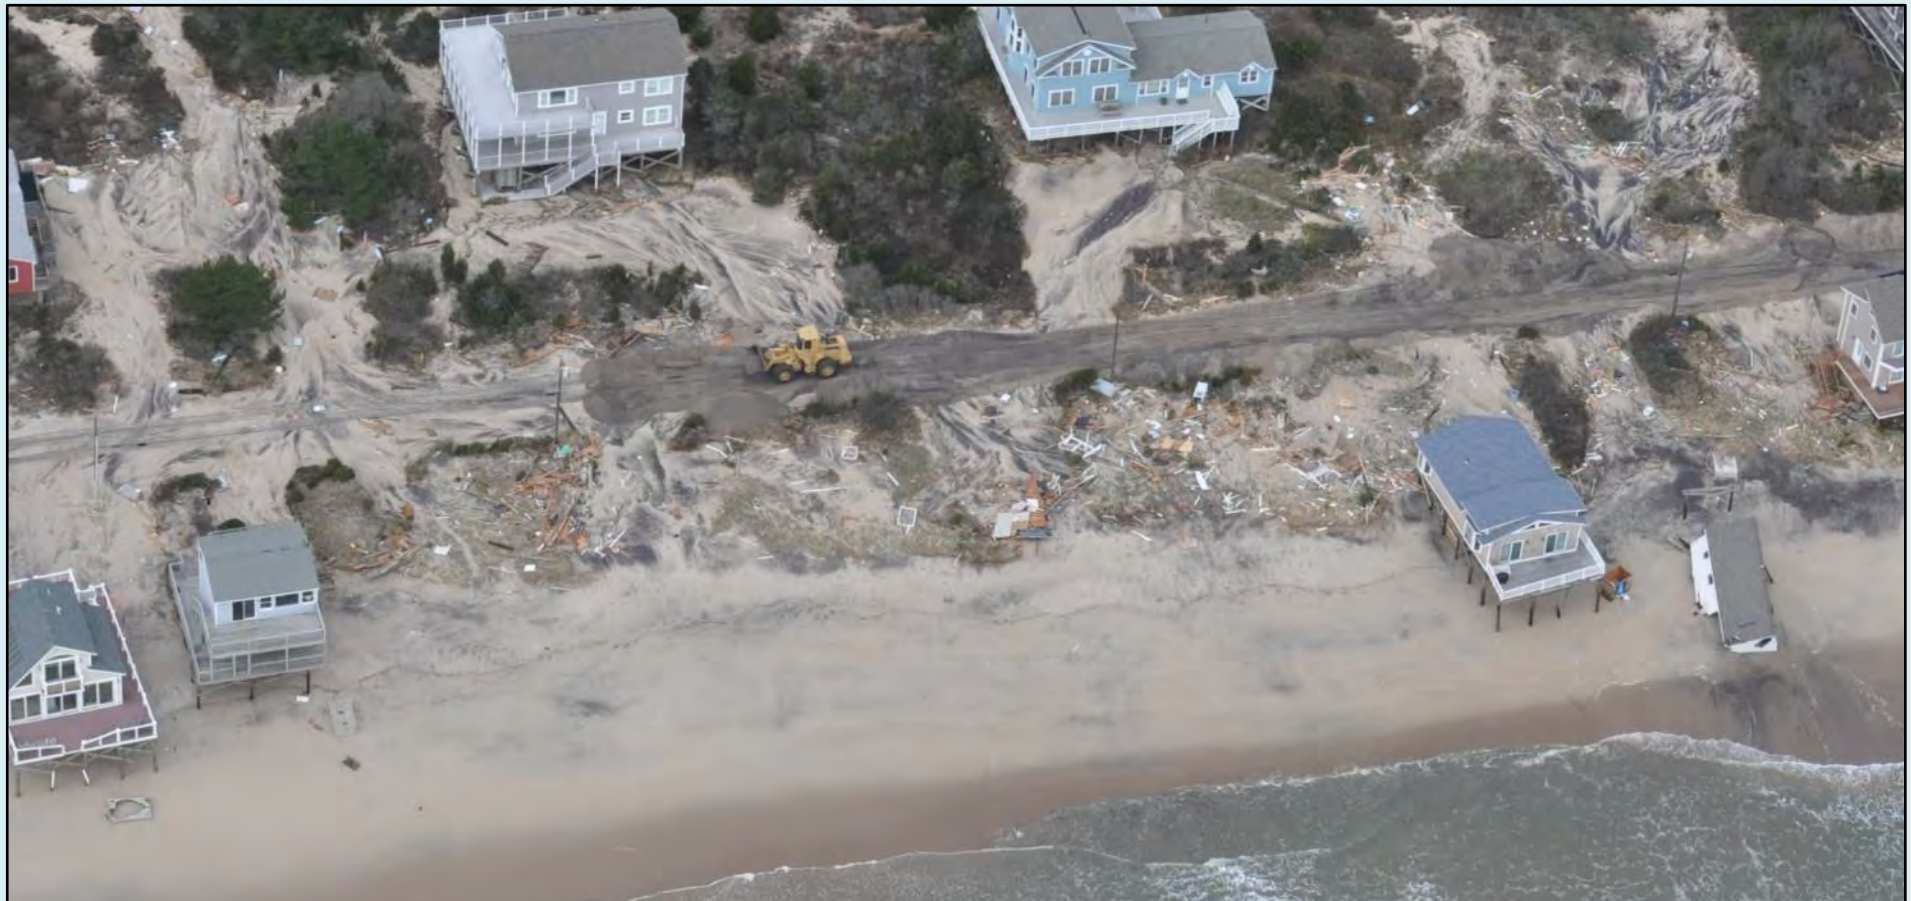
The response of the *humans* to washover fan deposition...
