Migrating Shorelines: Opportunities for Coastal Adaptation

Land and Water Summit March 2019

Adaptation Strategies

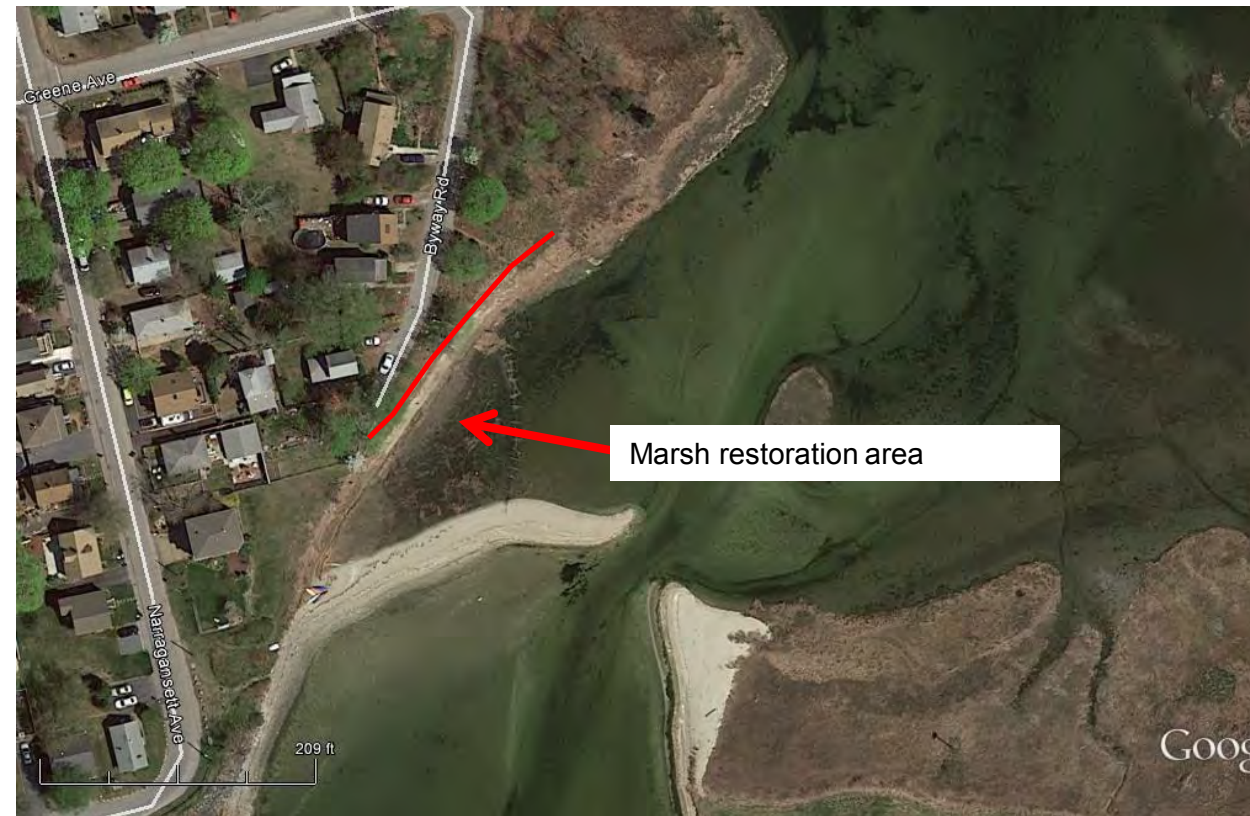
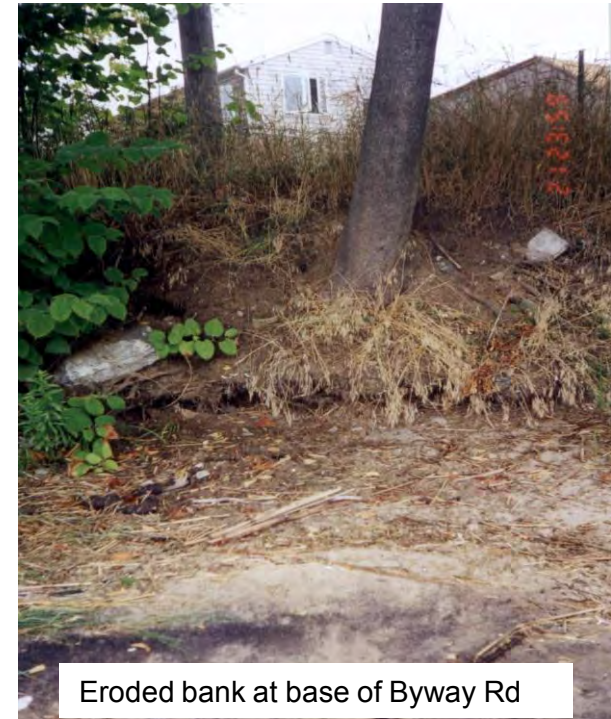
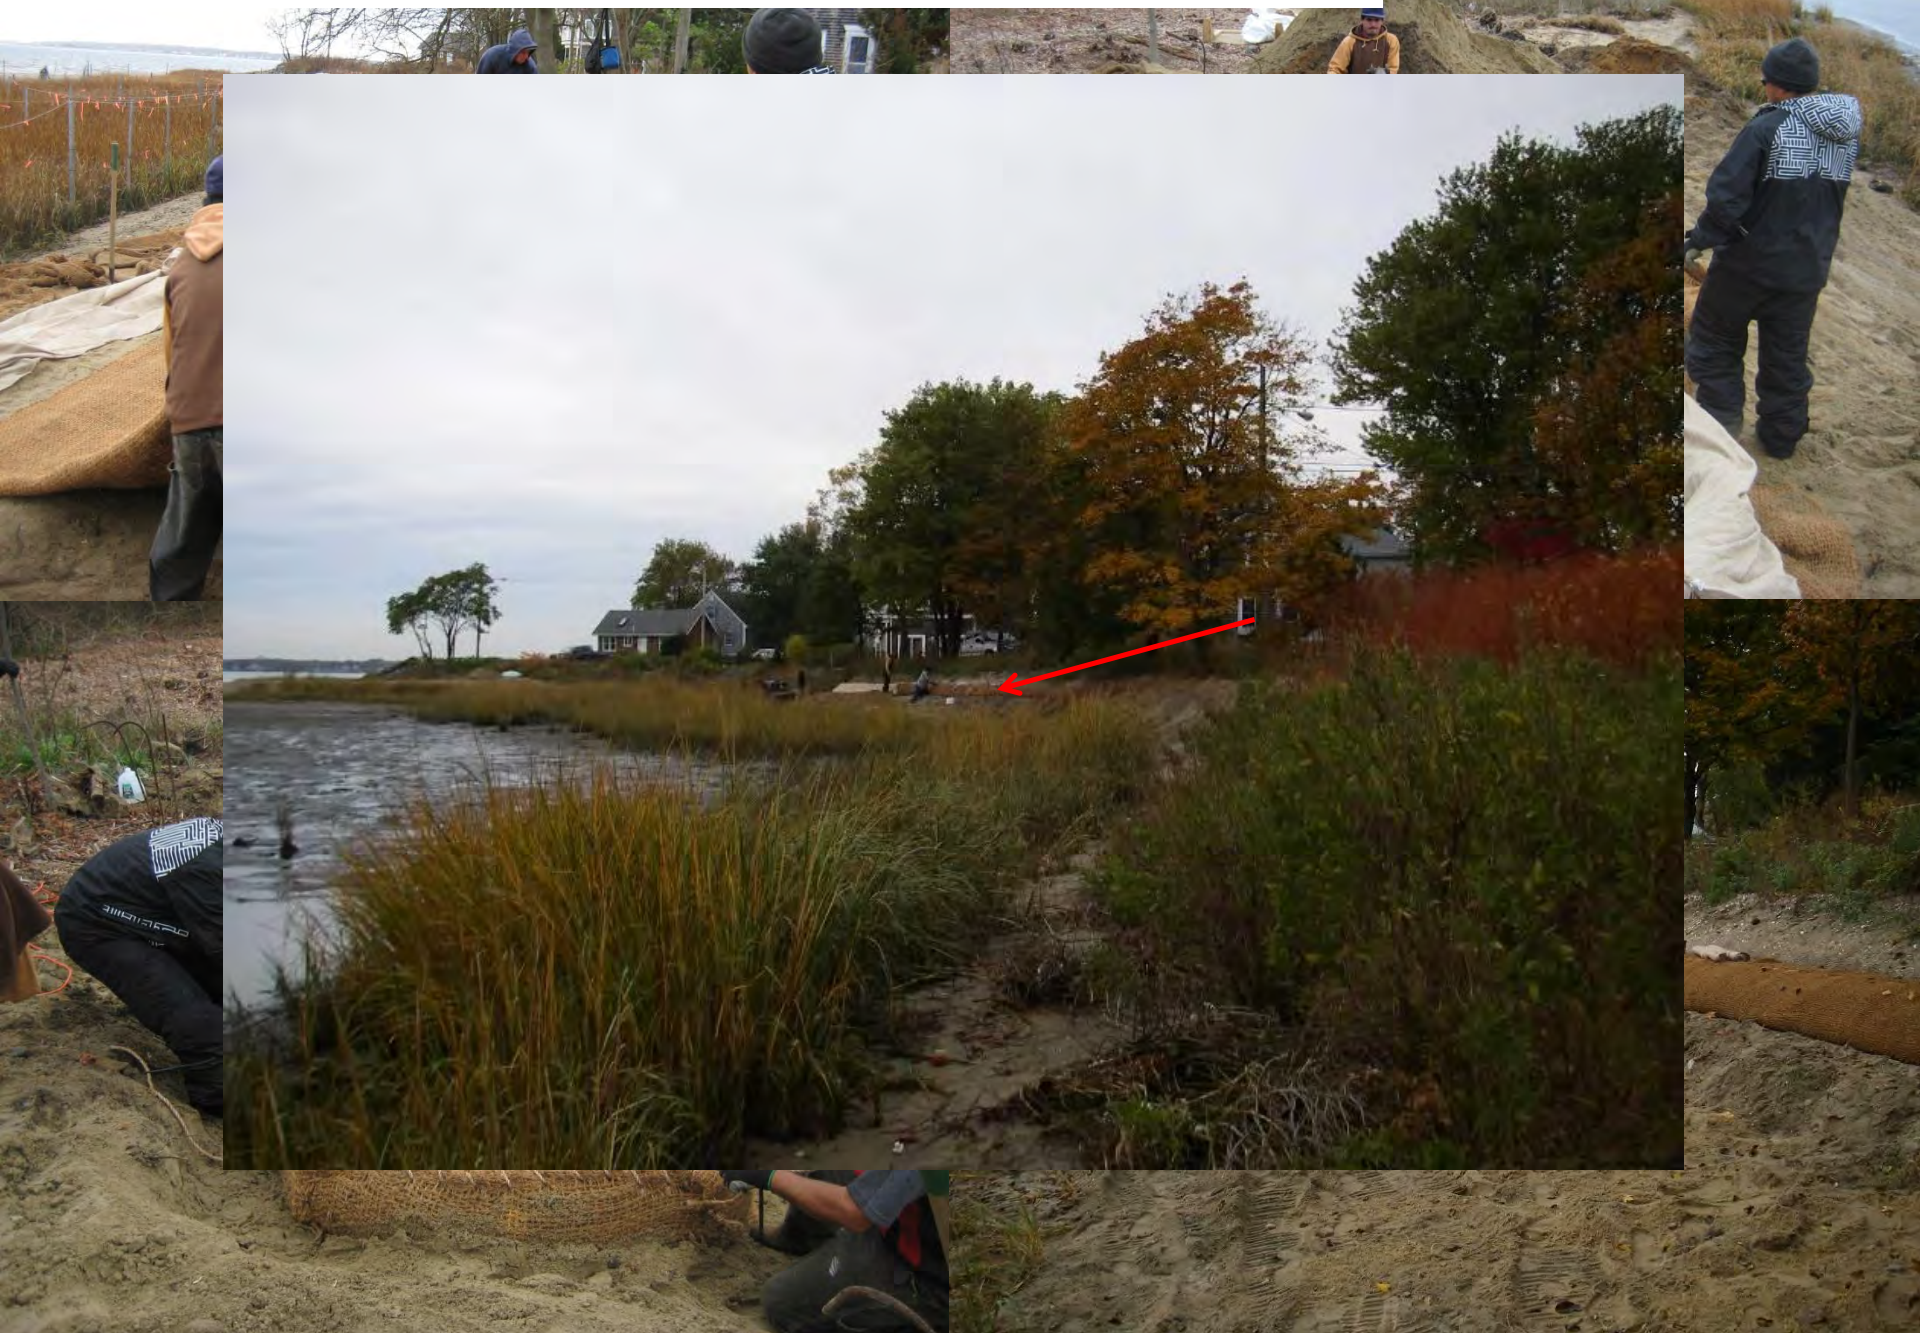
Allins Cove, Barrington: bank stabilization

Bank stabilization using coir envelopes

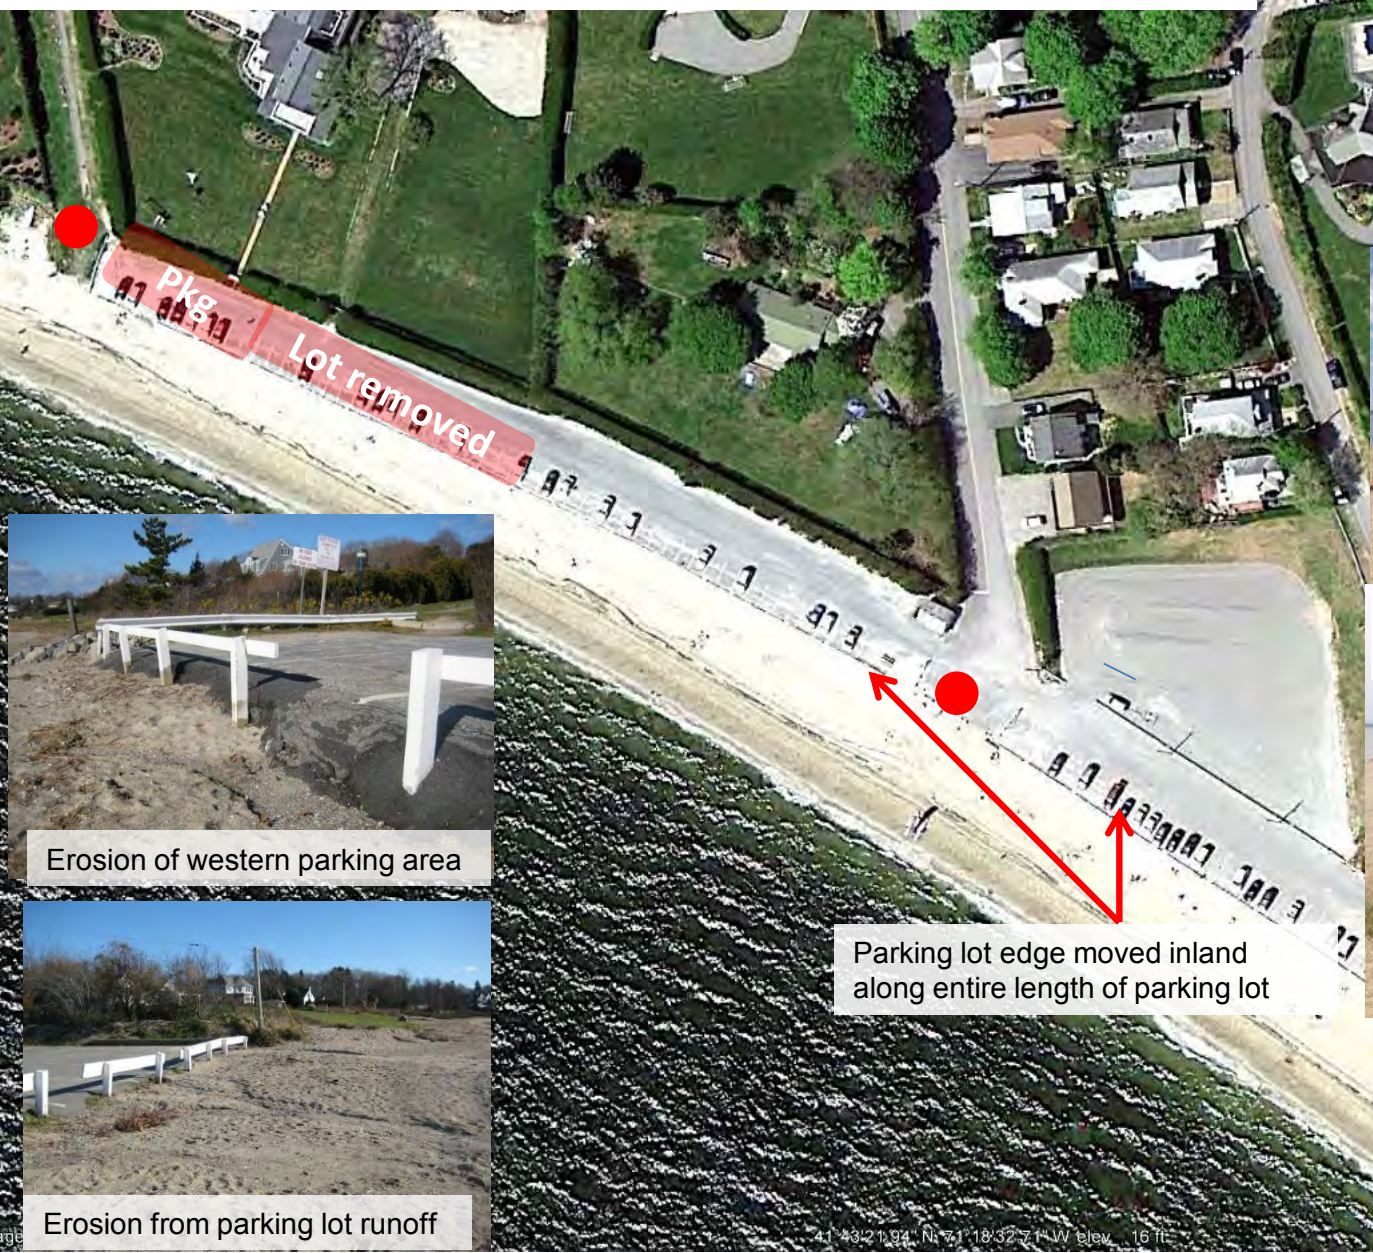
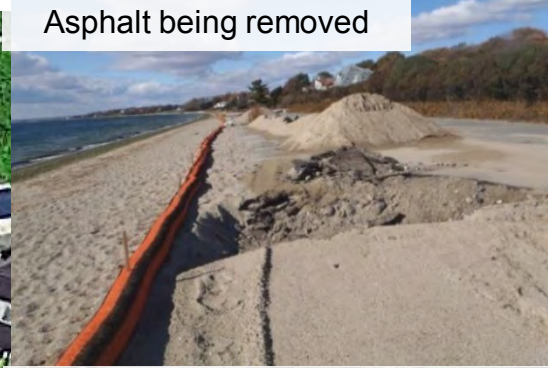
Barrington Beach: parking lot removal and stormwater infiltration

Asphalt being removed

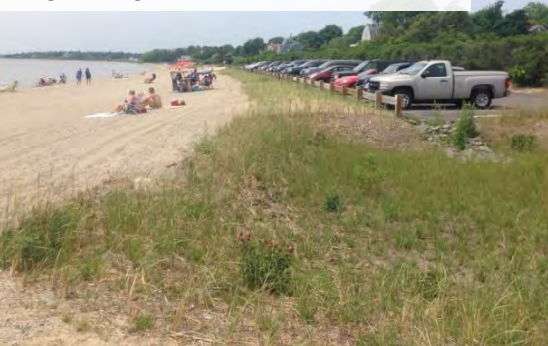
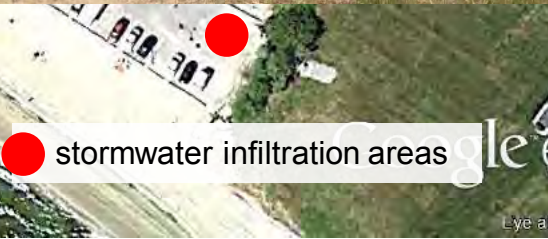
Dune grass planting in former parking area

Parking lot carve back area after 2 growing seasons

stormwater infiltration areas

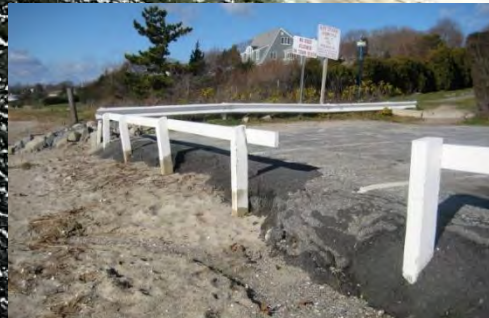
Erosion of western parking area

Erosion from parking lot runoff

Parking lot edge moved inland along entire length of parking lot

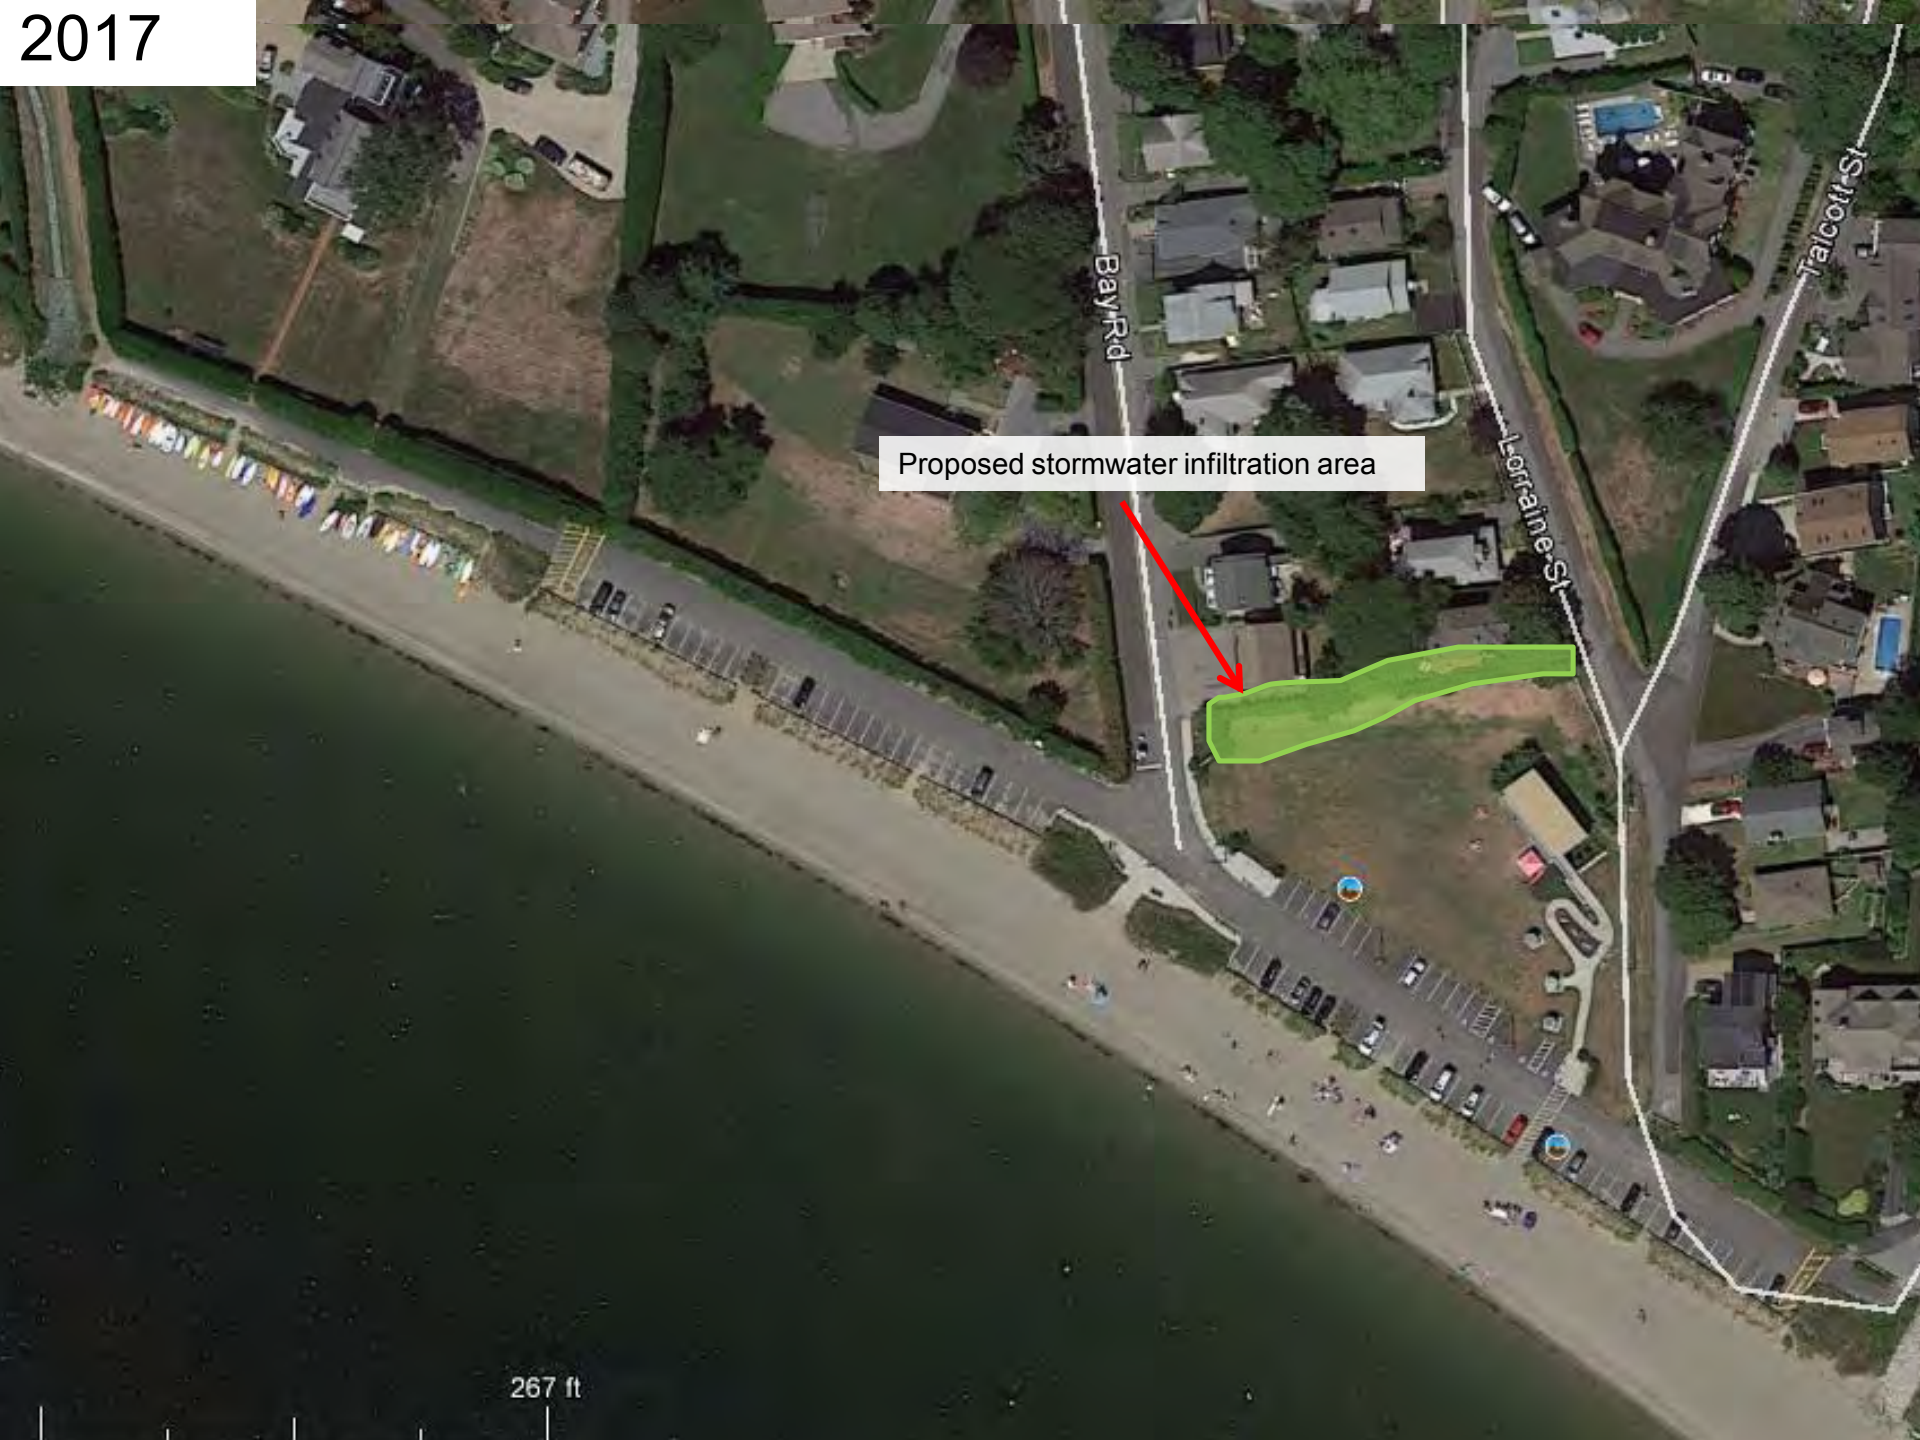
Proposed stormwater infiltration area

267 ft

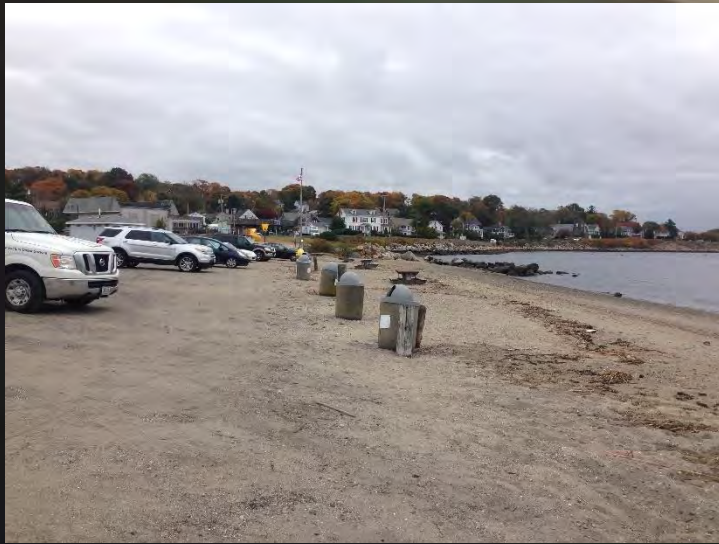
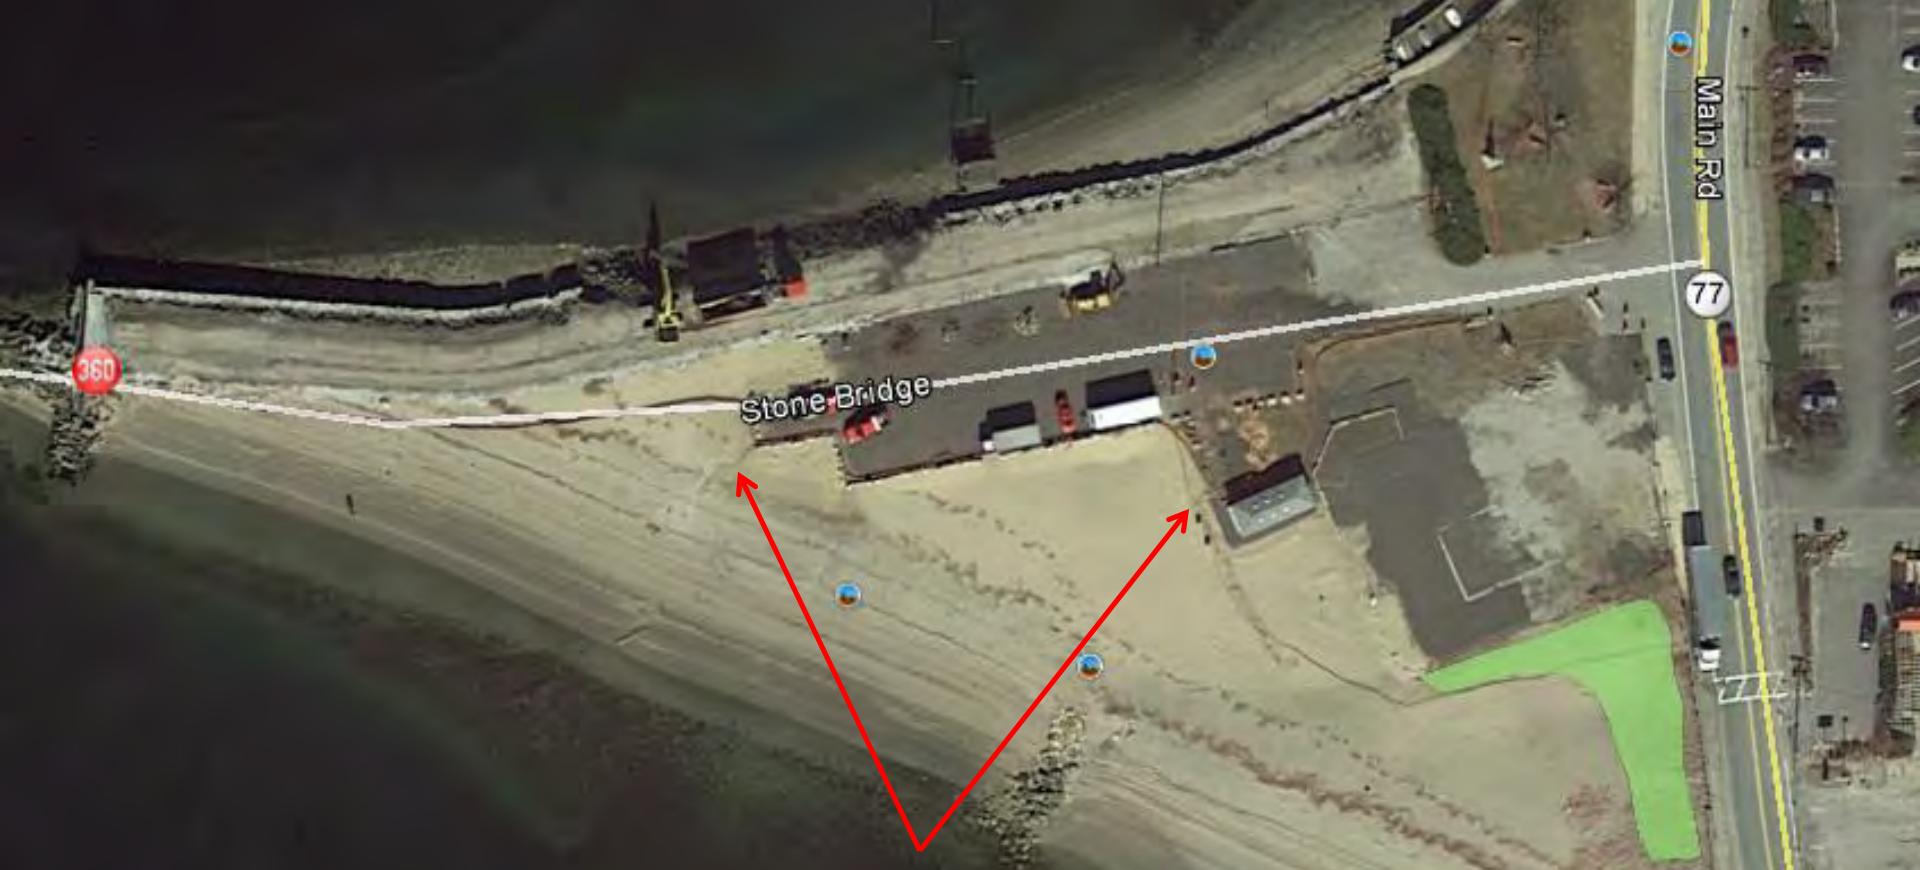
Grinnell's Beach, Tiverton: Buffer Restoration and Infrastructure Removal

Creating small sand berm/dune planted with dune grass between beach and relocated parking area

Relocated Parking area

Former gas station removed

Coastal buffer planting

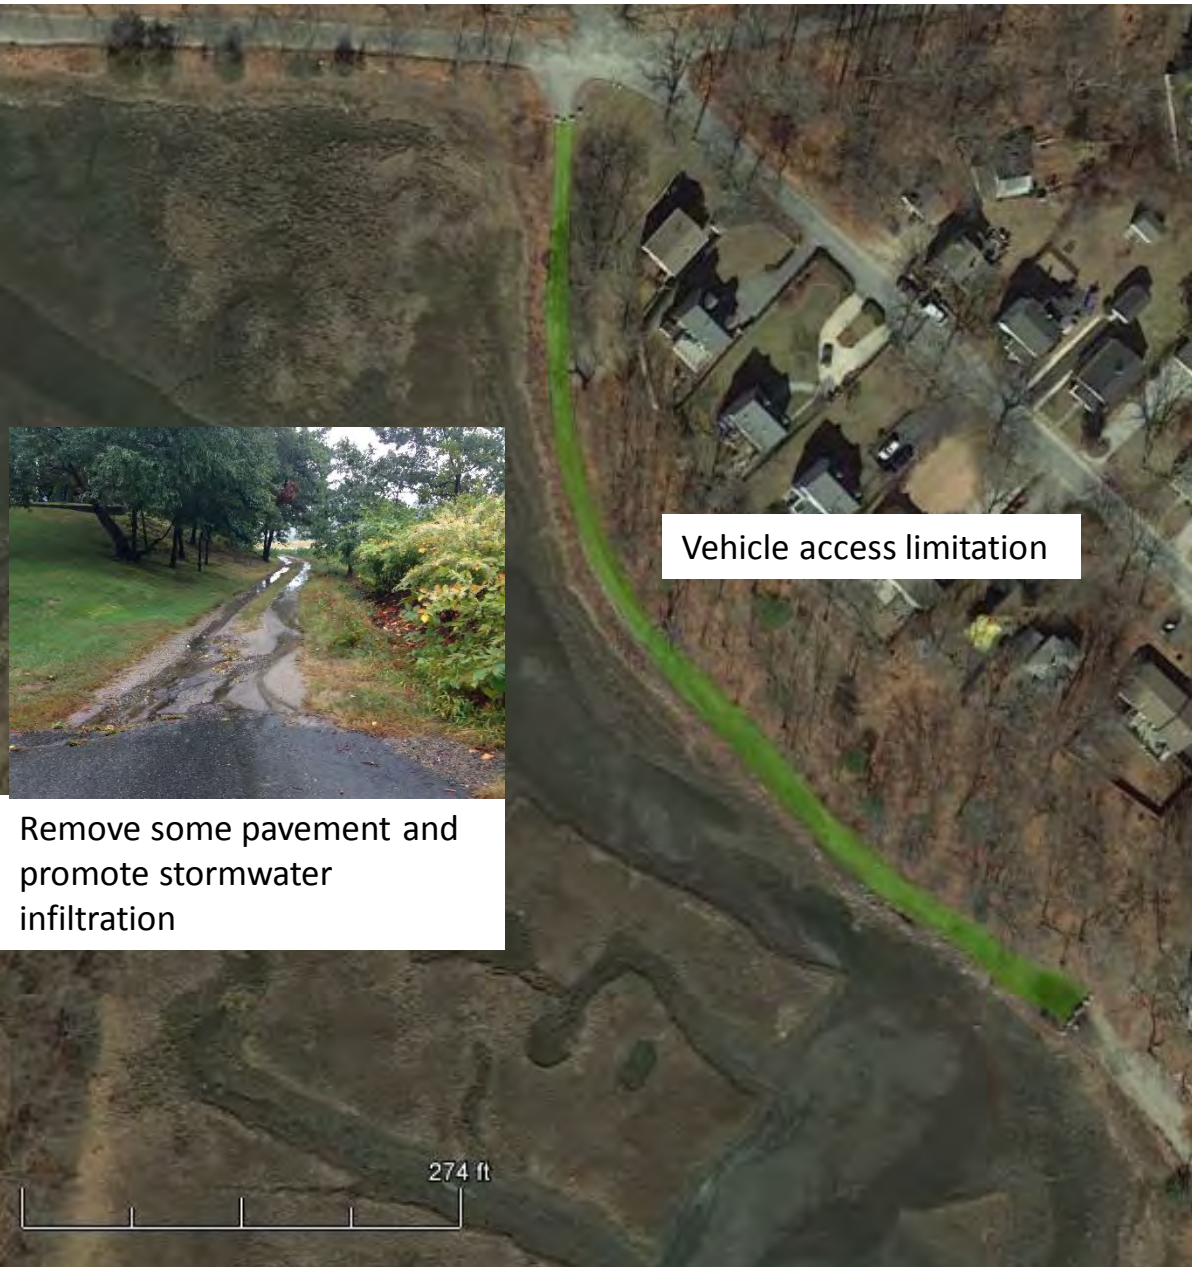
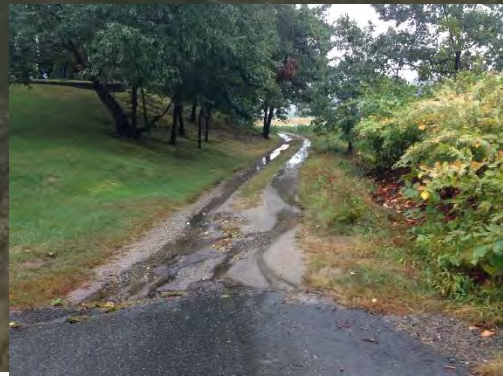
Midgely Avenue, Warwick: vehicle access limited; plan to treat stormwater and restore marsh in road area

Vehicle access limitation

Remove some pavement and promote stormwater infiltration

Limit vehicular access in area of road that regularly floods, remain open for pedestrian access

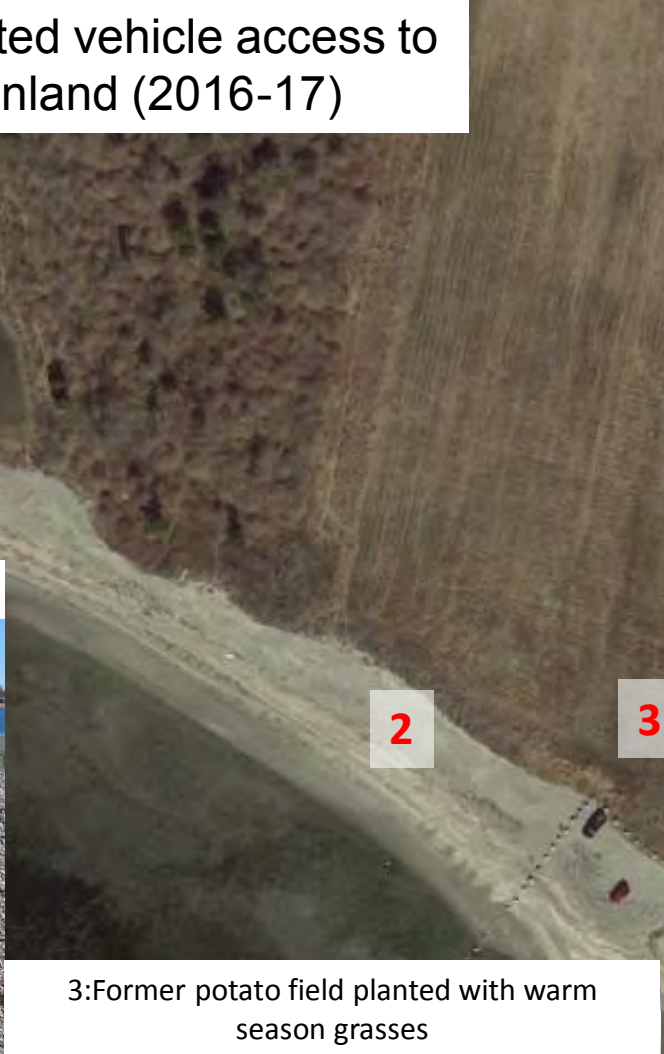
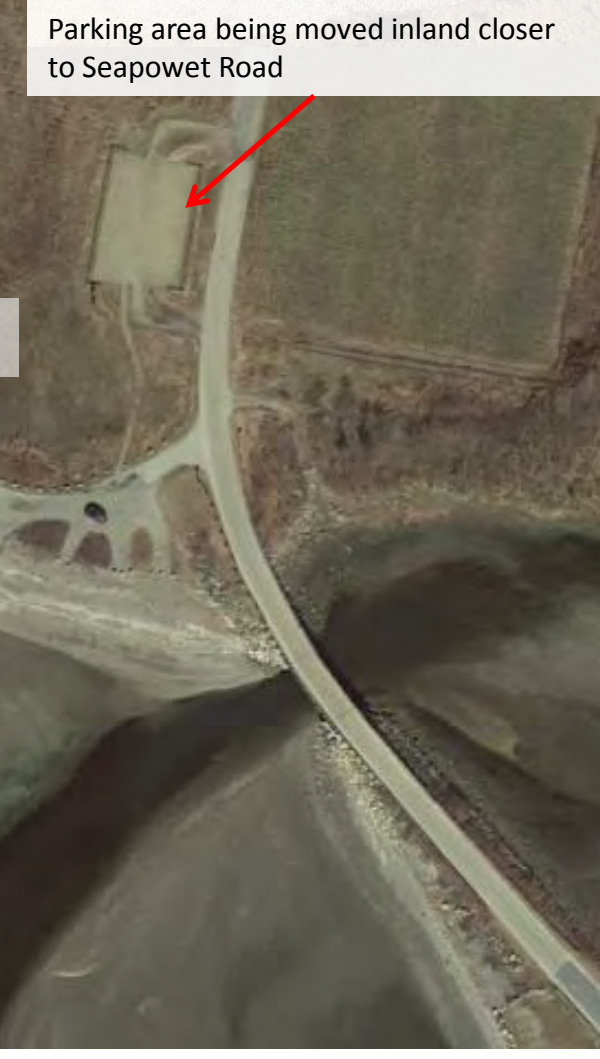
Seapowet Point, Tiverton: limited vehicle access to beach and moved parking lot inland (2016-17)

1: Eroding bluff along former parking area

2: Vehicular access limited while maintaining public access

3: Former potato field planted with warm season grasses

Parking area being moved inland closer to Seapowet Road

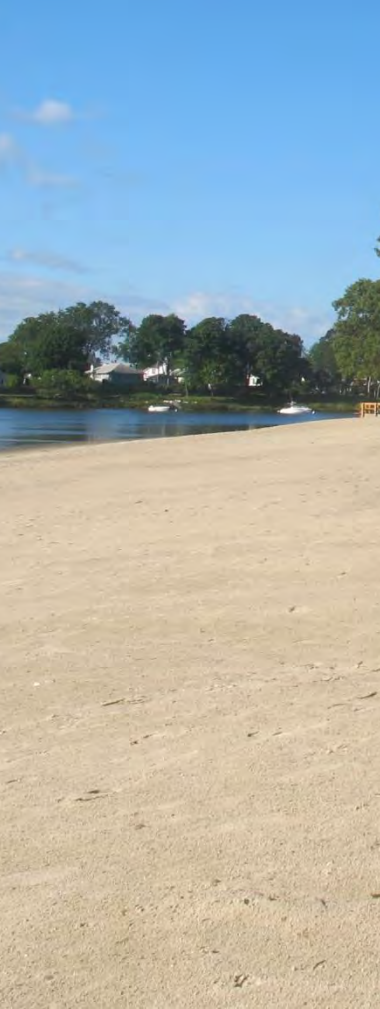
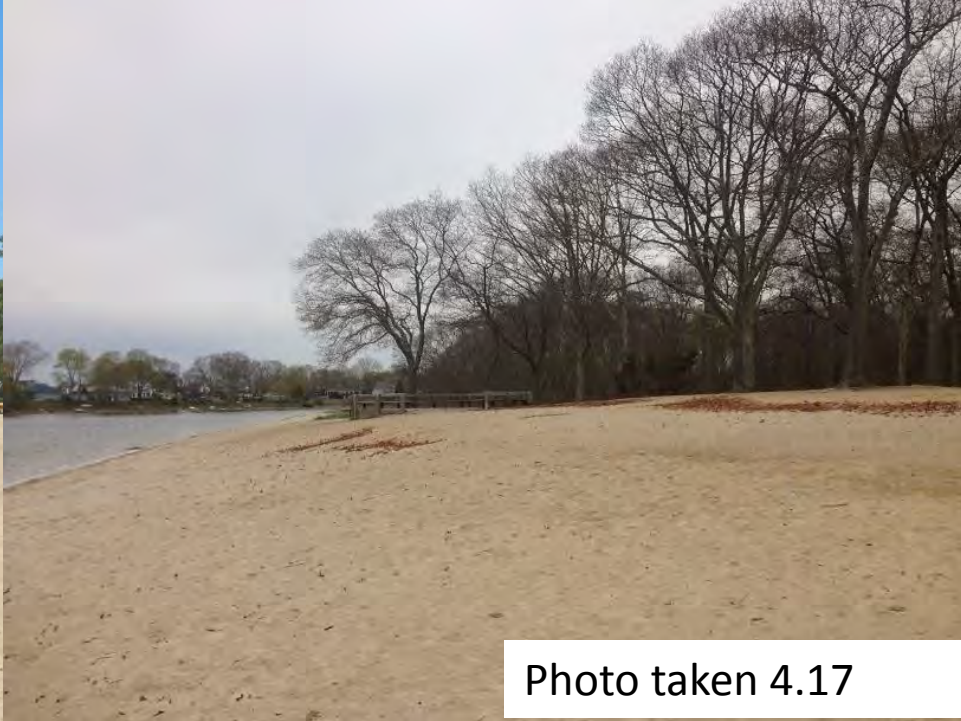
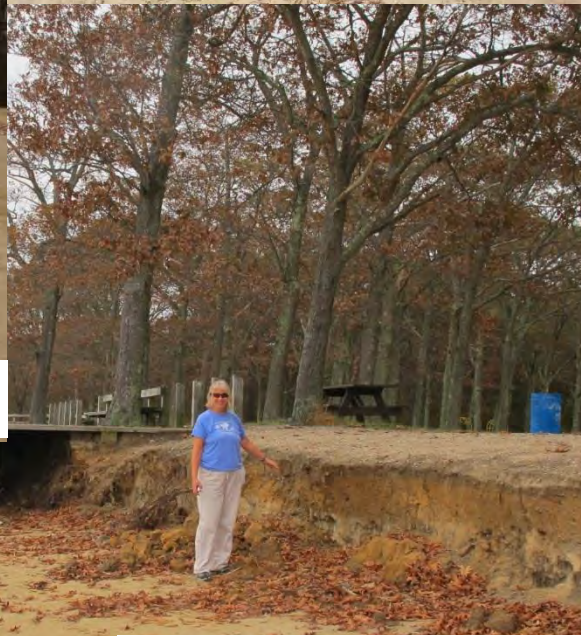
City Park Beach, Warwick: shoreline regrading

Photo taken 6.10

Photo taken 9.11

Photo taken 9.12

Photo taken 4.17

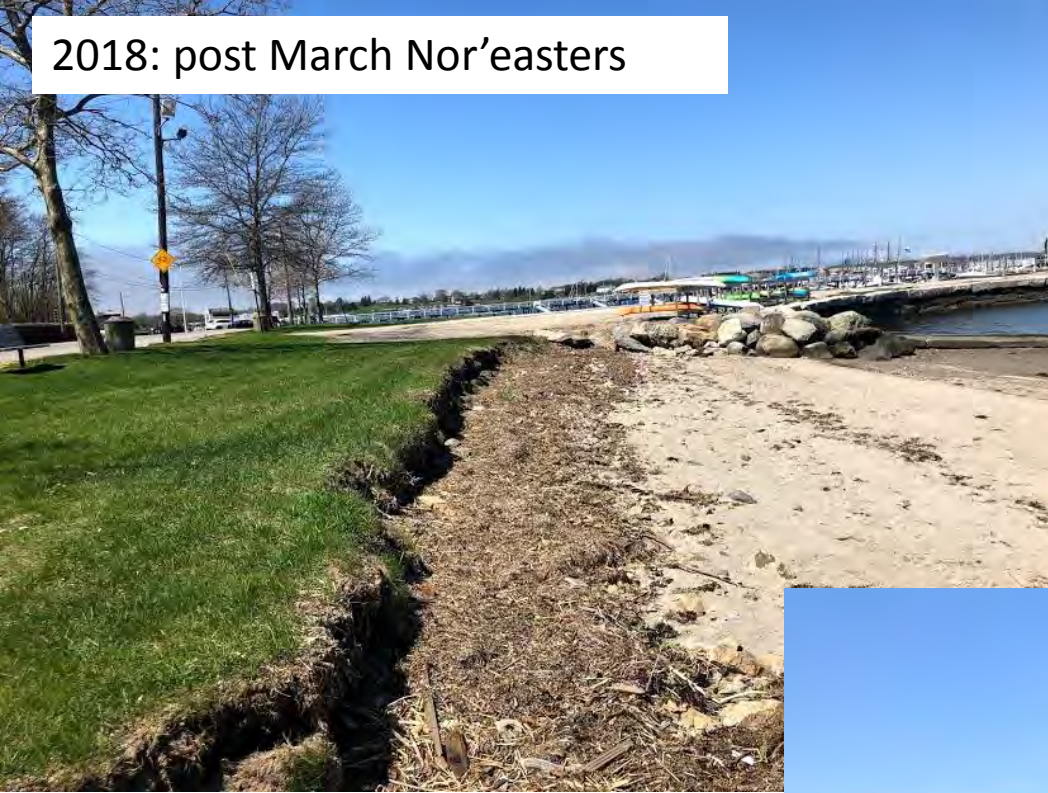
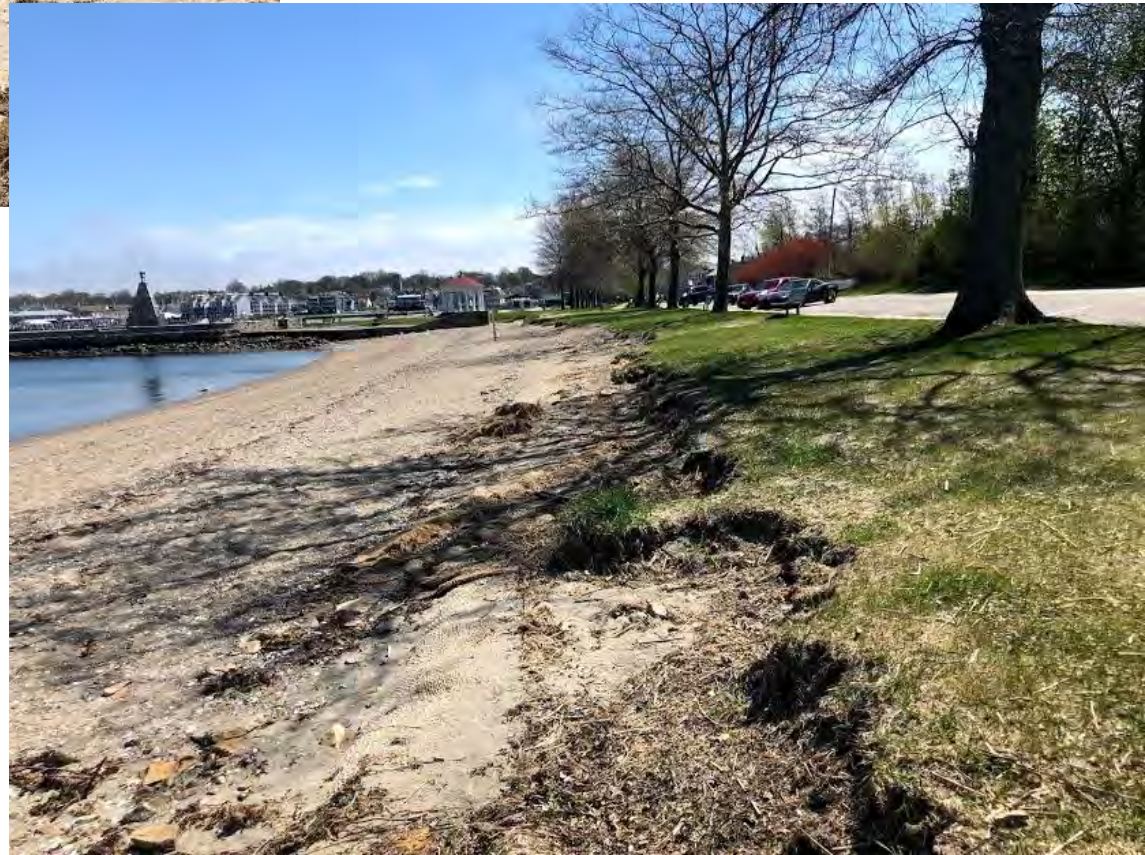
King Park, Newport

Coir envelope installation area 2014

Erosion along boat ramp

2018: post March Nor'easters

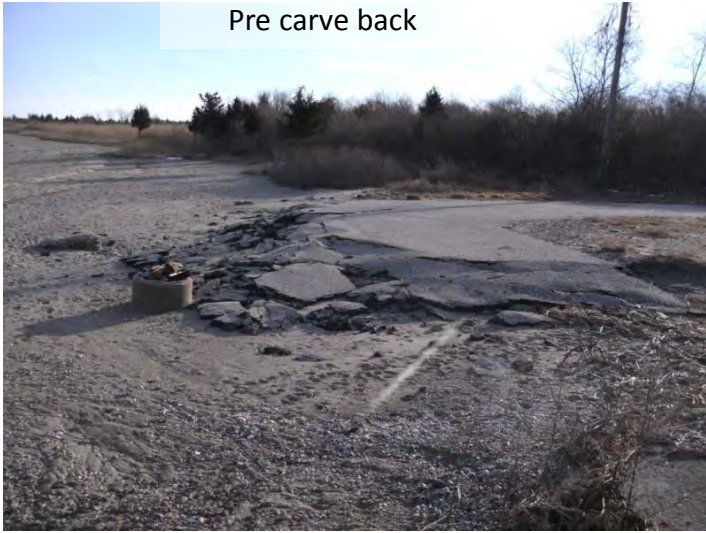
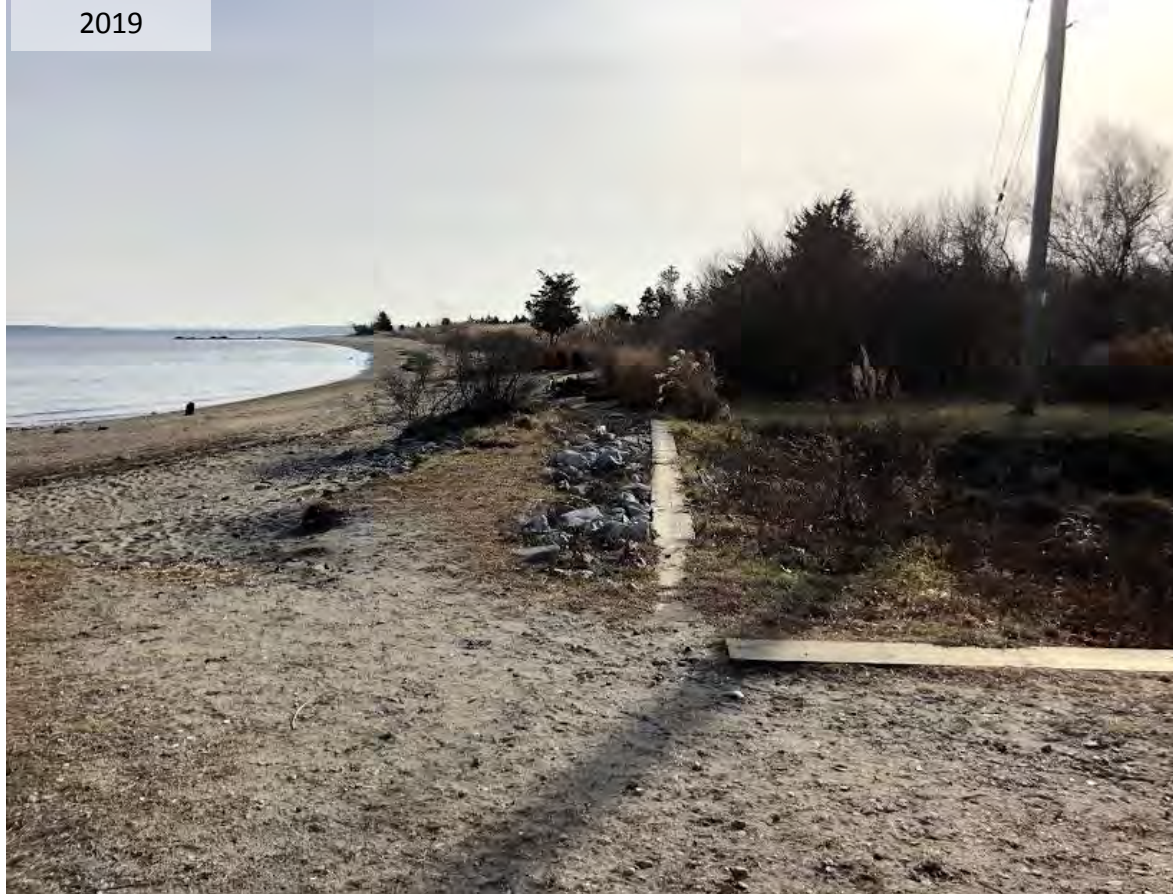
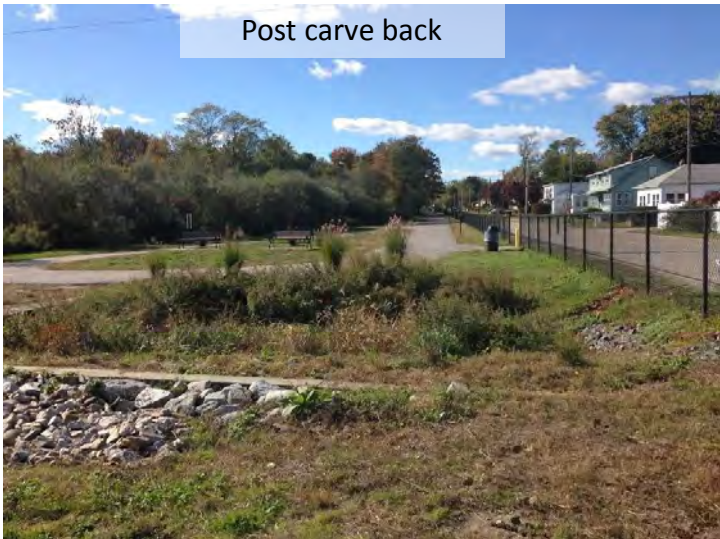
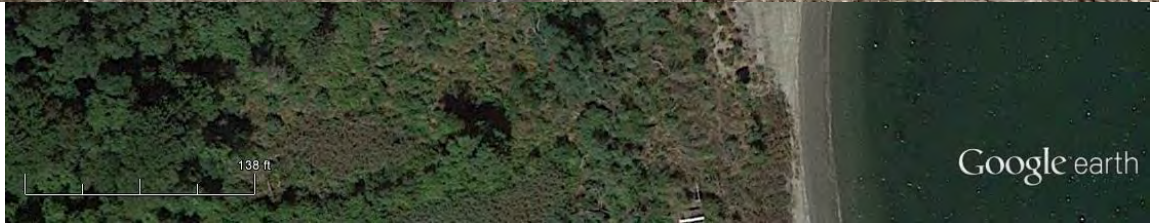
Pettee Avenue, North Kingstown: road removal

Pre carve back

Post carve back

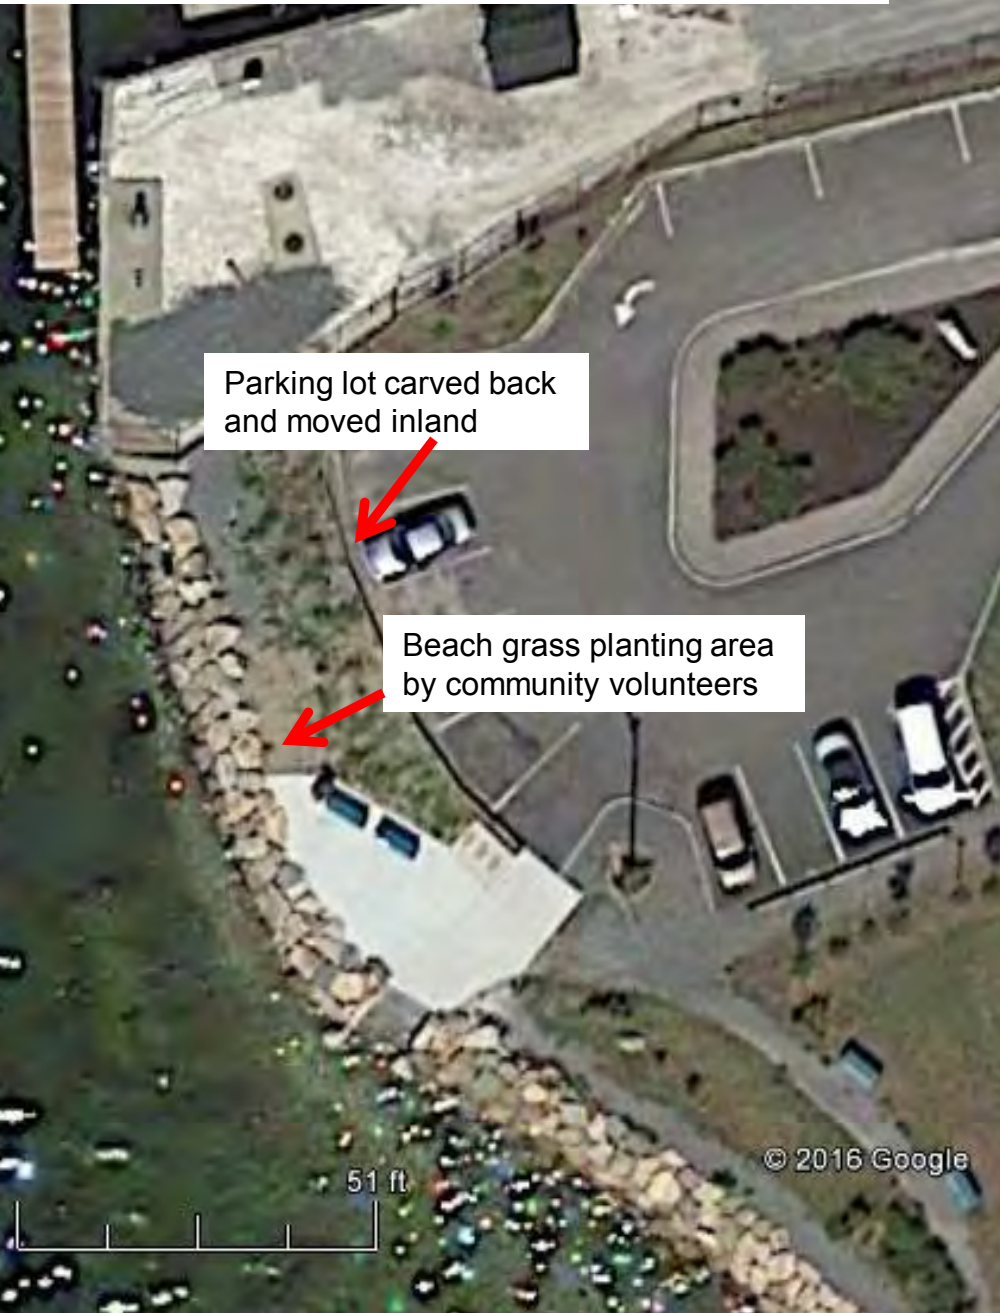
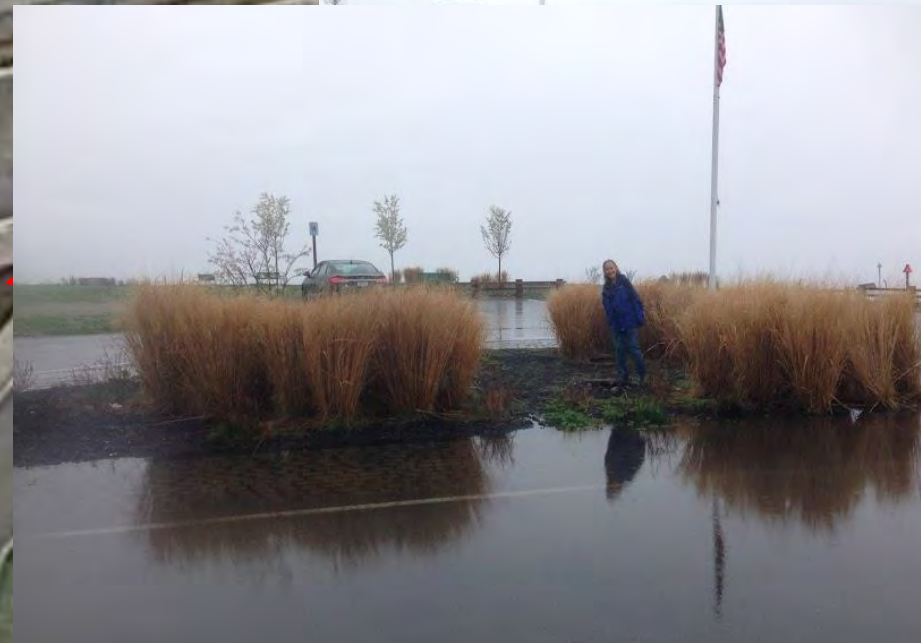
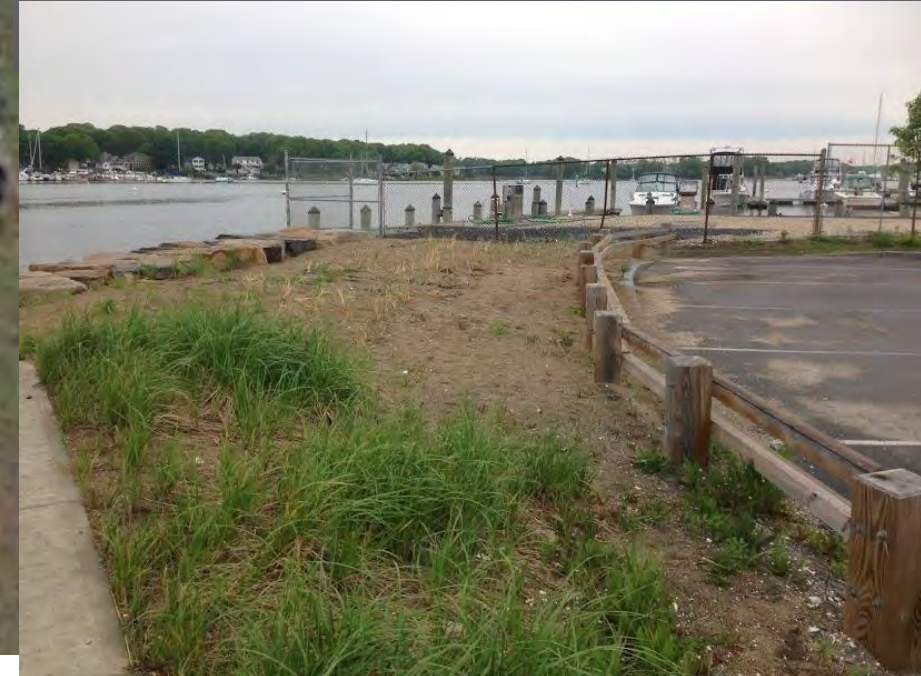
Latham Park adaptation

Runoff redirected to bioinfiltration area placed in former parking area
