Migrating Shorelines: Opportunities for Coastal Adaptation

Land and Water Summit March 2019

Adaptation Strategies

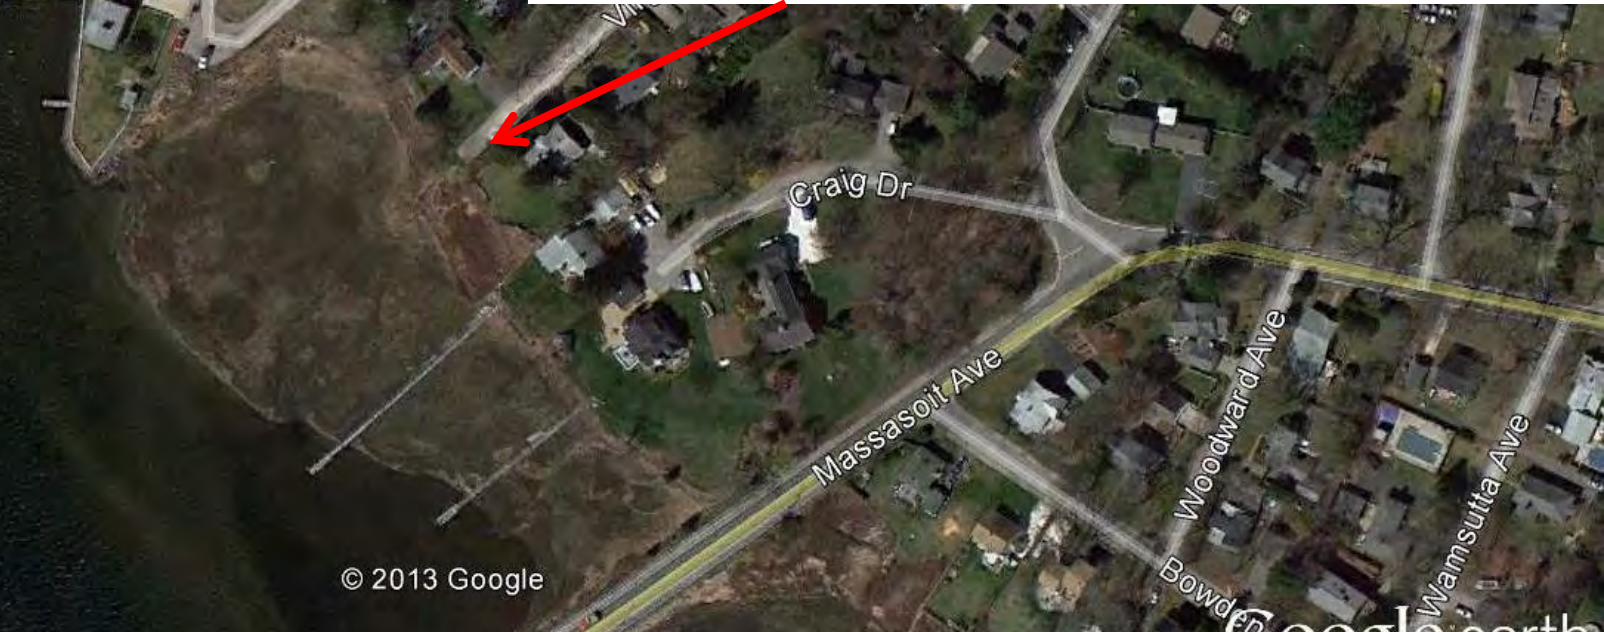
Proposed end of road retrofit to remove pavement and infiltrate stormwater before entering marsh along 100 Acre Cove
