Using the MyCoast Coastal Resilience Tool for Monitoring Shoreline Change and Coastal Resilience

**2019 Land and Water Conservation Summit
University of Rhode Island
March 9, 2019**

MyCoast: Rhode Island

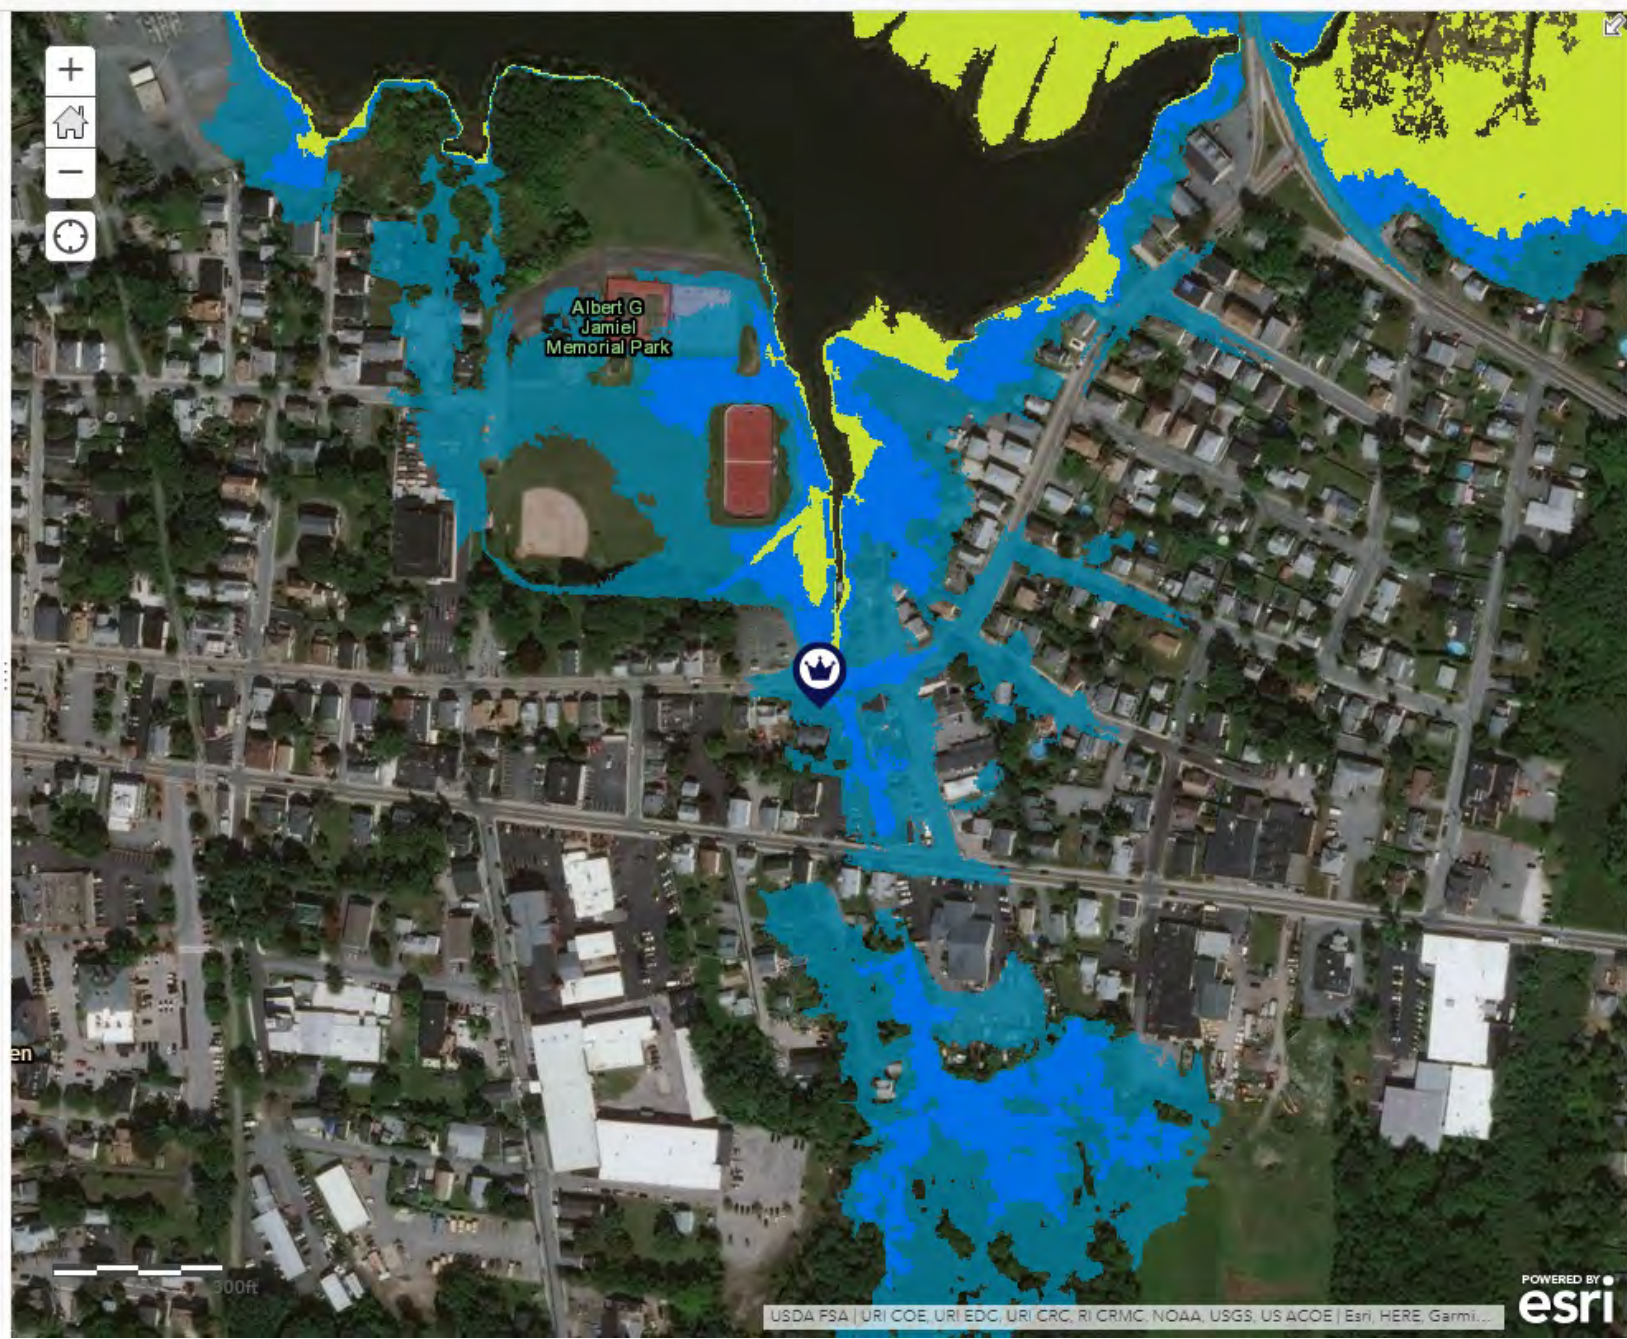
Will 1-FOOT of SEA LEVEL RISE affect my property?

Will 2-FEET of SEA LEVEL RISE affect my property?

Will 3-FEET of SEA LEVEL RISE affect my property?

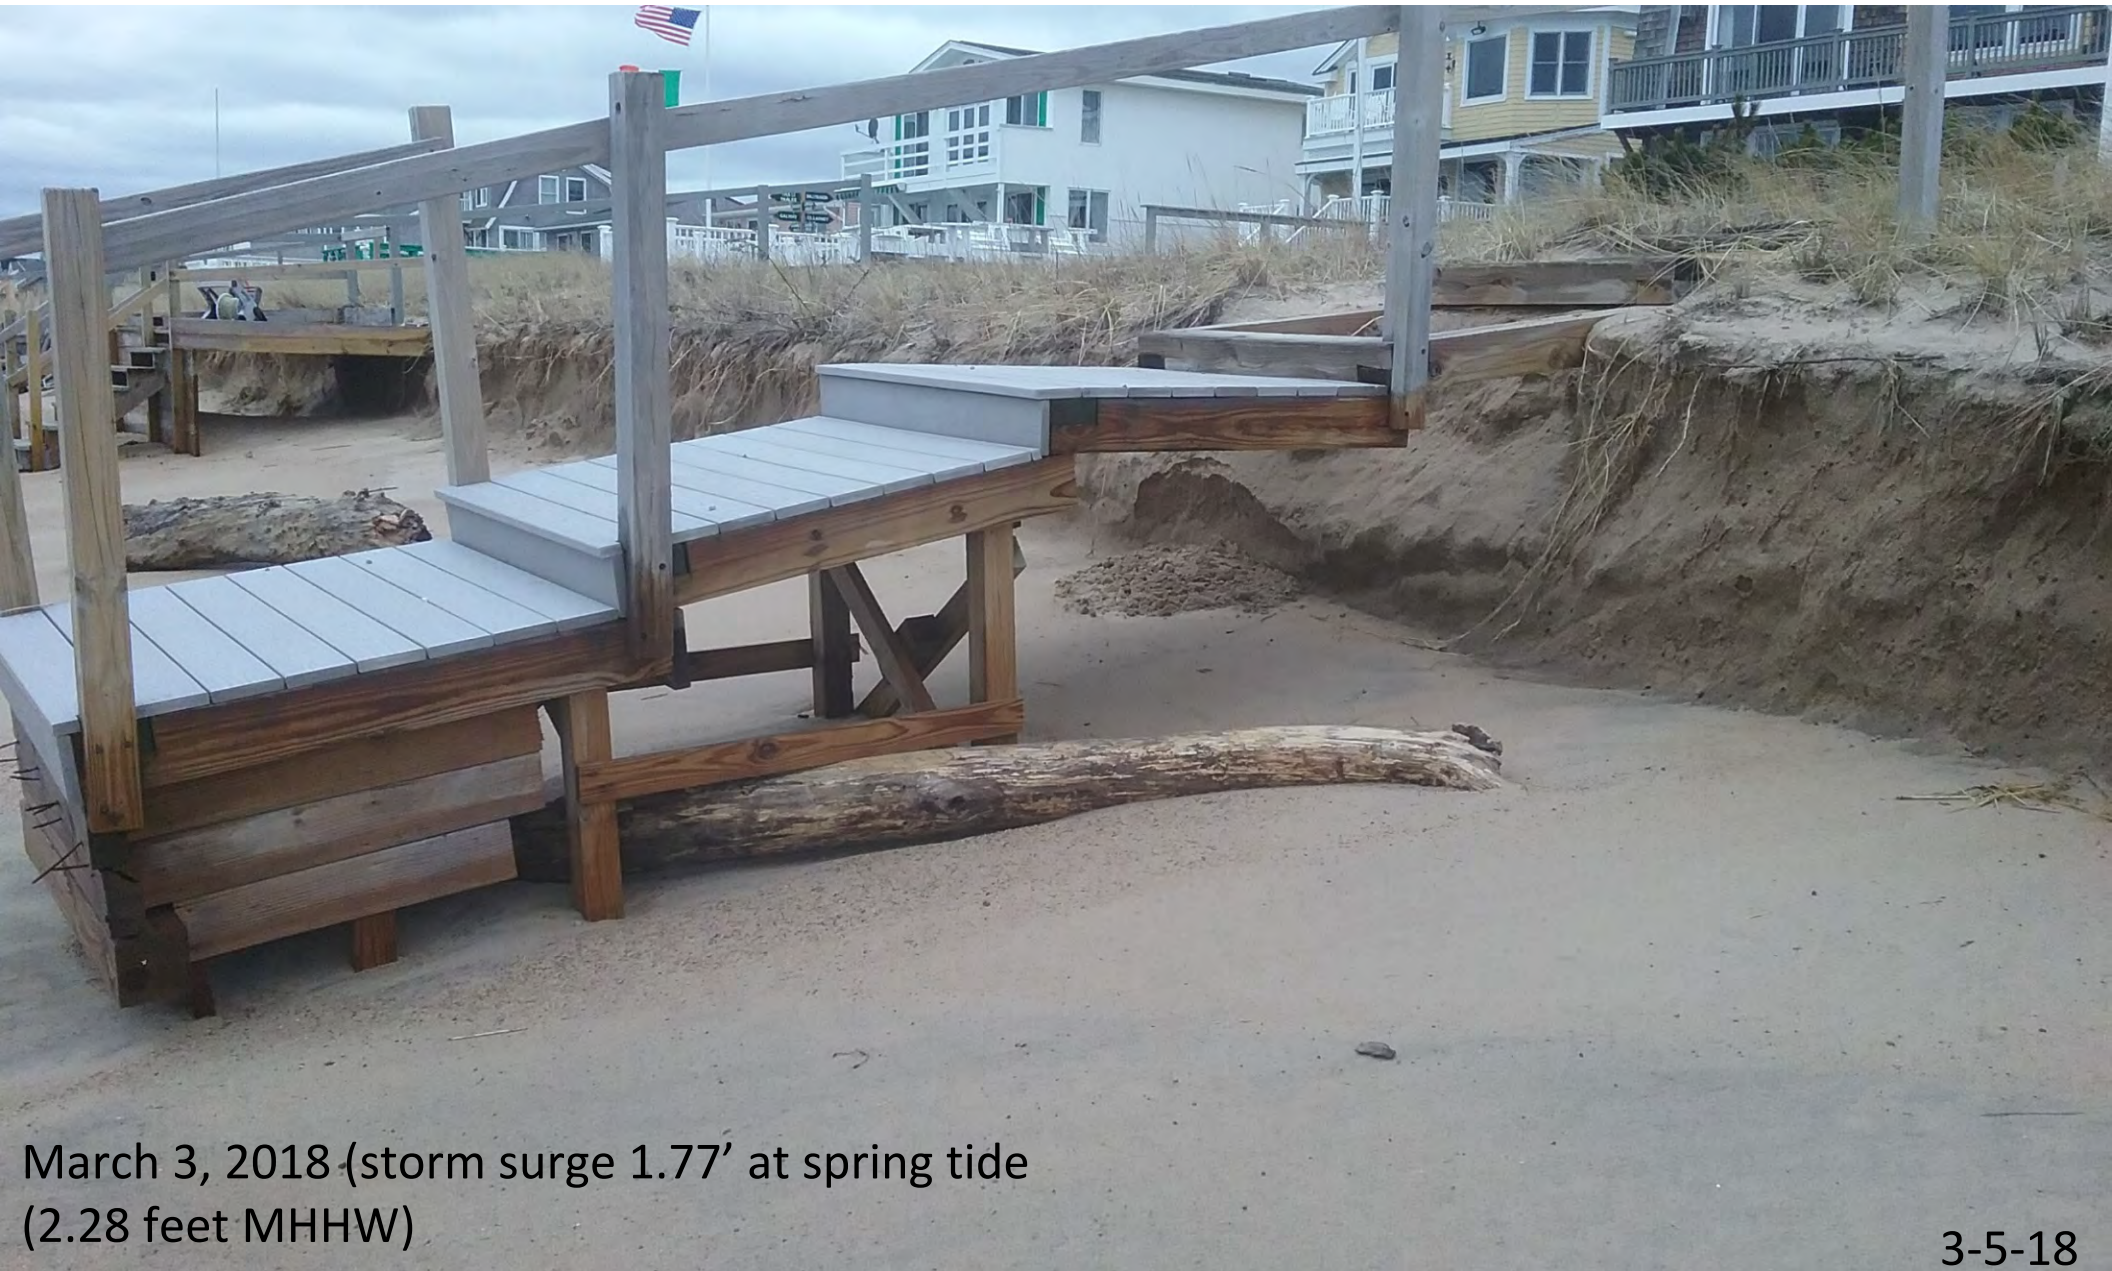
March 3, 2018 (storm surge 1.77' at spring tide
(2.28 feet MHHW))

minor beach and dune erosion

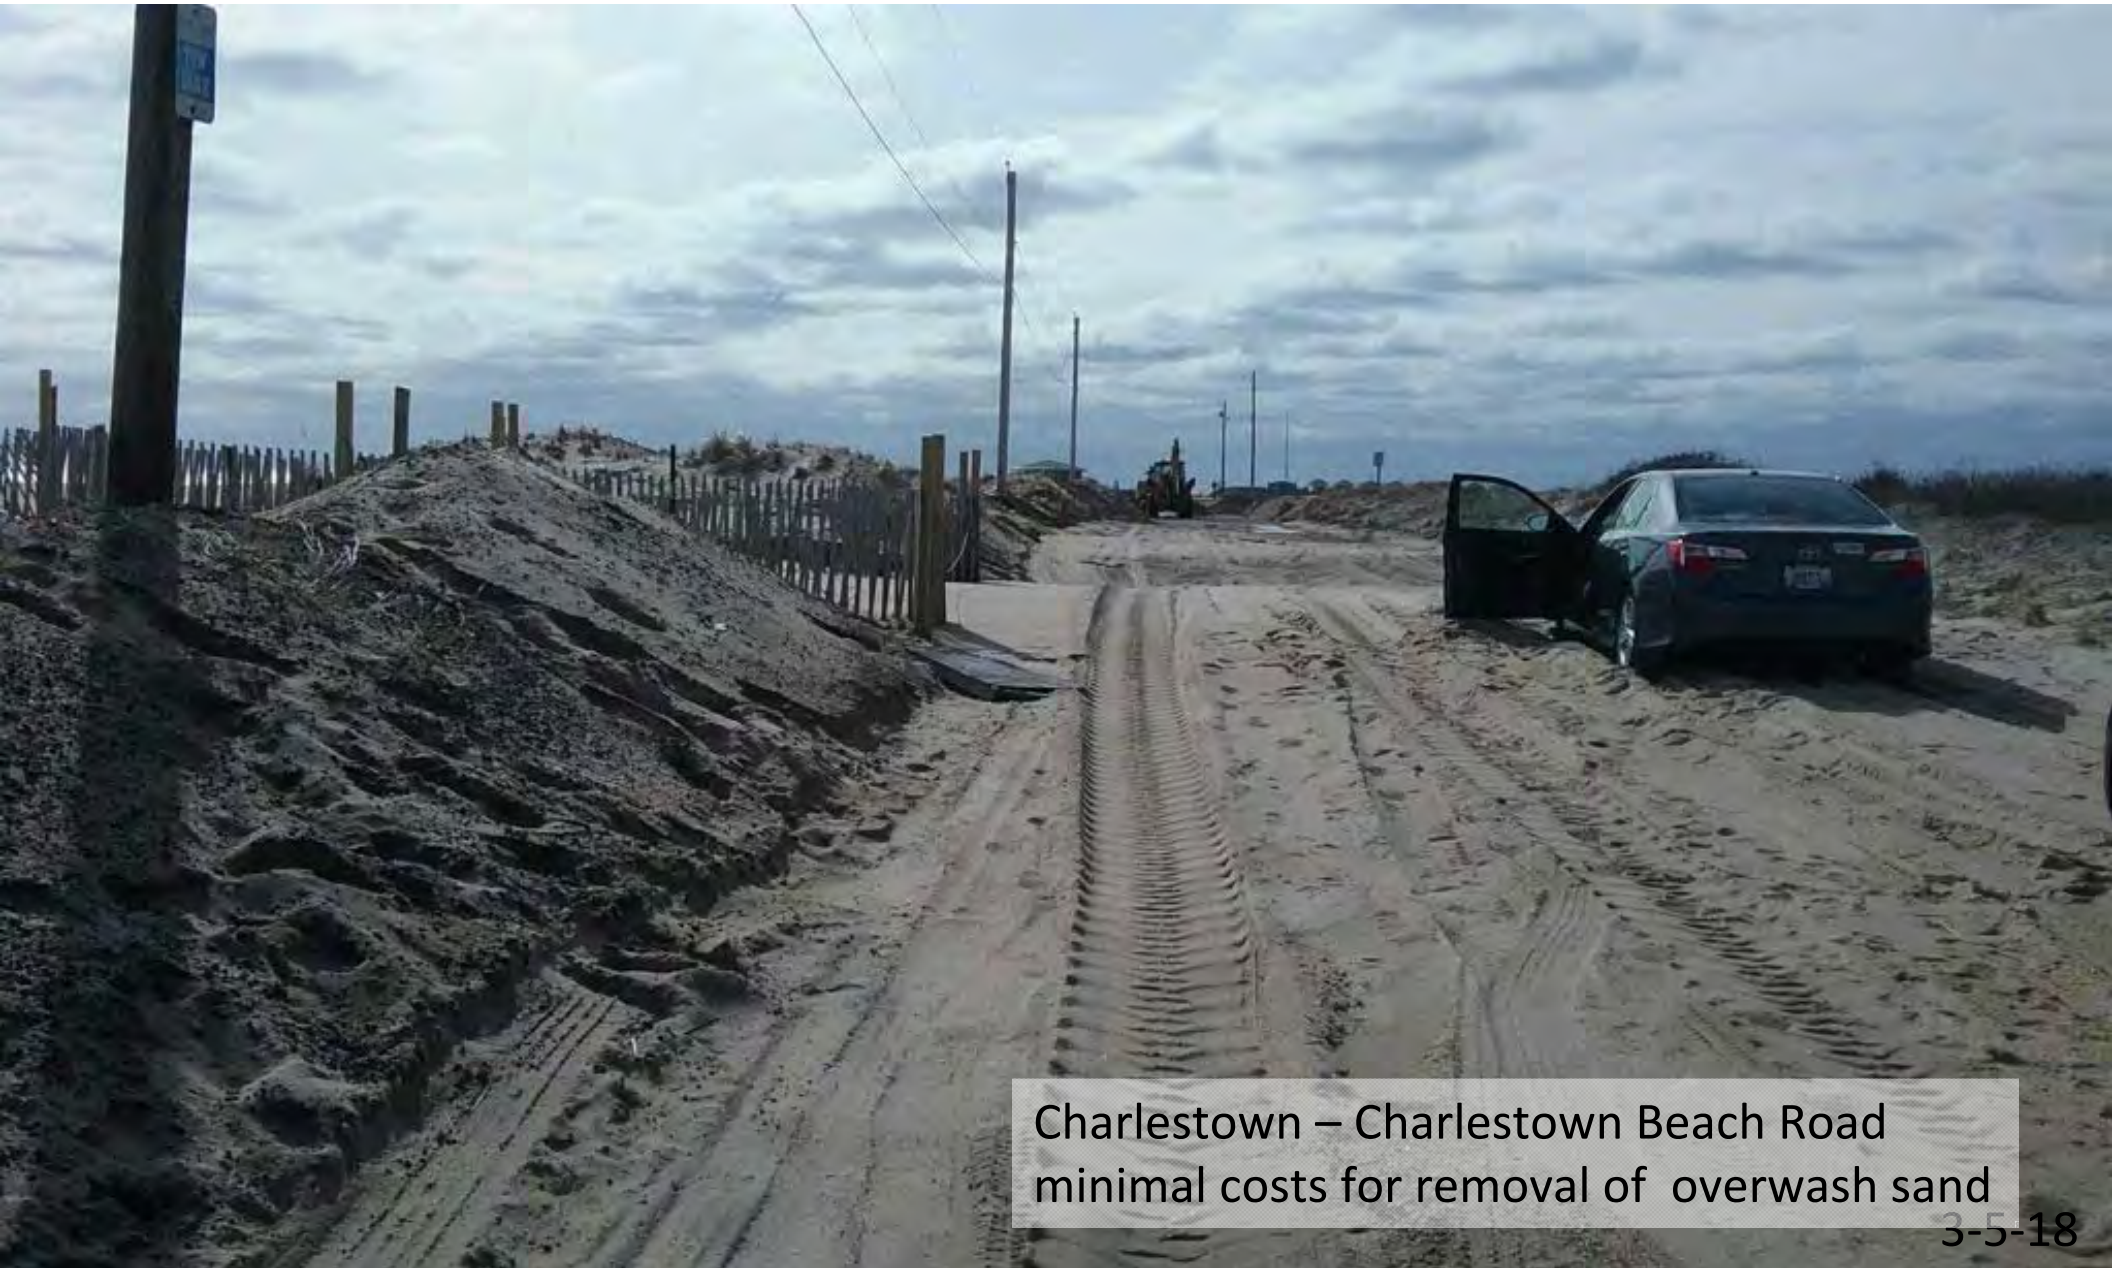
Charlestown – Charlestown Beach Road
minimal costs for removal of overwash sand

Minor overwash and tidal flooding
