**Providence
Stormwater
Innovation
Center**

Roger Williams Park stormwater/green infrastructure demonstration site

ROGER WILLIAMS PARK

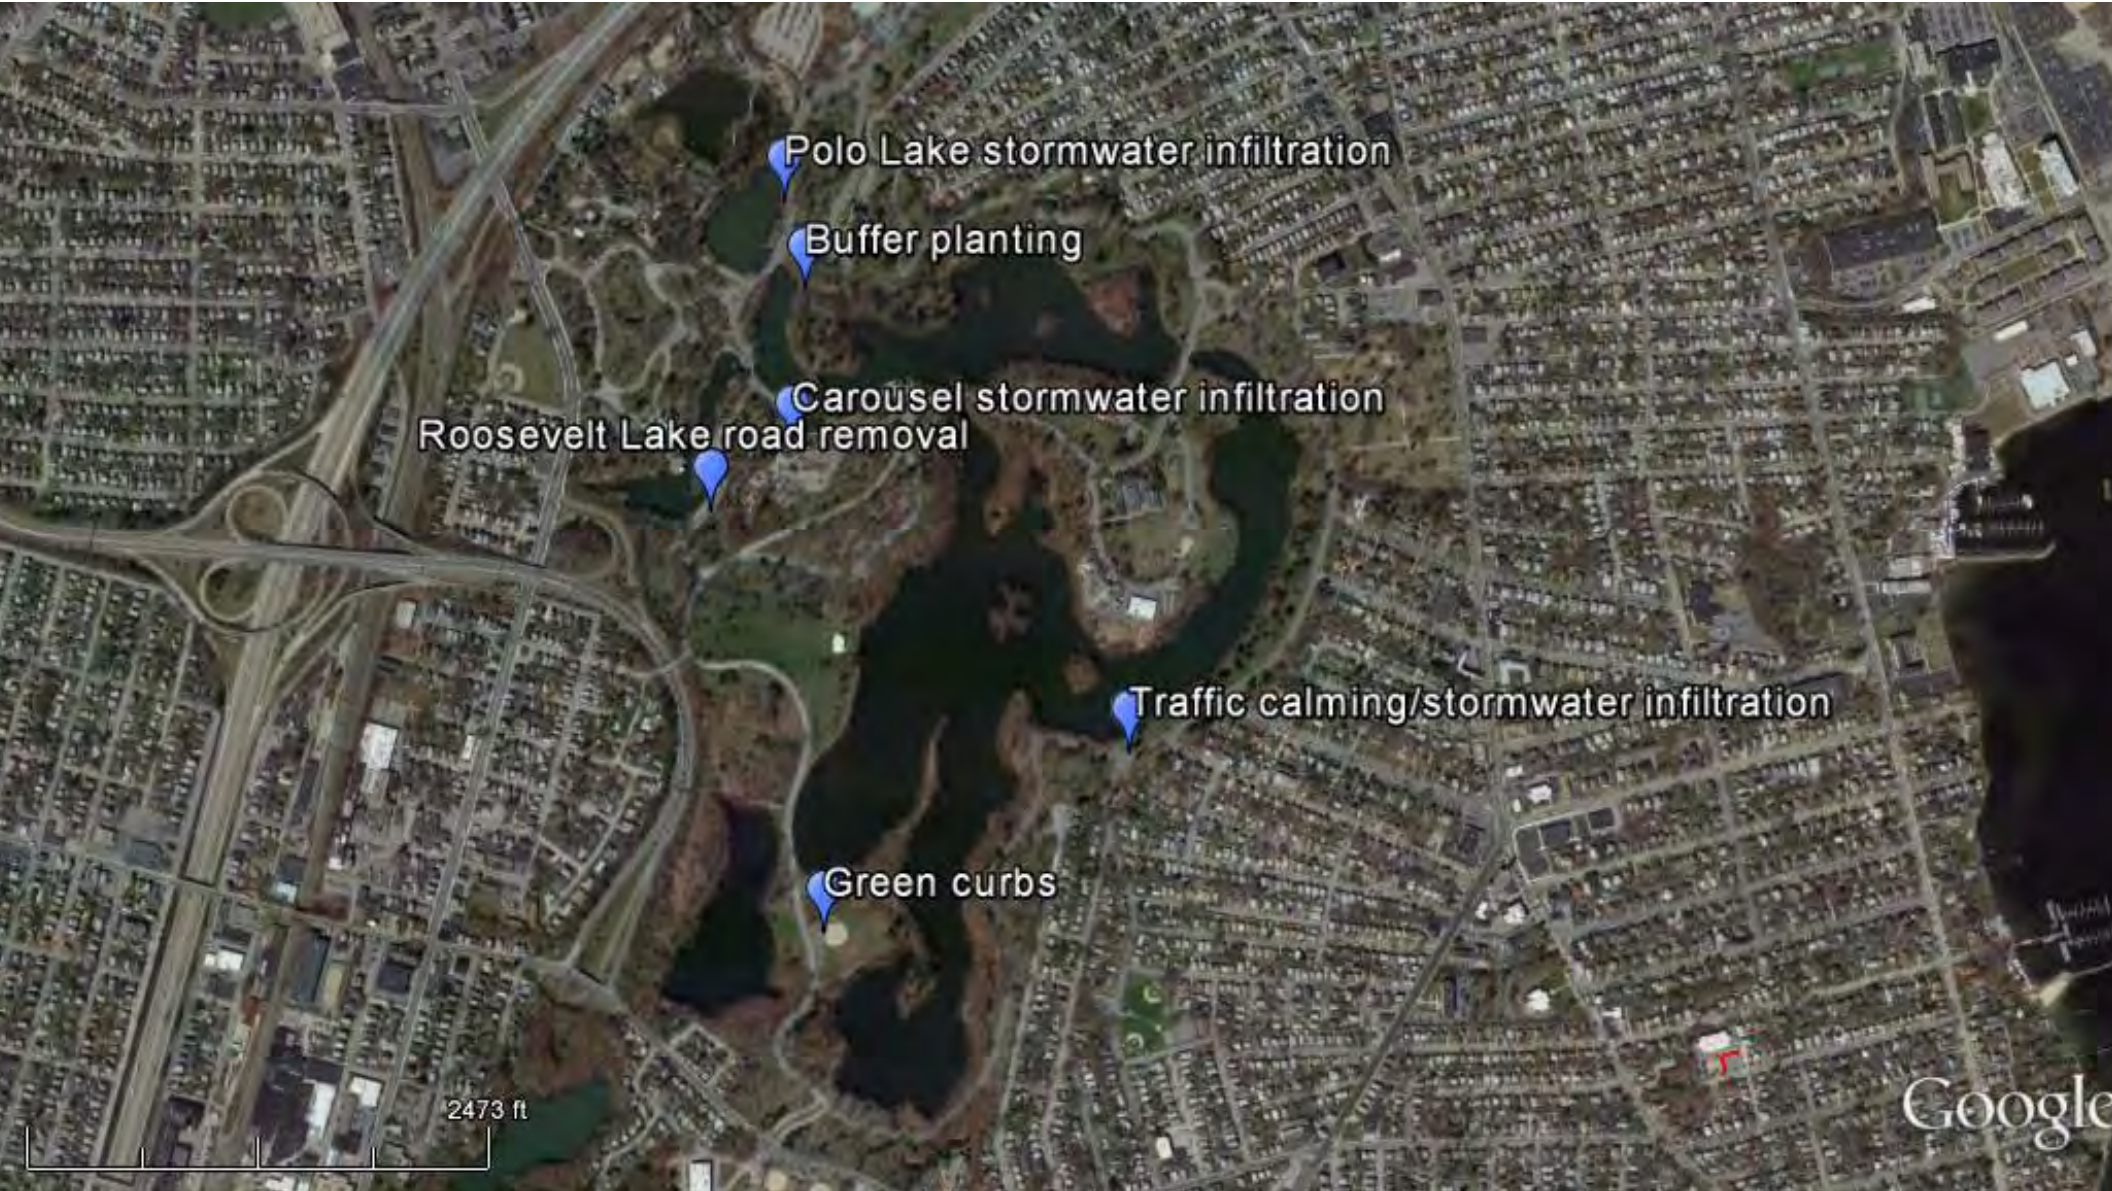
Polo Lake stormwater infiltration

Buffer planting

Carousel stormwater infiltration

Roosevelt Lake road removal

Traffic calming/stormwater infiltration

Green curbs

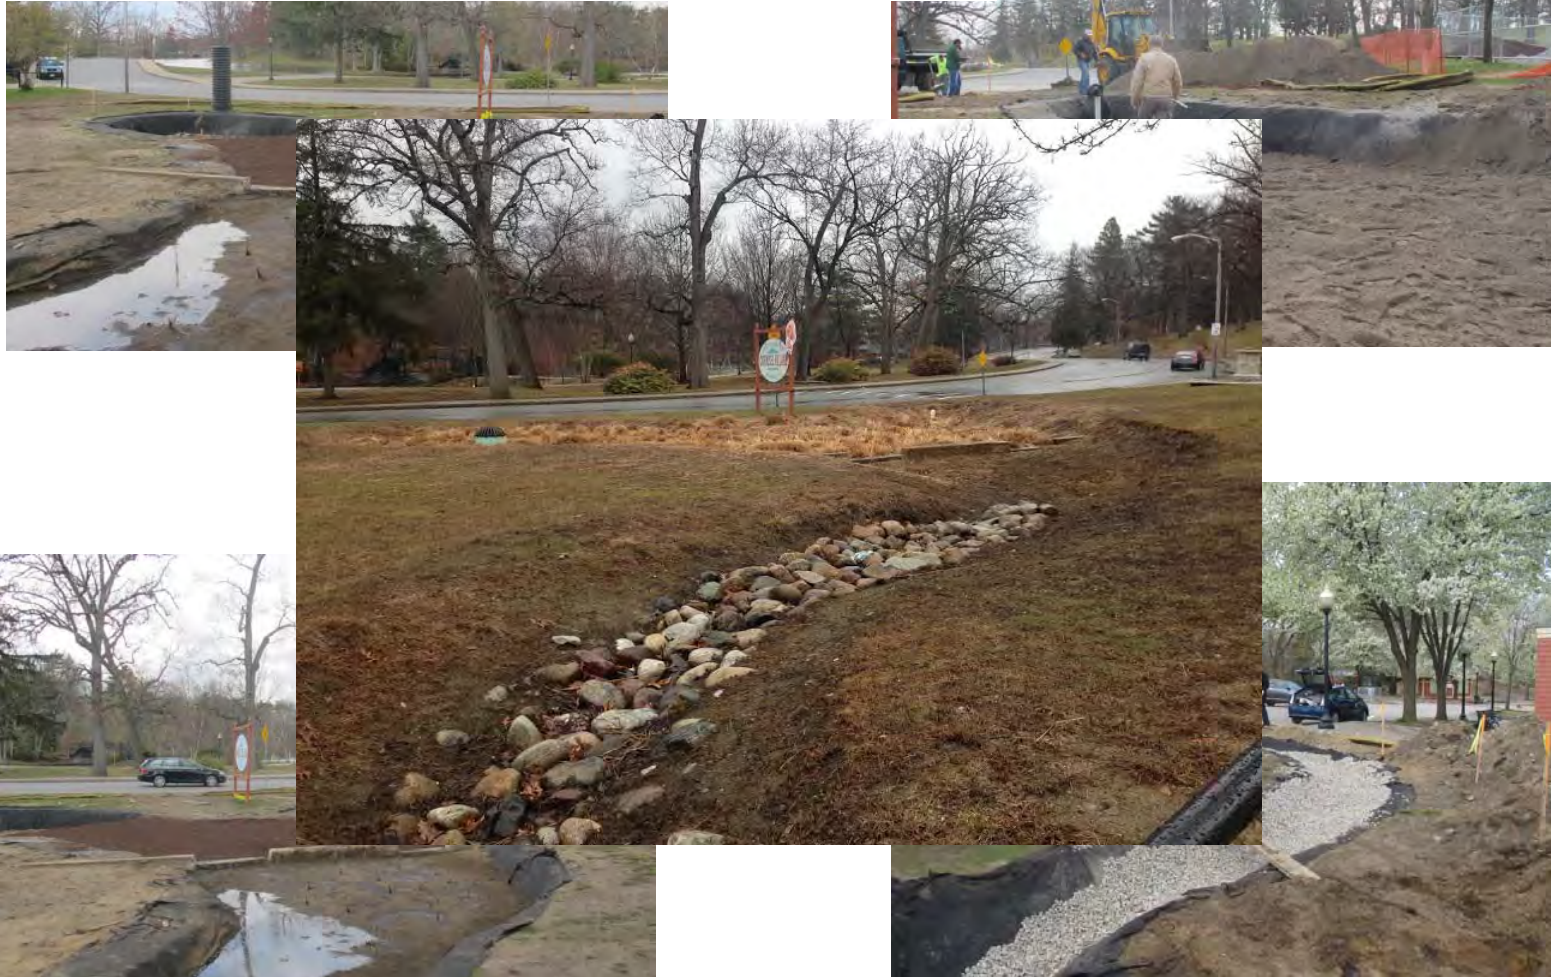
Roger Williams Park Carousel infiltration area

- installed 2012

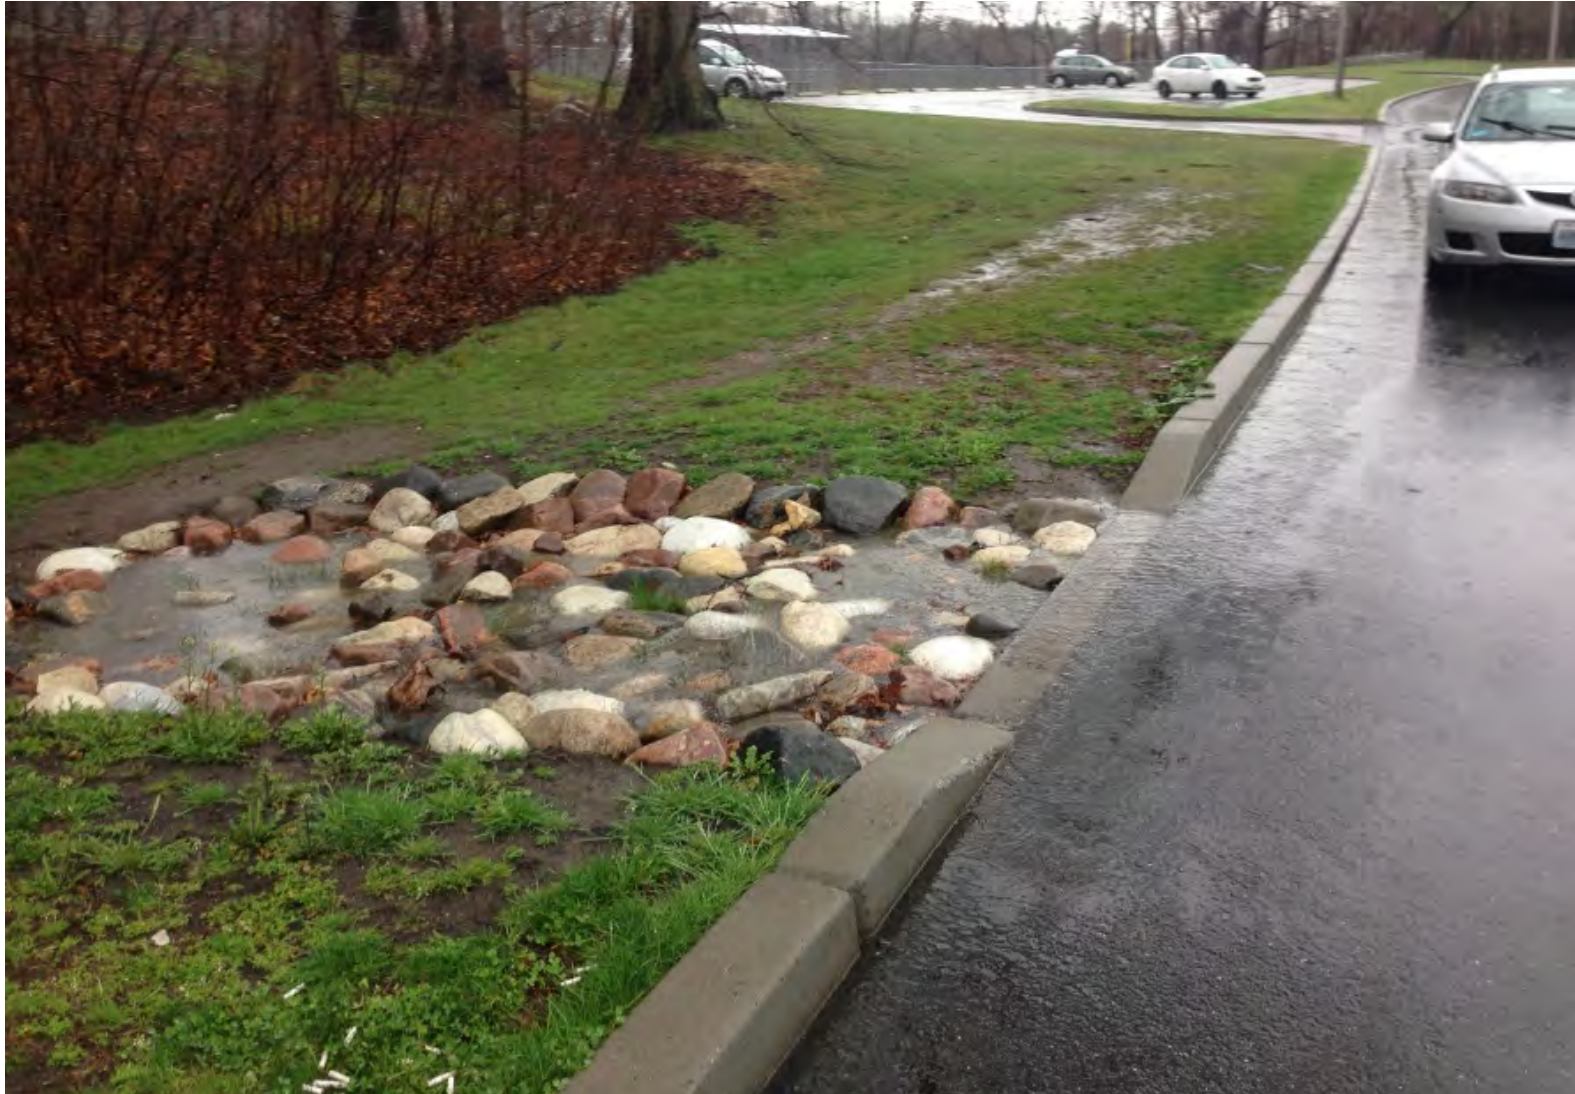
Roger Williams Park stormwater infiltration: green curbs

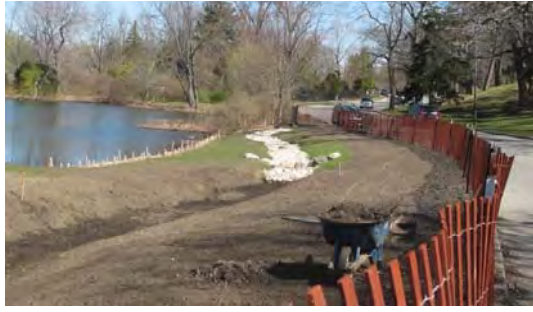
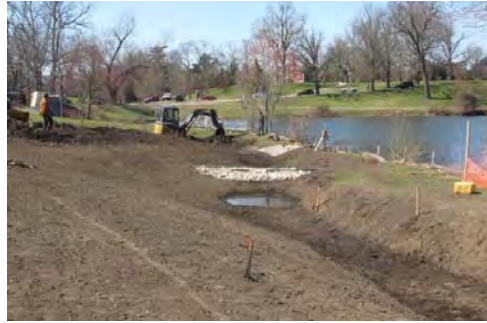
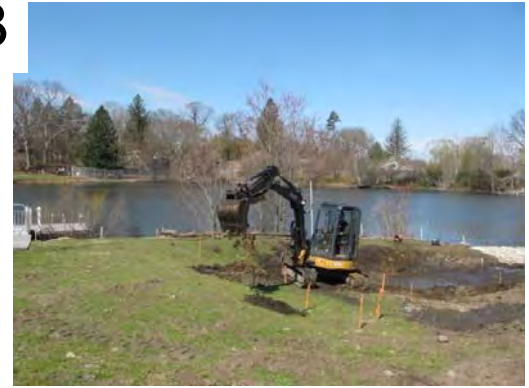
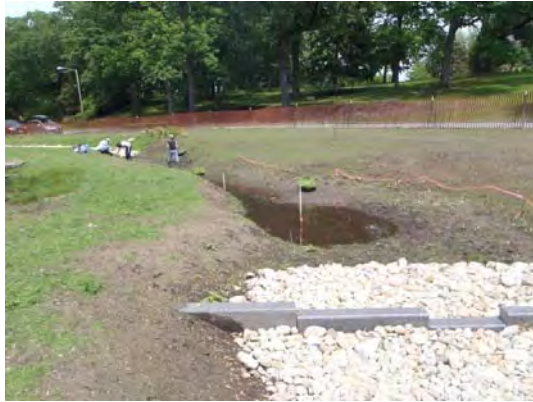
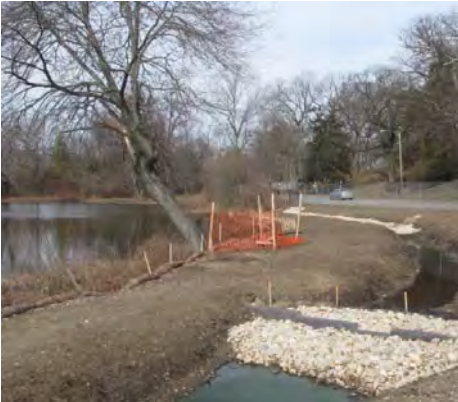
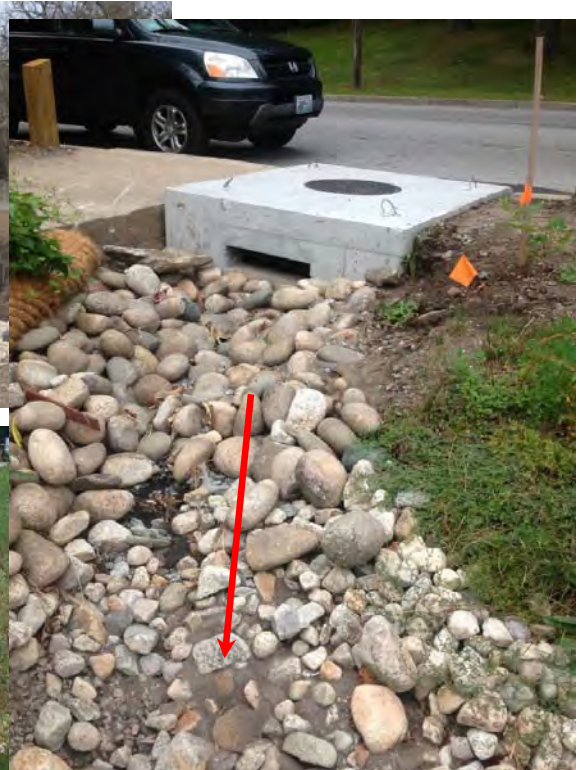
Polo Lake stormwater infiltration: 2013

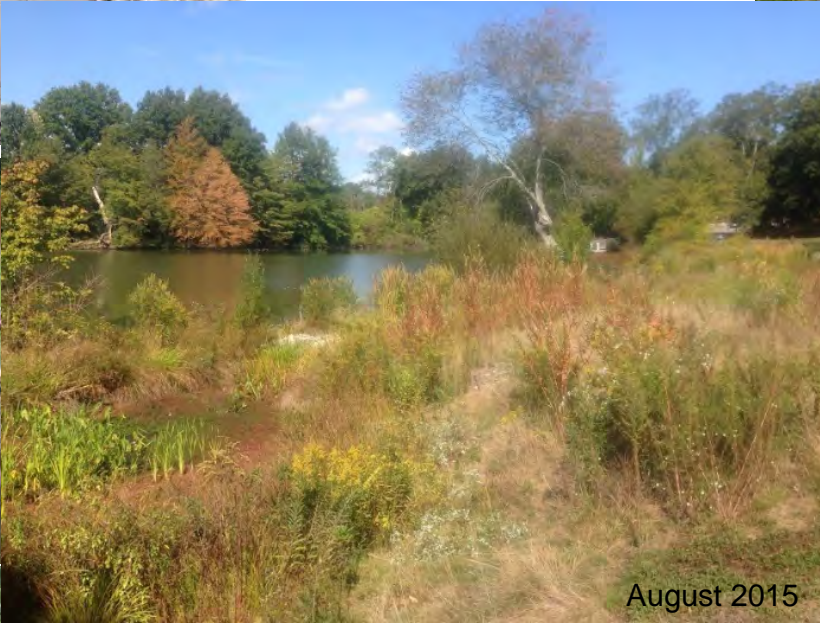
Polo Lake wetland/buffer planting: 2013

August 2015

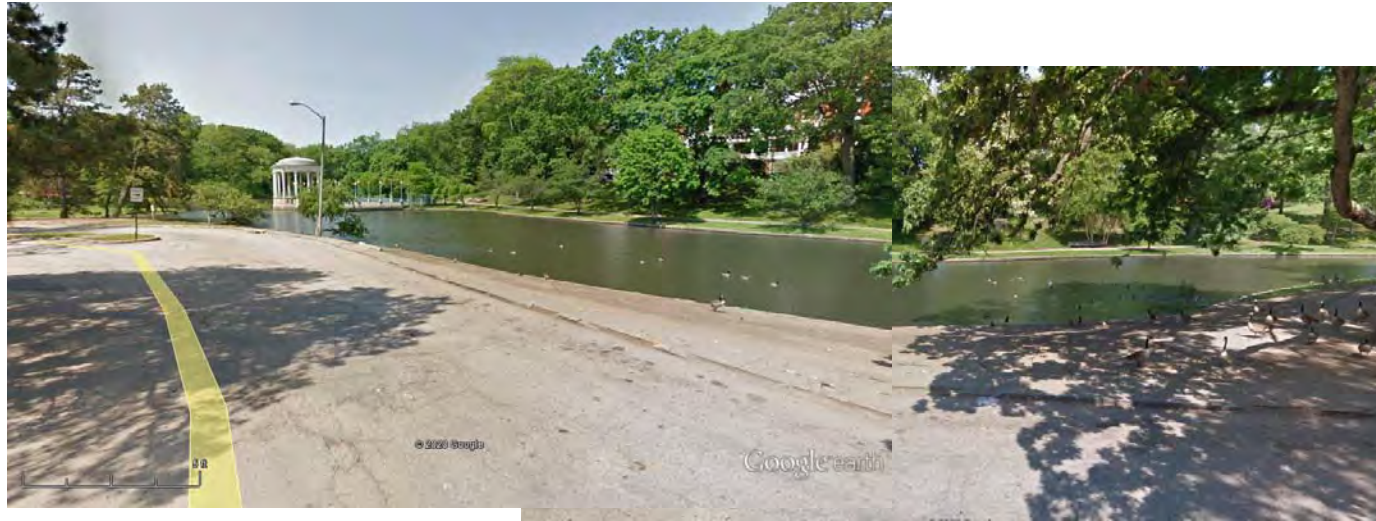
Roosevelt Lake road removal: 2013

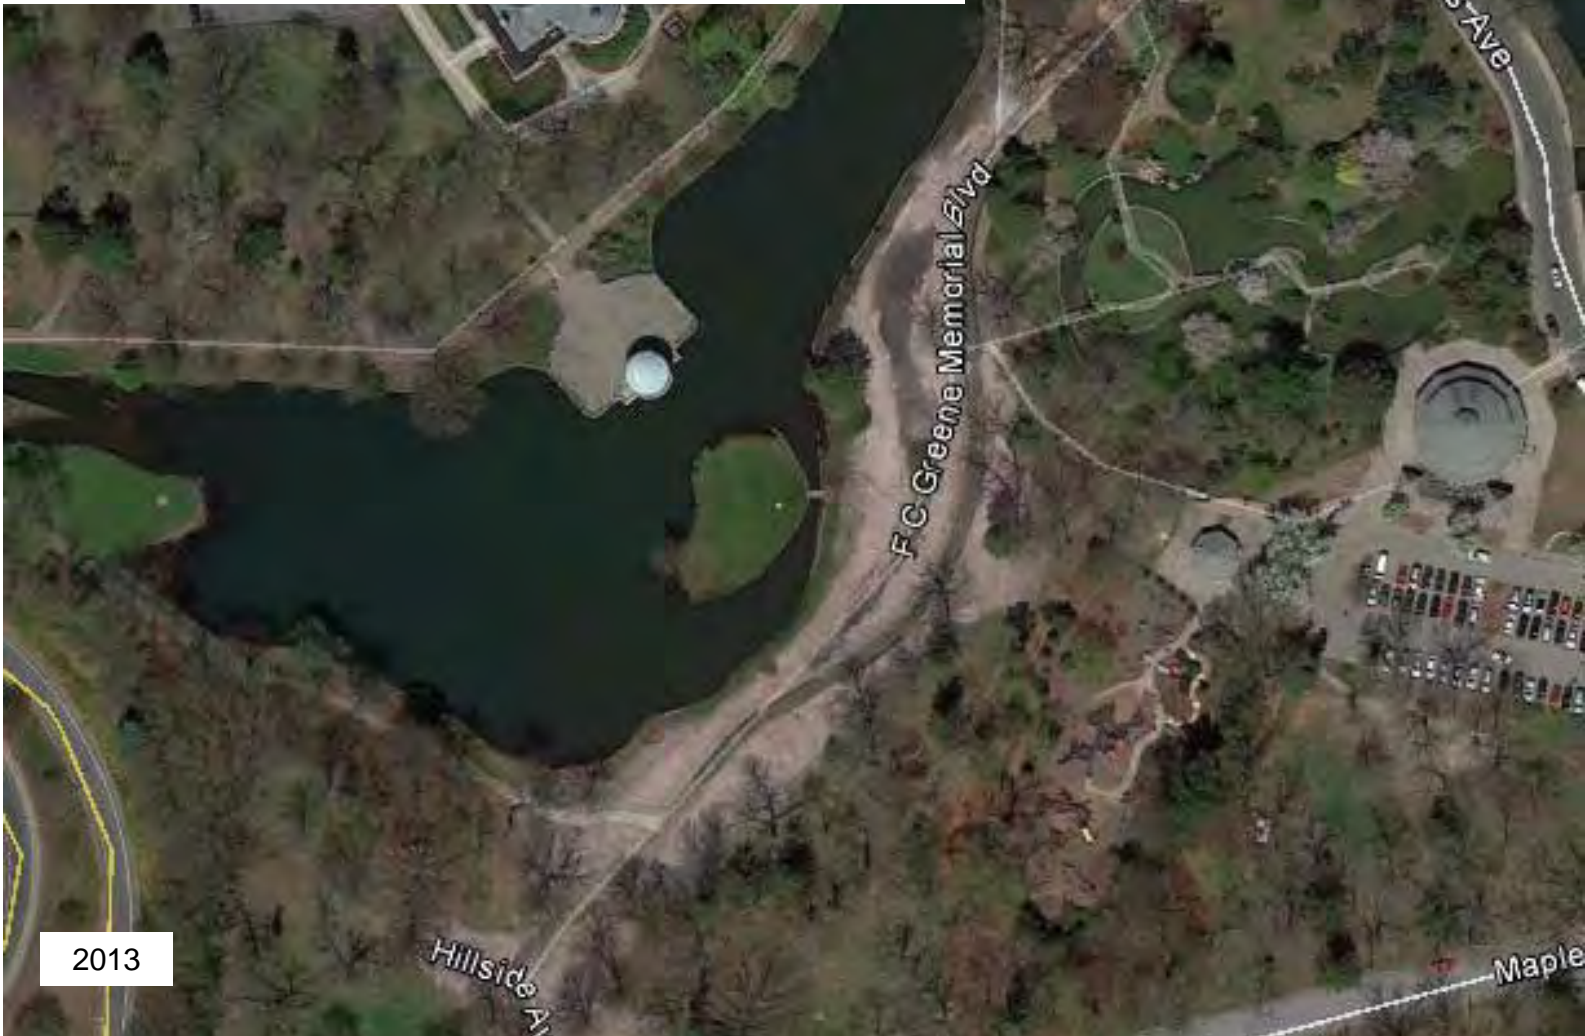
Roosevelt Lake road removal: 2013

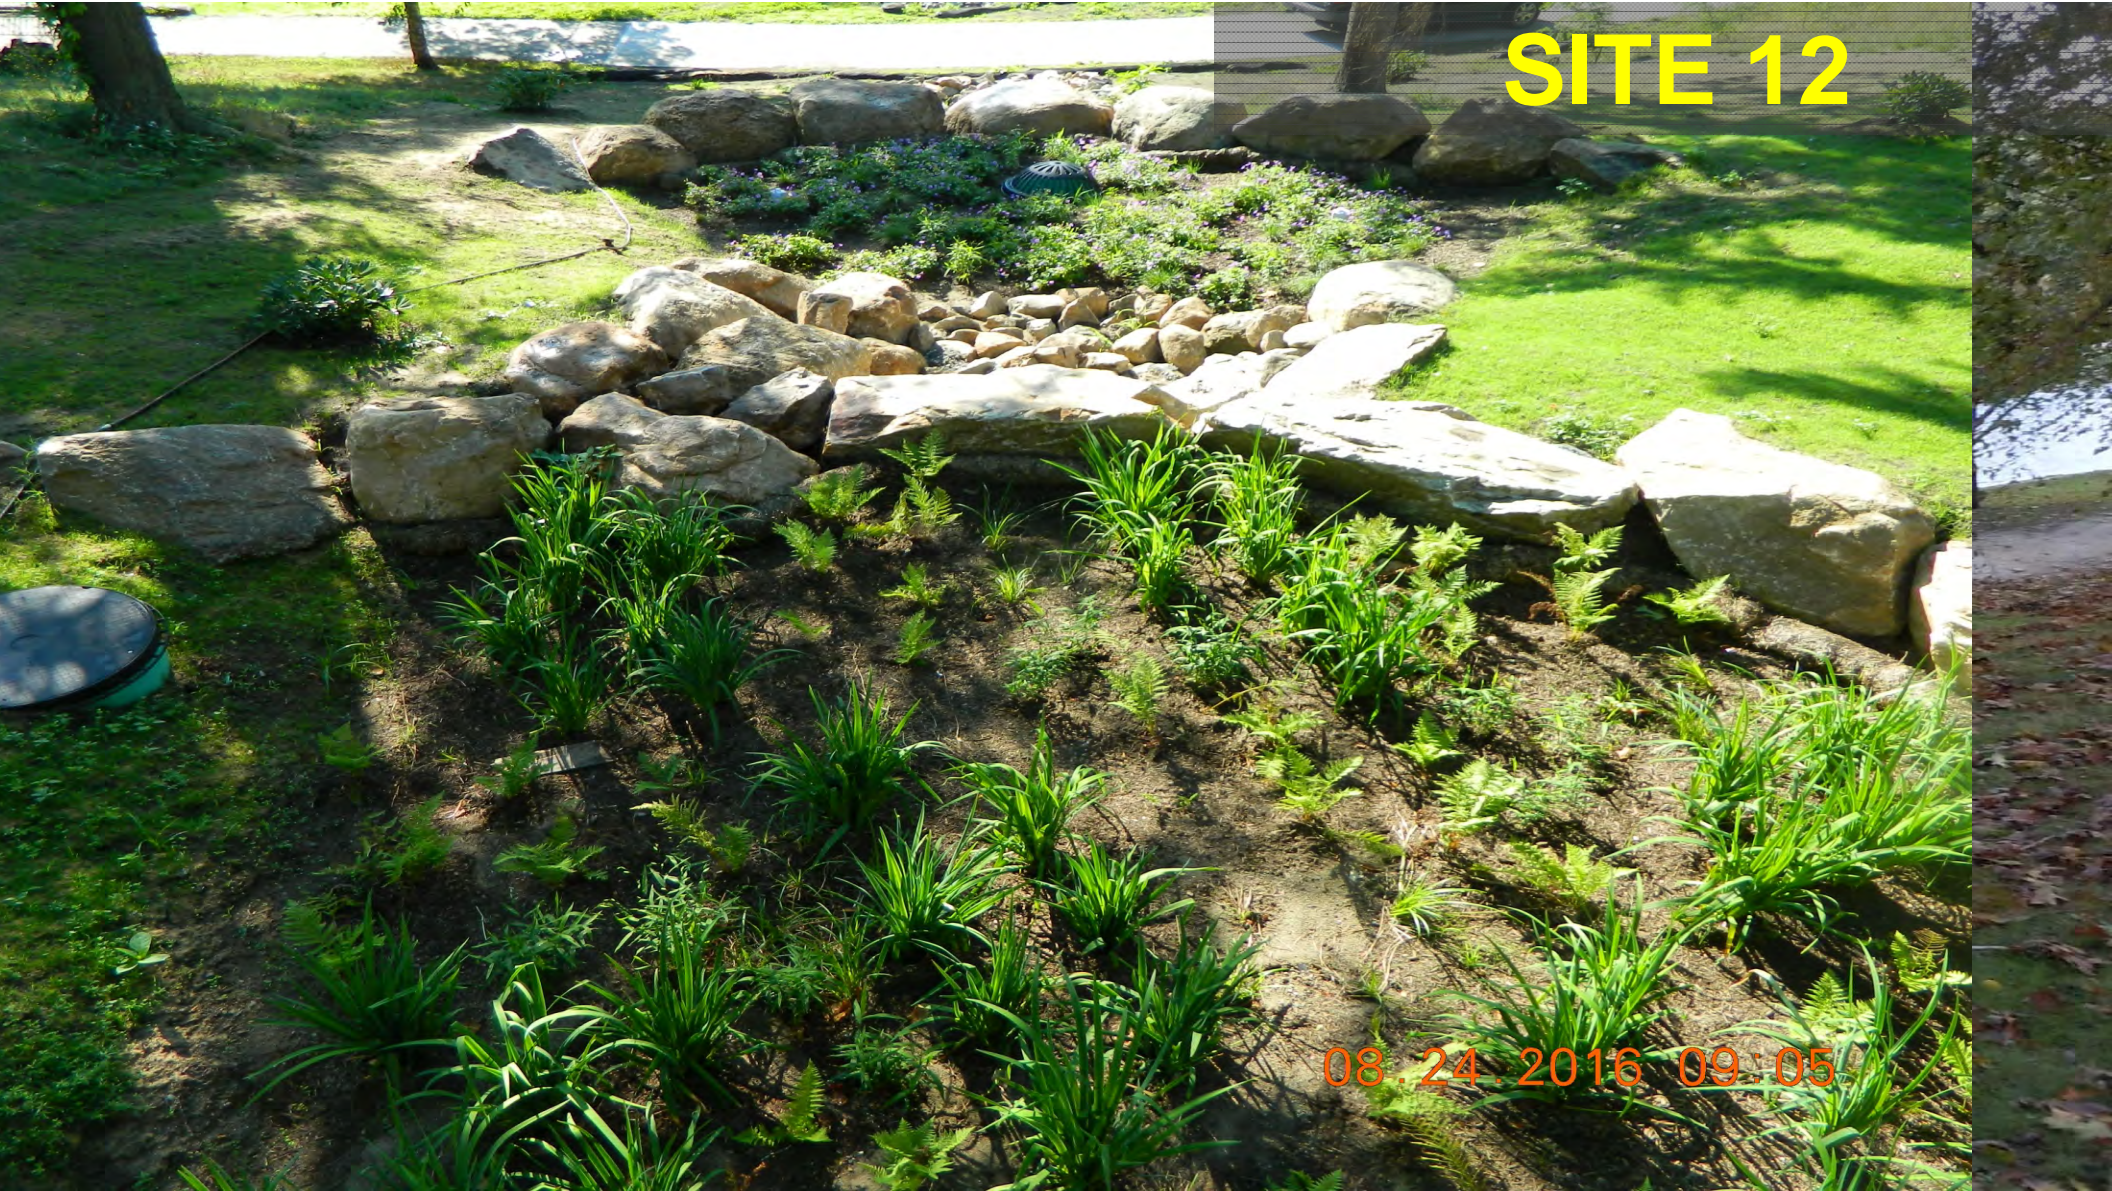
Breach in System Boulder Wall

Construction Practice

- Boulder Walls Need to be Set Higher in Terrace
- Mortar or Fill Voids in Boulder Walls
- Confirm Overflow is Lower Than Boulder Wall

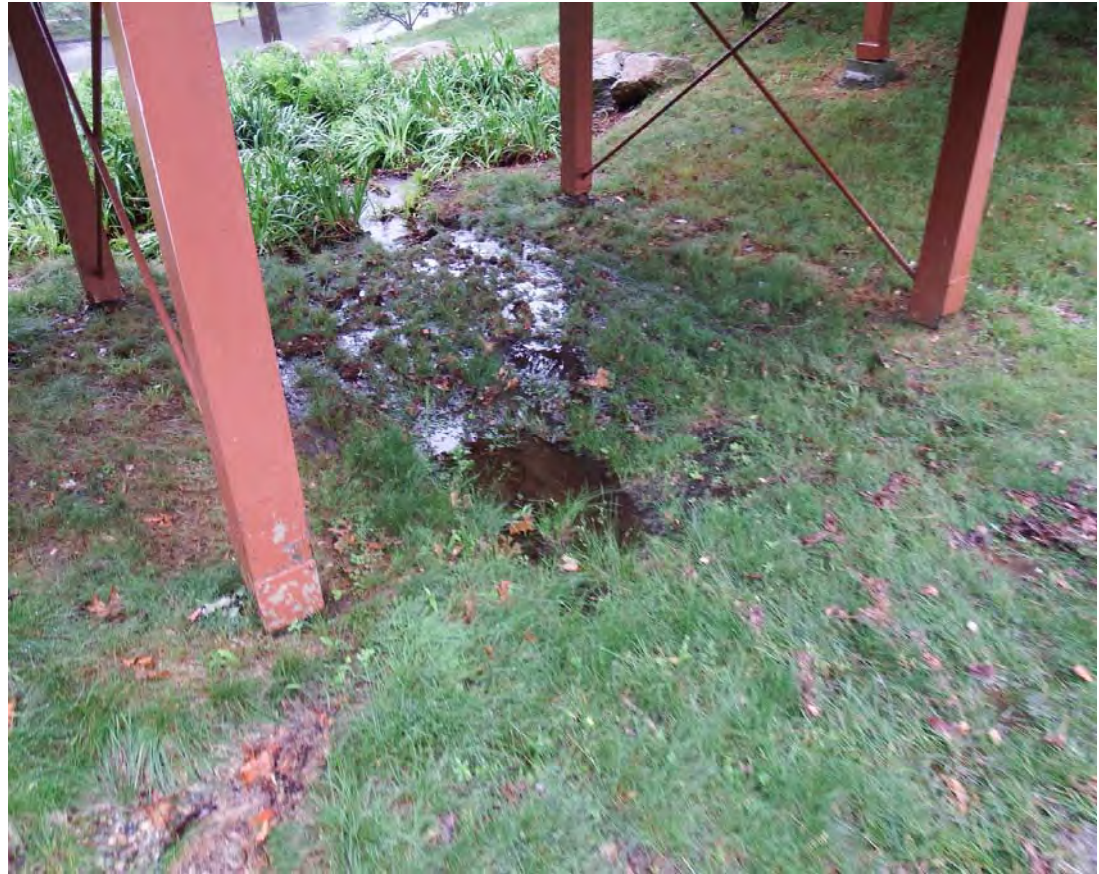
SITE 17/18-WET SWALE

Stormwater
Pretreatment

Buffer Restoration

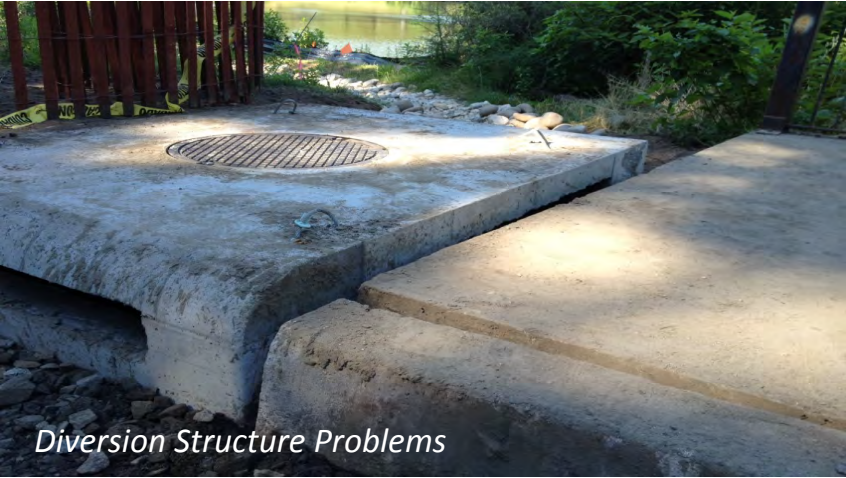
Diversion Structure Problems

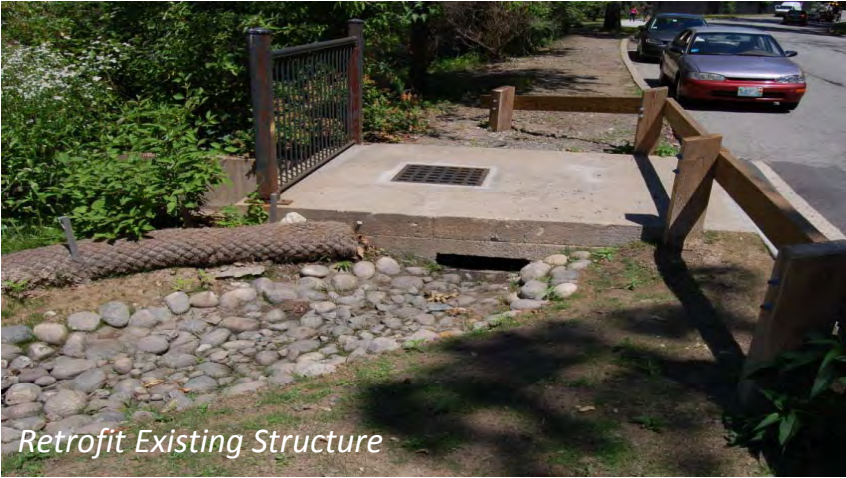
Retrofit Existing Structure

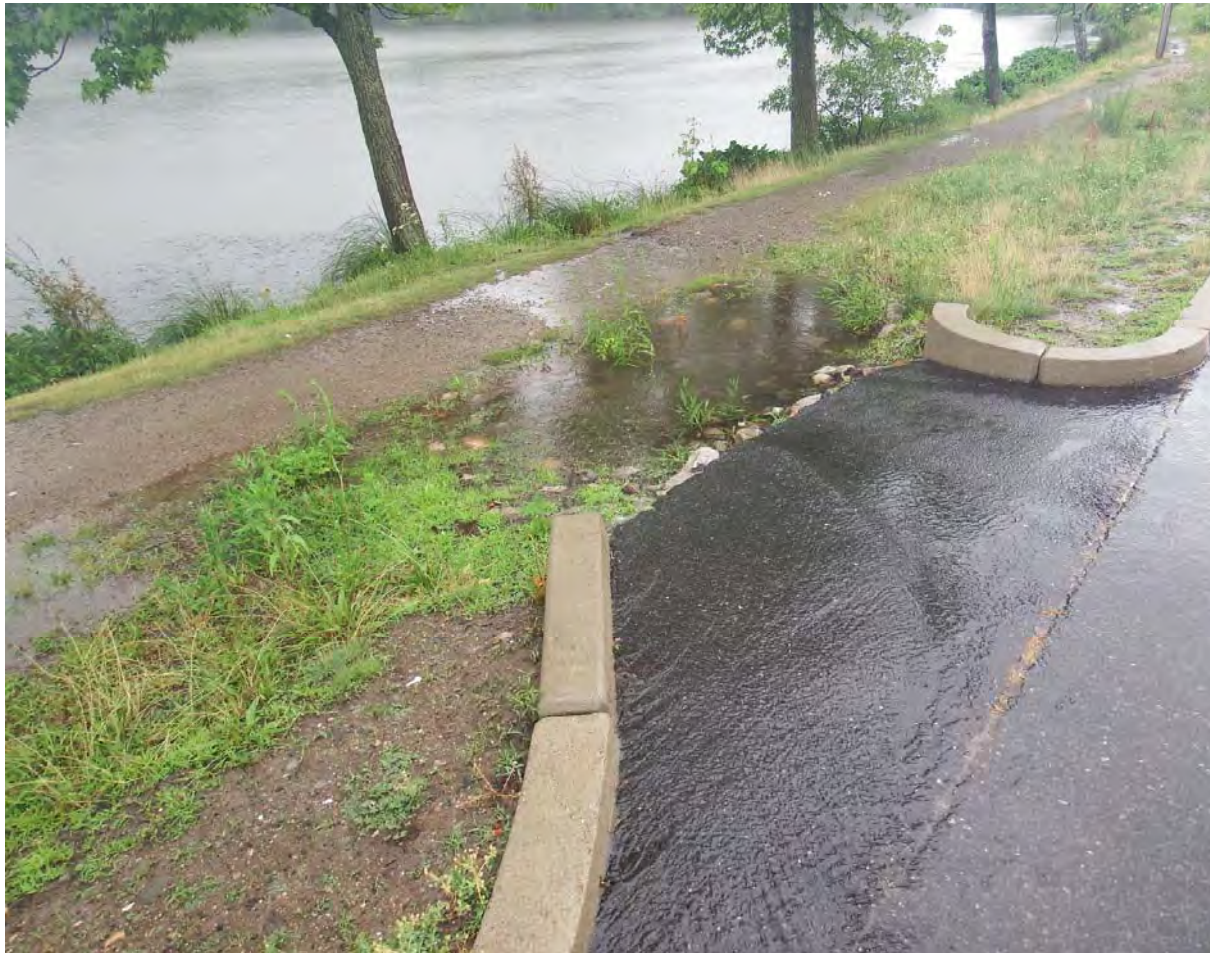
System Malfunction – Berm Elevation

Over Compaction

- Control Access
- Review Materials
- Repair
- Re-establish Proper Elevation for Water Direction

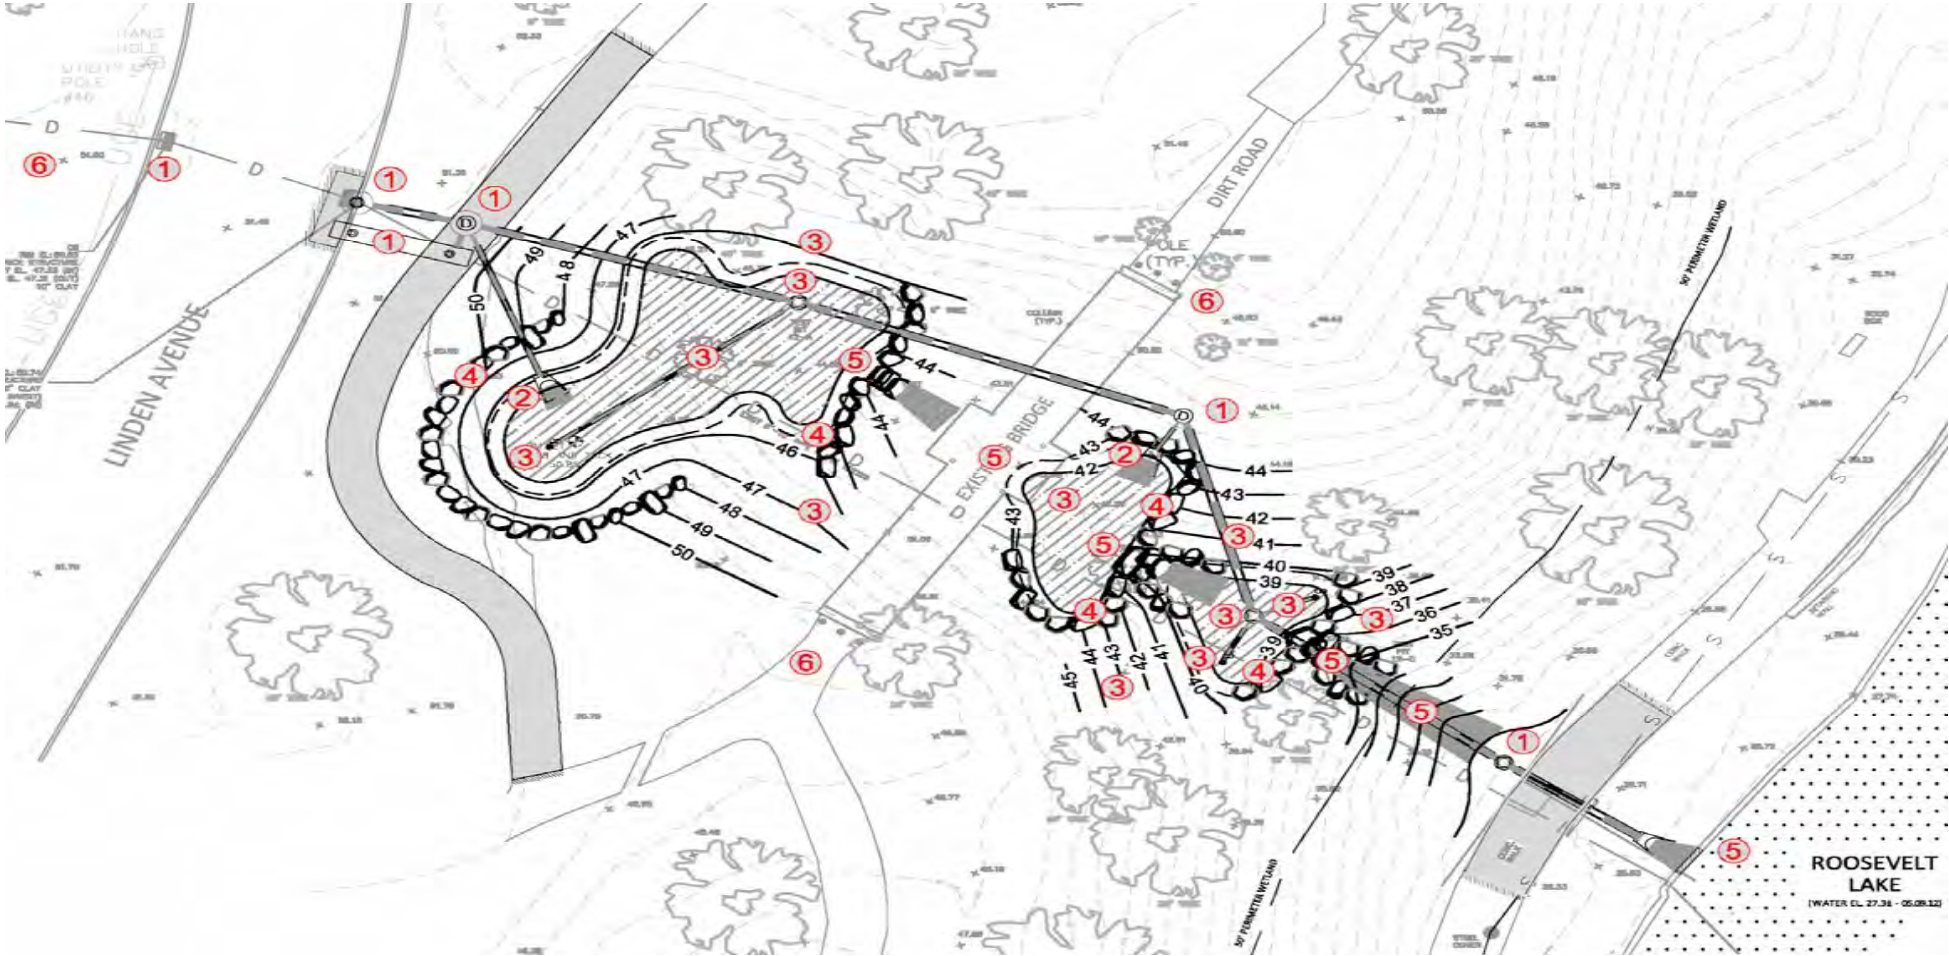
**Roger Williams Park - Providence, RI
Site 12 – Terraced Bioretention
Operation and Maintenance Checklist**

Maintenance Item	Description	Maintenance Required? (Y/N)
1. Drainage Structures: Includes: Manholes/Diversion Structures/Water Quality Units and Outlets Inspect annually and after major storm events (2" of rain or greater)		
Debris	Remove all trash, leaf litter and debris.	
Manholes/Diversion Structures/Outlets	Check for sediment accumulation that impacts inflow. If sediment accumulation. Schedule cleaning. Check for leaf litter and inlet clogging and clear.	
ADS Water Quality Unit	Per manufacturers recommendations. See Appendix D of O&M manual.	
Drainage Network	Check contributing and associated catch basins, manholes and pipes for sedimentation/clogging

2. Bioretention Inlet Inspect annually and after major storm events (2" of rain or greater)		
Debris	Remove all trash and debris from the swale and forebay.	
Sediment/Organic Debris Removal	Check for sediment accumulation. Remove sediment as necessary	
Vegetation Maintenance	Check to ensure vegetation is not blocking the inlet. Prune/thin vegetation as necessary. Remove undesirable woody vegetation and weeds.

3. Bioretention System Inspect at least bi-annually and after major storm events the first year; then annually and after major storm events (2" of rain or greater)		
Debris	Remove all trash and debris from the surface of the bioretention system.	
Side Slopes	Check for signs of erosion gullies, animal burrowing, or slumping. Repair as necessary.	
Sediment	Check for sediment accumulation that impacts infiltration. Remove any sediment accumulation and properly dispose.

Maintenance Item	Description	Maintenance Required? (Y/N)
Vegetation Maintenance / Replacement	Check for erosion and signs of scouring. Remove and replace ill-established, dead or severely diseased plants annually. Remove undesirable woody vegetation and weeds. See Sheet LA-1 of Construction Plans for appropriate species. Grasses should be cut back annually in the spring.	
Overflow Structure	Check for sediment accumulation that impacts inflow. If sediment accumulation. Schedule cleaning. Check for leaf litter and inlet clogging.	
Water Draining properly	If standing water is observed in the bioretention area 48 hours after a storm event: Check cleanouts for underdrain clogging. See plans Aerate/Rototill the bottom 6 inches to breakup any hard-packed sediment, and replenished with mulch

4. Boulder Walls Inspect annually and after major storm events (2" rain or greater)		
Boulder Walls	Check for wall settlement, areas of erosion or water seepage. Repair as necessary.

5. Emergency Spillways Inspect annually and after major storm events (2" rain or greater)		
Emergency Spillways	Check for settling gullying, erosion damage or settling. Repair as necessary and return to design grades.	
Overflow	Look for areas of erosion in the overflow swale between bioretention areas. Repair as necessary.

6. Routine Grounds Maintenance Inspect annually or as needed.		
Debris	Remove trash from perimeter areas.	
Pavement Sweeping	Sweep roads minimum once a year after spring thaw.	
Contributing drainage area	Check for erosion/sediment sources from the surrounding area

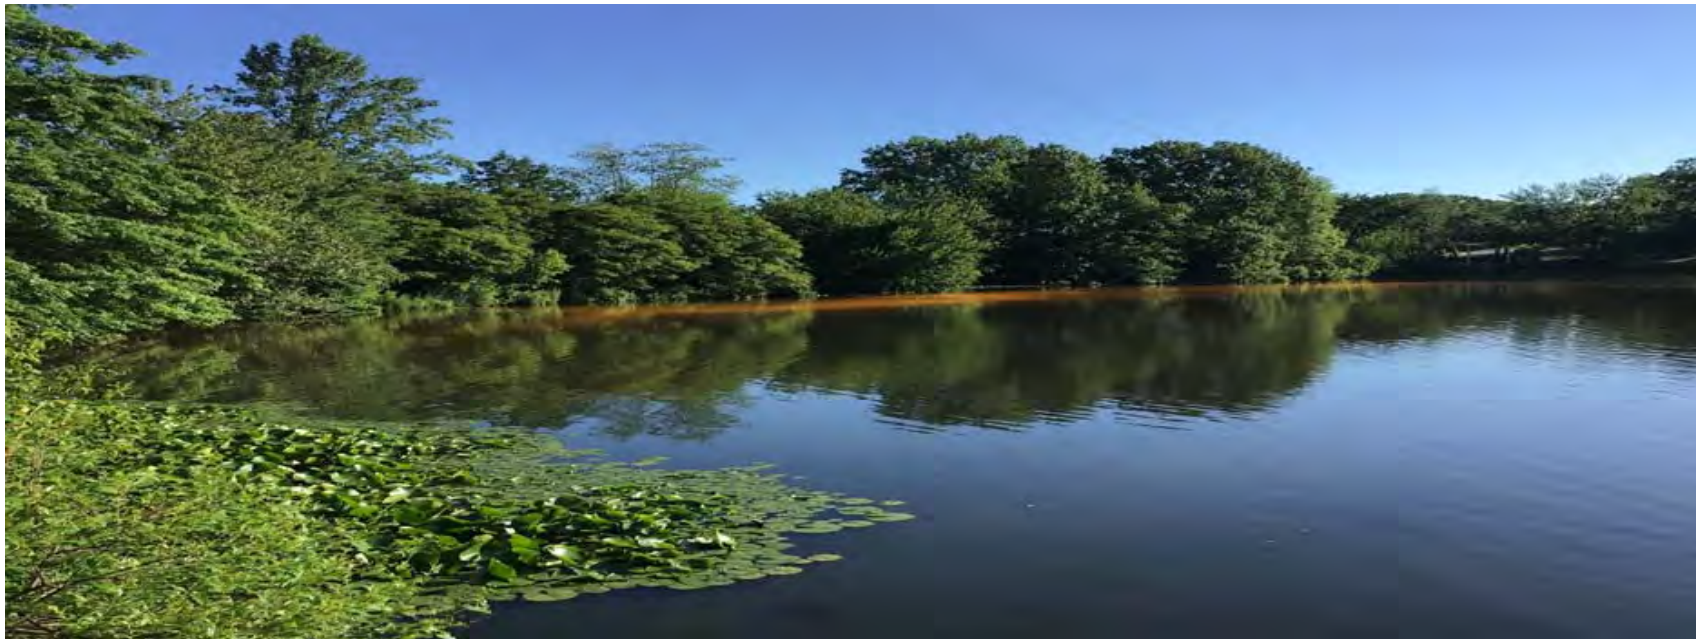
Cyanobacteria Monitoring

- Organize Volunteers to participate in Cyanobacteria Monitoring Collaborative
- Bloomwatch App
- Cyanoscope Training

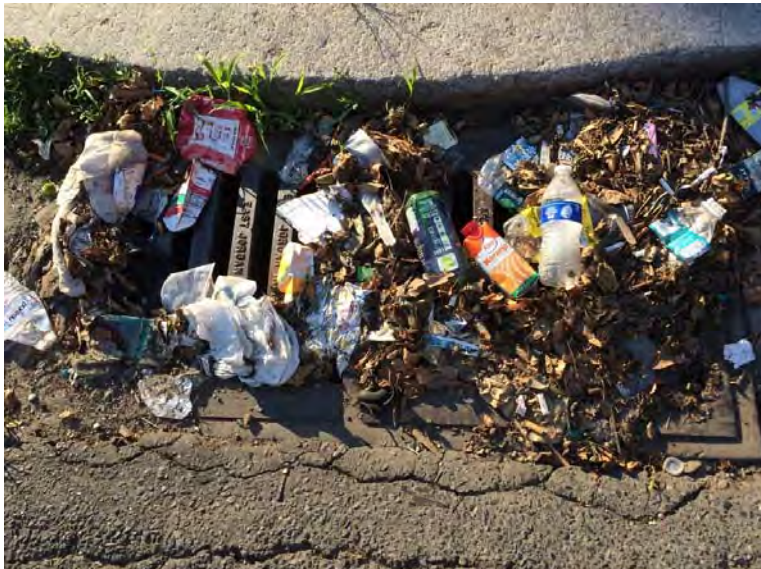
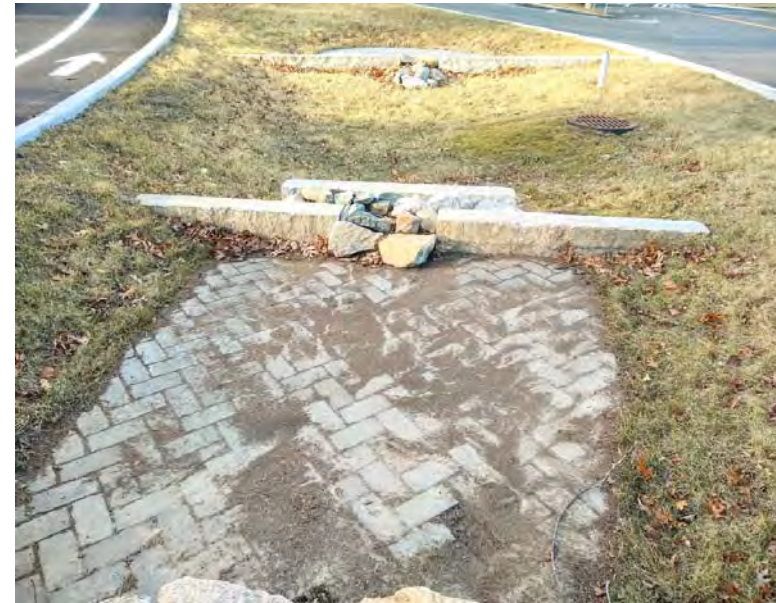
Visual Inspections of BMPs

- Inlet and outlet are functioning
- Invasive plants
- Trash, debris, leaves
- Excessive sediment in forebay
- Water draining properly
