# Providence Stormwater Innovation Center

## Providence Stormwater Monitoring Program

**Will Helt & Ryan Kopp**

**Audubon Society  
of Rhode Island**

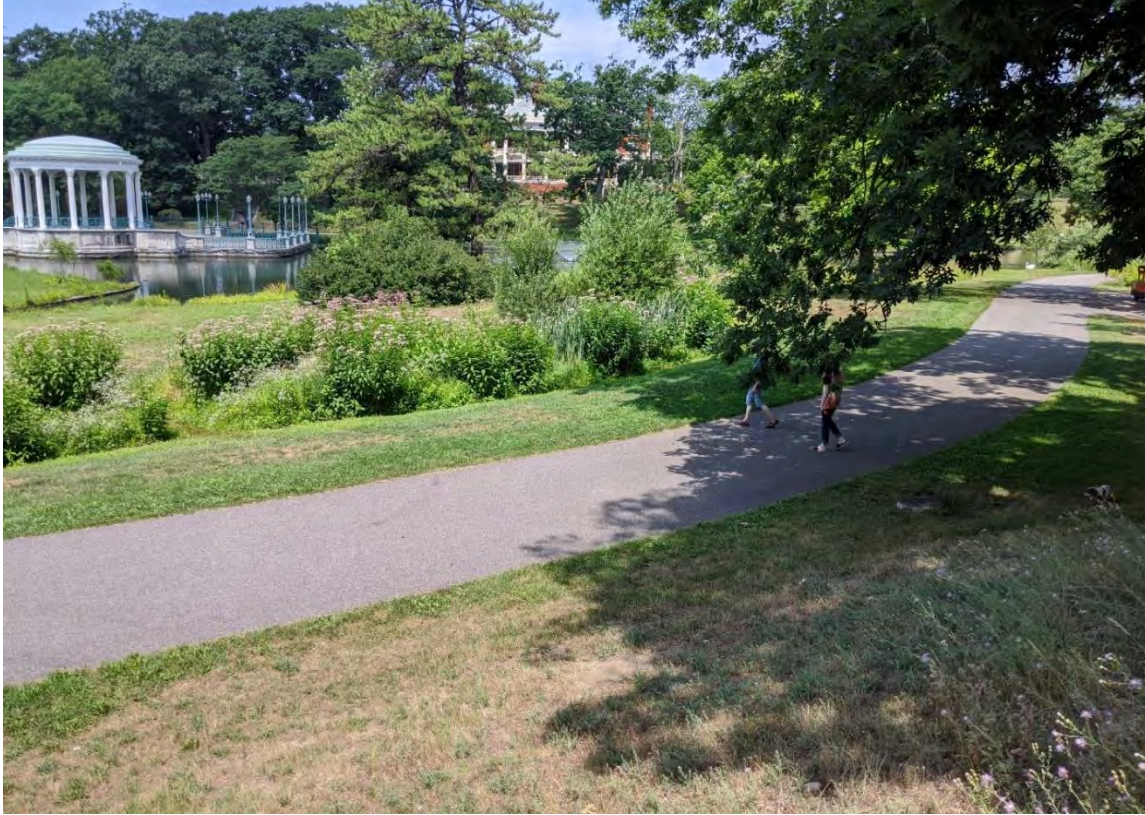
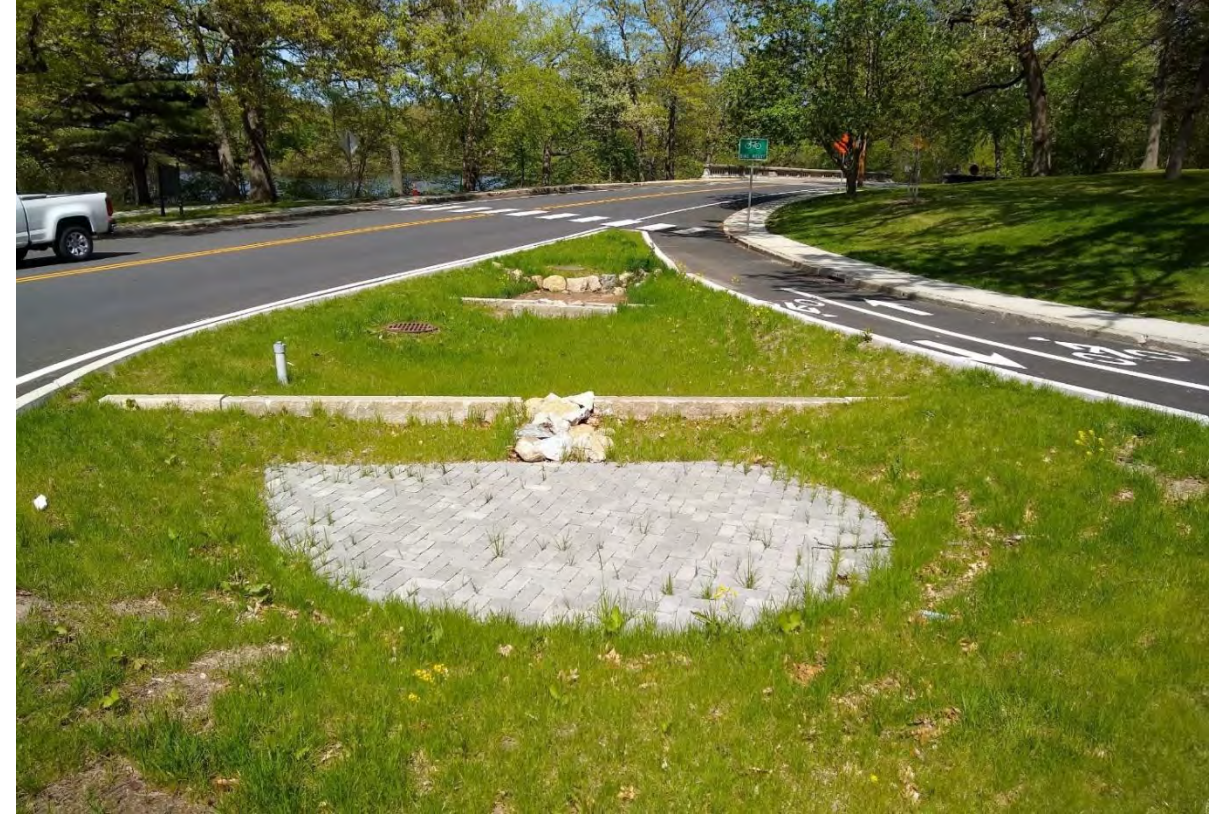
## Infiltration Basin - Bioretention Basin

# Structural BMPs

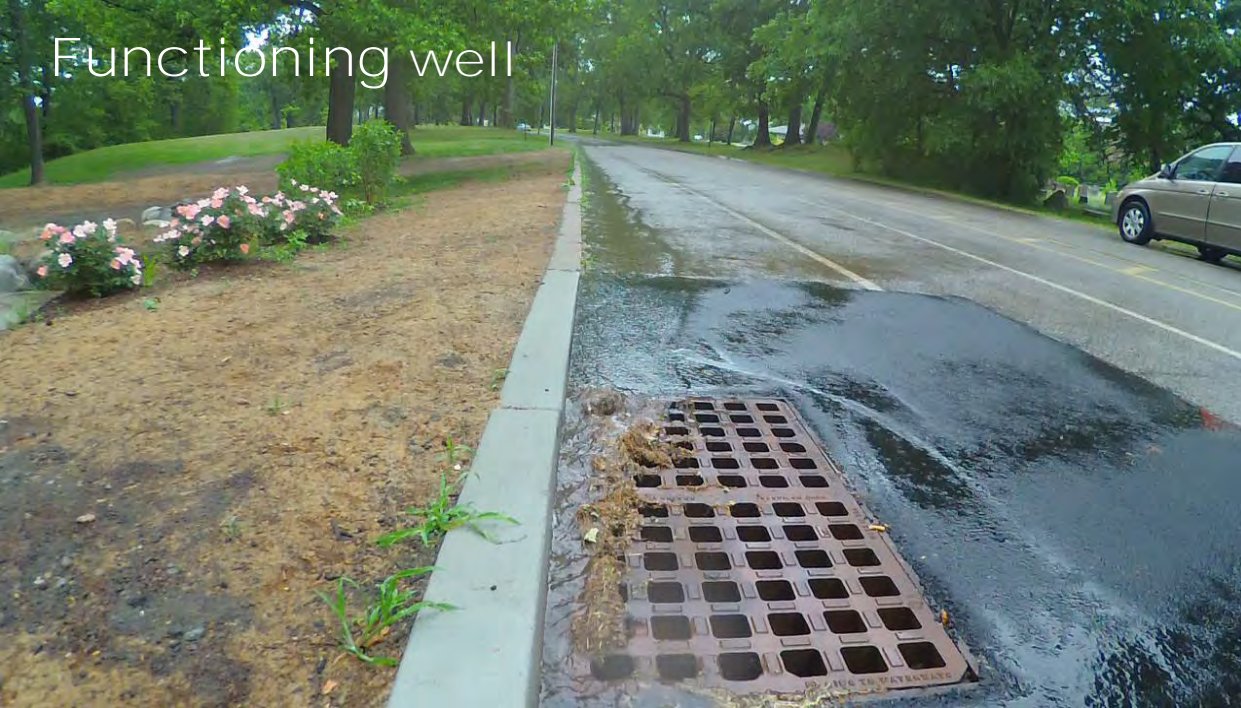
Functioning well

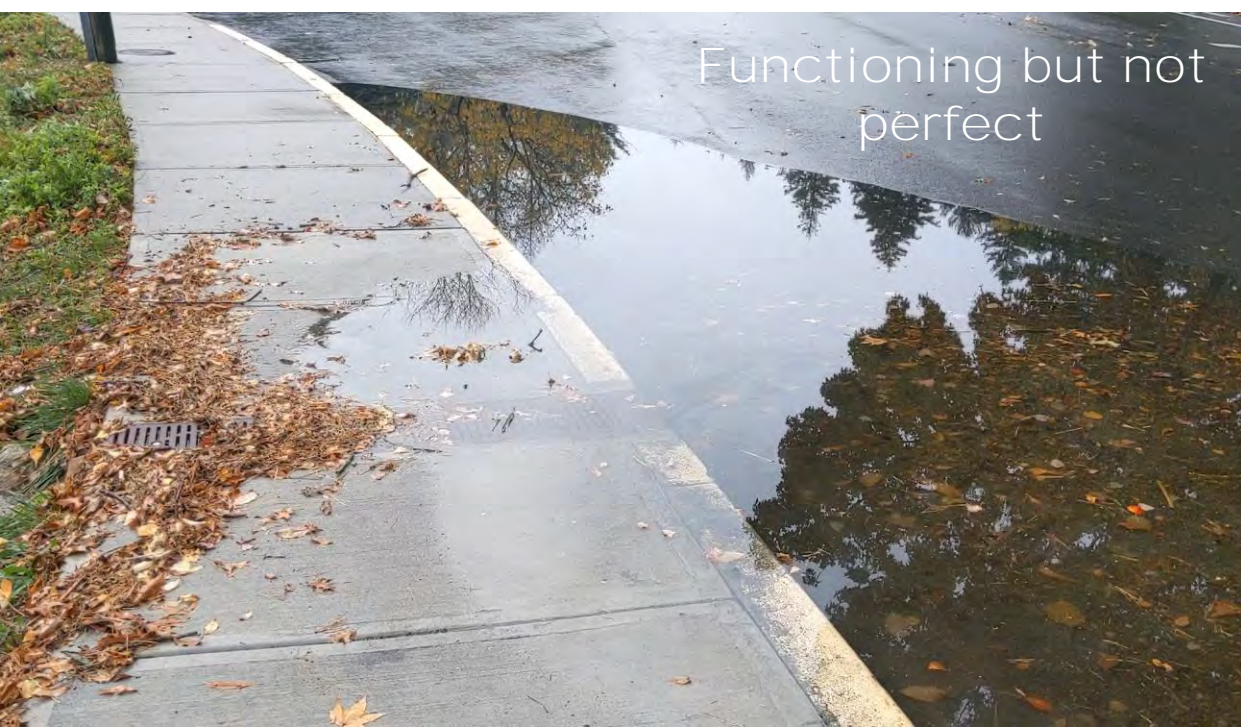
Functioning but not perfect

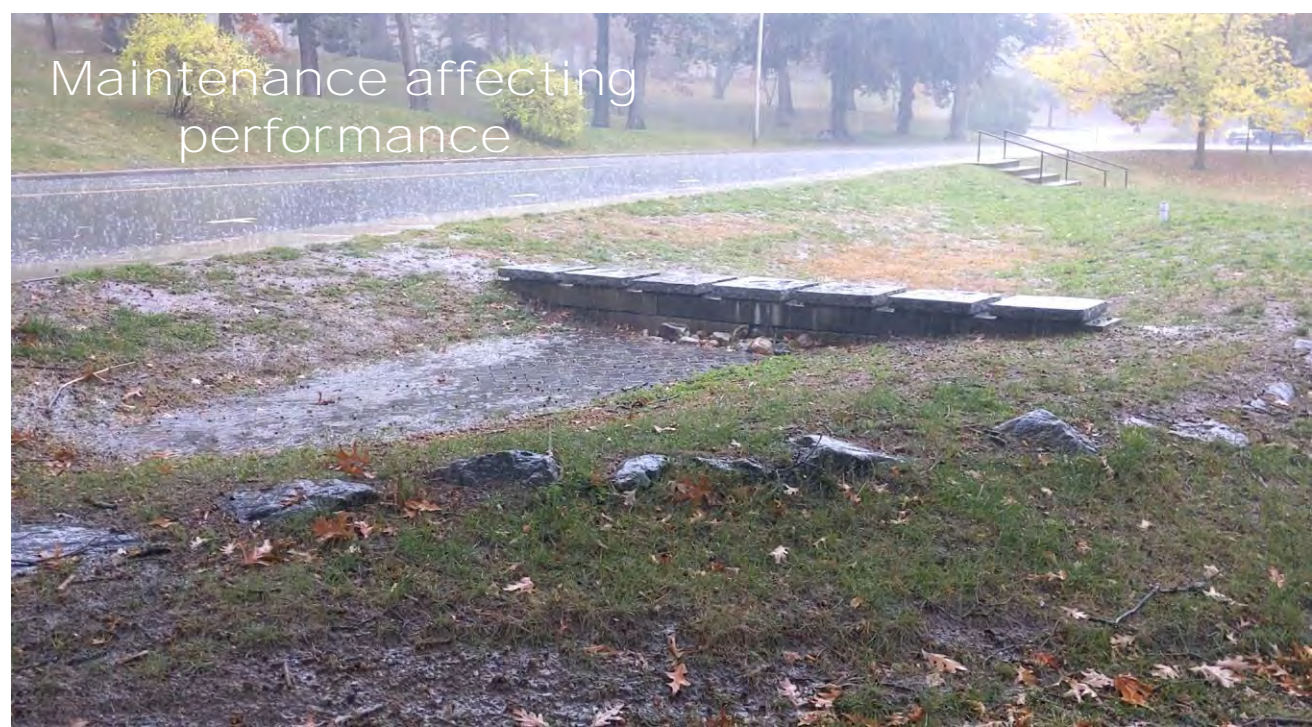
Maintenance affecting performance

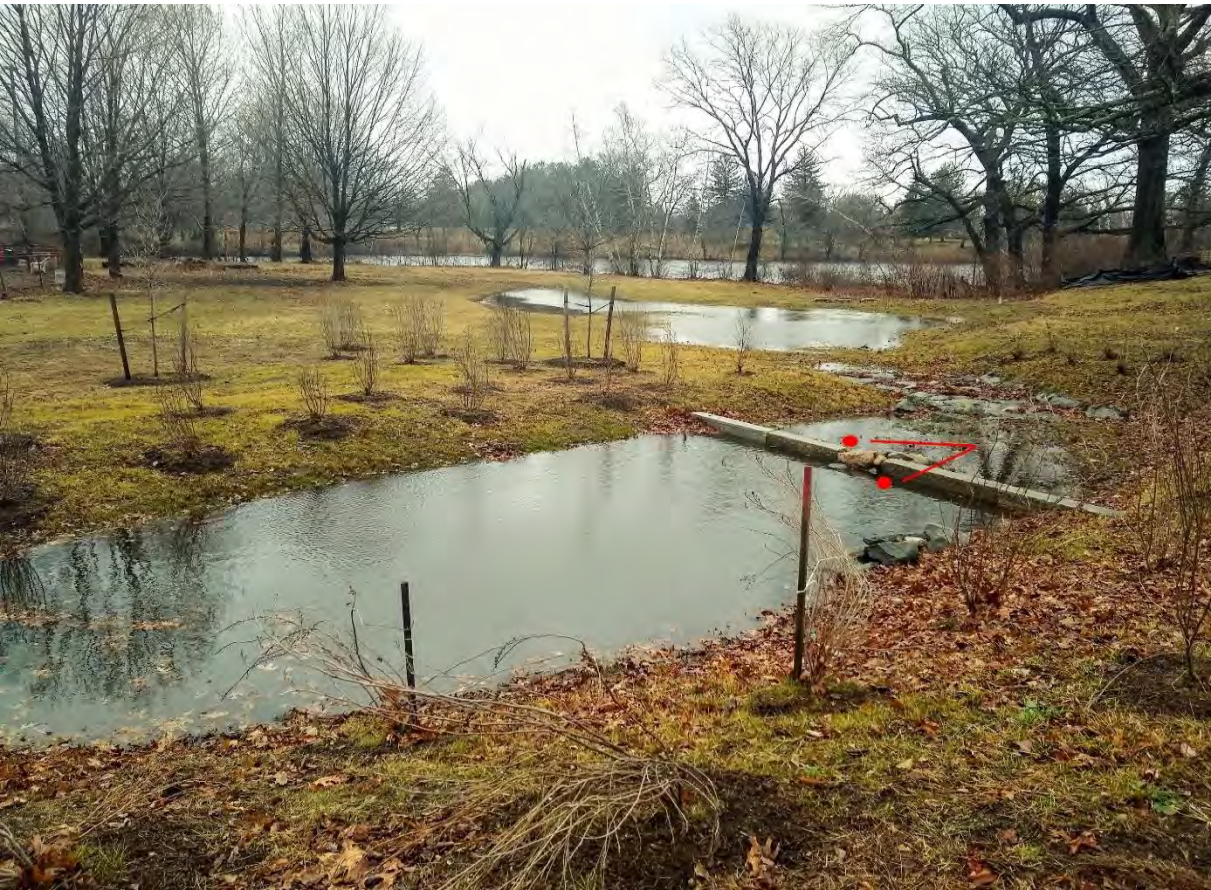
# Performance Monitoring

- Logging pressure transducers in forebay, treatment area and well
- Survey the systems
- Compute volume of water entering the system
- Verify vs modeled volumes for a specific sized rain event
- Rotate transducers between BMPs twice per year

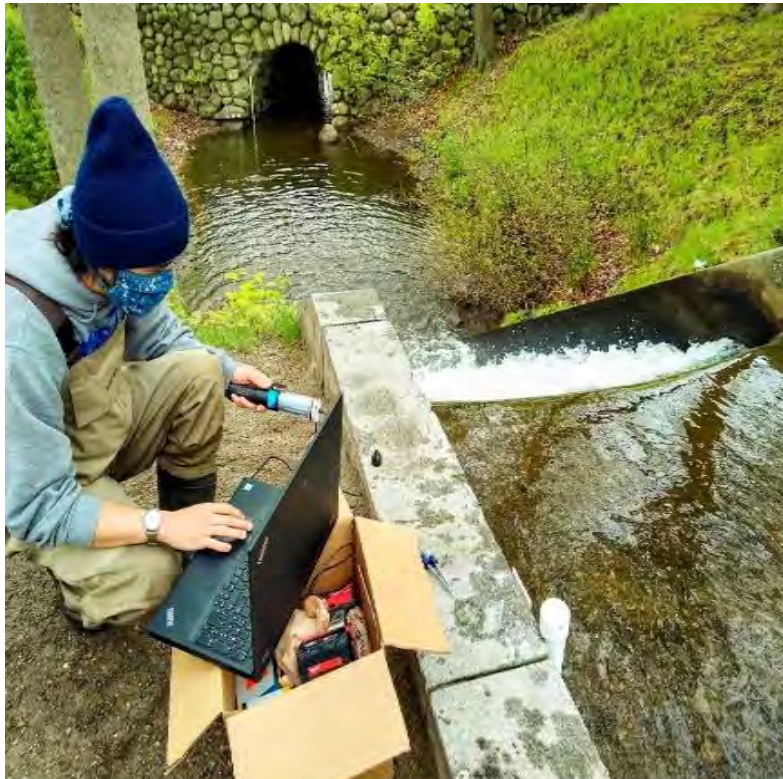
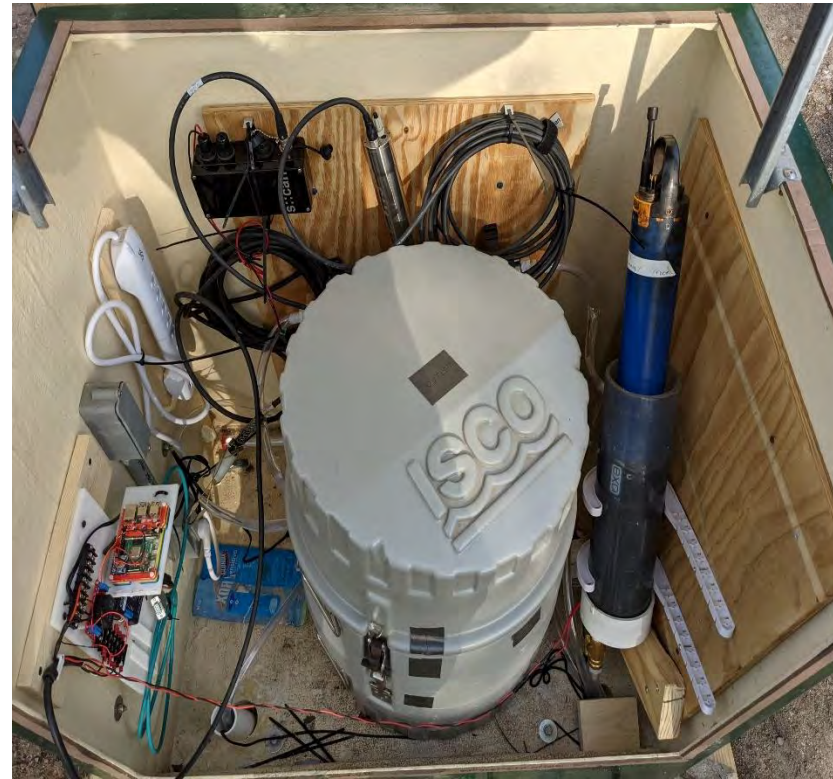
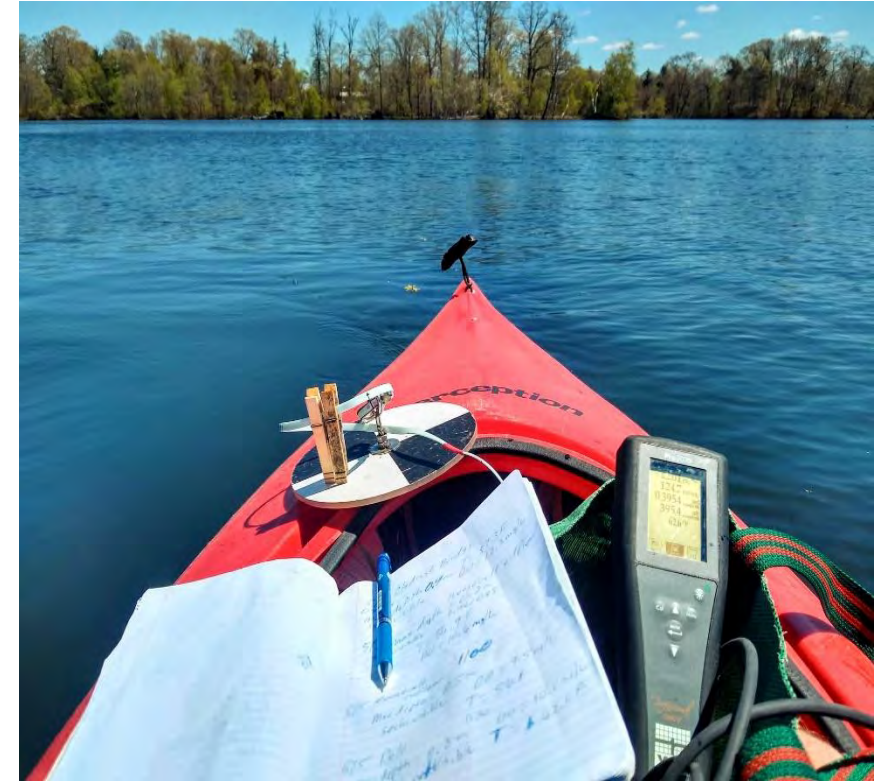
# Water Resource Monitoring

- Continuous Water Quality
- Continuous Streamflow
- Precipitation
- Volunteer Water Quality Sampling (Watershed Watch)
